AGENDA

Works Committee Meeting Tuesday, 23 August 2022 at 6:30 PM

The Town of East Fremantle (Town) has engaged specialist coastal and port engineers, M P Rogers & Associates Pty Ltd (MRA) to prepare a 10-year riverwall maintenance priority plan. The Town manages approximately 3.5 km of foreshore which is comprised of mixed built, natural and private foreshore assets. The riverwalls and other built foreshore assets managed by the Town are the focus of this maintenance priority plan. It should be noted that while most of the Town's foreshore built assets can be classified as vertical block walls, some other built assets such as mortared rock revetments and groynes also exist and have been included the development of this riverwall maintenance priority plan. The foreshore managed by the Town extends from East Street in the west to Petra Street in the east as shown Figure 1.1.

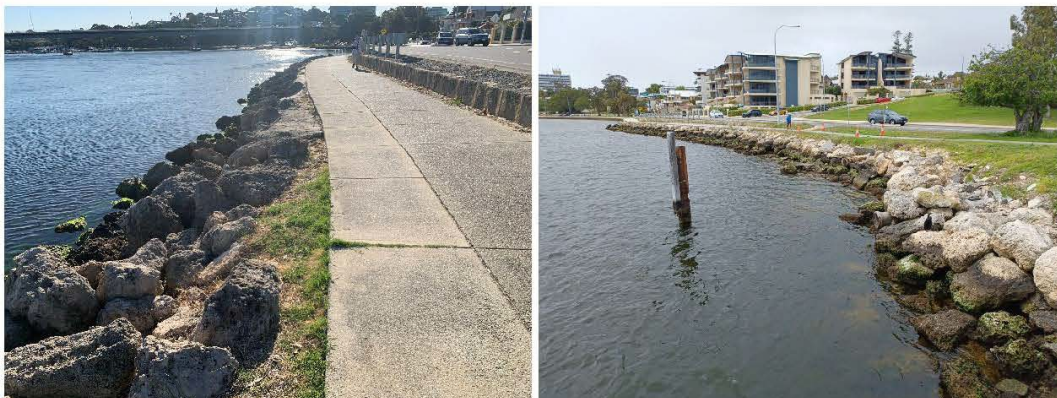
Figure 3.1 Path Behind Revetment (L) & Overtopping Damage (R)

Asset ID	Approximate Chainage (m))	Asset Type	Condition Rating	Consequence Rating	OCI
SLFre01 Fremantle Bridge.B01	0-20	Rock Revetment	4	3	19

This asset straddles the boundary of the City of Fremantle and the Town of East Fremantle. It appears that most of the asset is within the City of Fremantle's jurisdiction, however approximately 20 metres appear to lie within the Town's boundary. The asset is a limestone rock revetment in poor condition. It features undersize rock with steep sections, insufficient width and damage from uncontrolled surface runoff. There is evidence of voids and overtopping damage behind the crest.

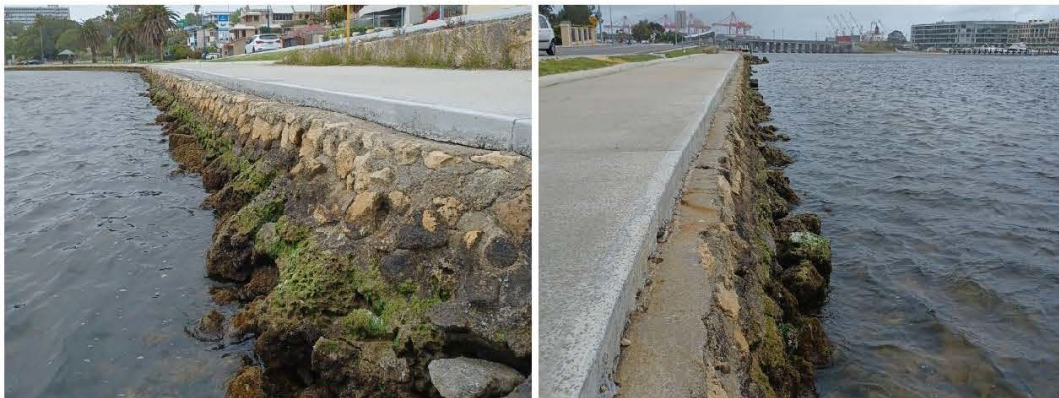
Figure 3.2 J Dolan Park Wall Looking East (L) & Looking West (R)

Asset ID	Approximate Chainage (m)	Asset Type	Condition Rating	Consequence Rating	OCI
SLEFr06 Stirling Bridge J Dolan Park.B03	20-80	Wall	3	3	13

The asset is a vertical wall made from mortared natural limestone rock backed by a concrete pedestrian path which serves as a capping. Some mortar decay around the toe is evident, causing voids and loose rock. The path is cracked in places, possibly due to a loss of fines through voids. Repointing and void repair maintenance works are recommended to prevent further damage to the path.

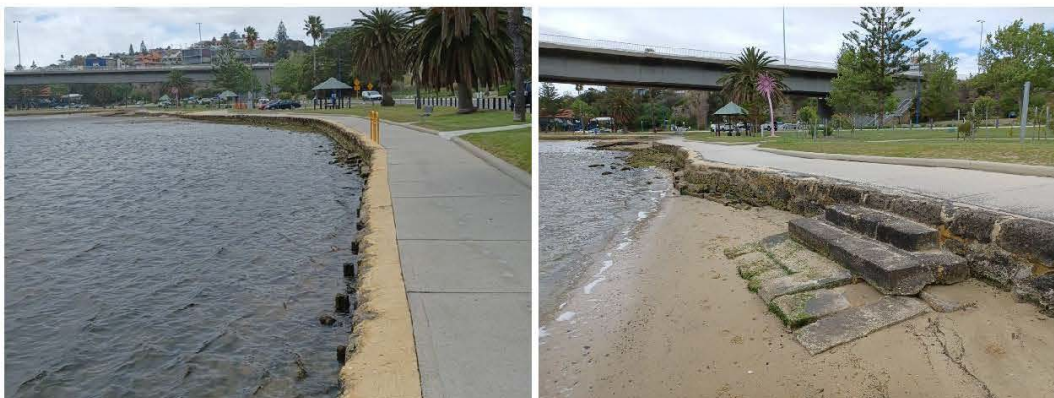
**Figure 3.3 Limestone Block Wall (L) & Access Stairs (R)**

Asset ID	Approximate Chainage (m)	Asset Type	Condition Rating	Consequence Rating	OCI
SLEFr06 Stirling Bridge J Dolan Park. B02	80-240	Wall	3	3	13

The asset is a low vertical limestone block wall backed with a concrete pedestrian path which serves as capping. Panel/post toe protection is present at the upstream and downstream extents. The wall is generally in fair condition, with the face and crest showing signs of recent regrouting. The limestone block steps are in poor condition and require rebuild. The concrete path on crest appears to be relatively new and is in good condition. Scheduled maintenance is recommended to maintain the asset to its current condition.

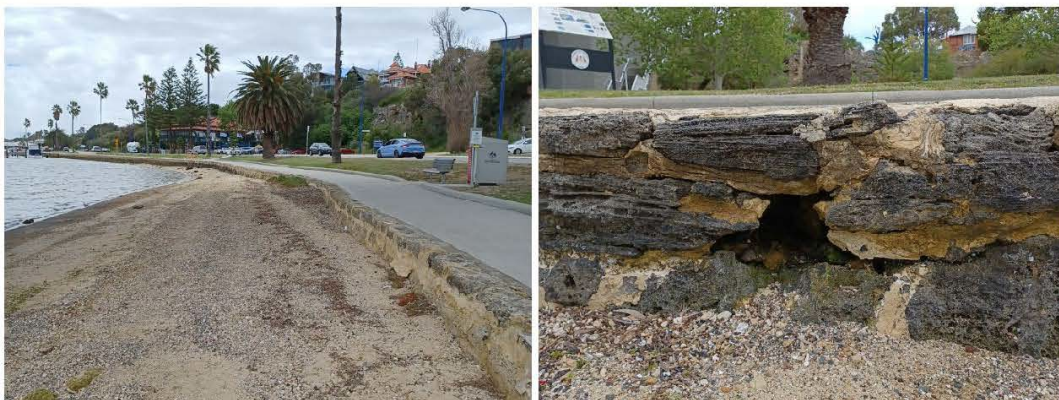
Figure 3.4 Sandy Beach (L) & Downstream Void (R)

Asset ID	Approximate Chainage (m)	Asset Type	Condition Rating	Consequence Rating	OCI
SLEFr06 Stirling Bridge J Dolan Park. B01	240-370	Wall	3	3	13

The asset is a low vertical limestone block wall backed with a concrete pedestrian path which serves as a capping. The concrete path is generally in good condition and the wall exhibits signs of recent repointing works. A sandy beach is protecting the lower portion of the wall, with panel and post toe protection visible in parts. Some of the panels were displaced or damaged. One notable void was present at the downstream end which required maintenance. Scheduled maintenance is recommended to maintain the asset to its current condition.

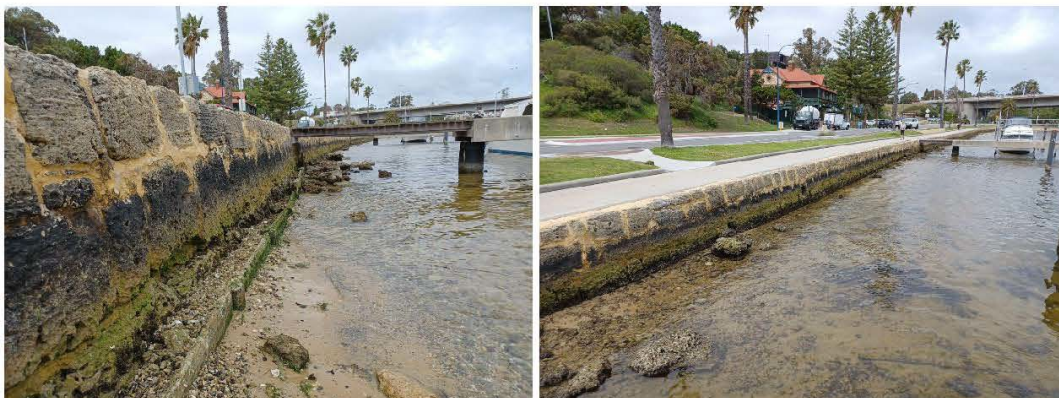
Figure 3.5 Limestone Blockwall with Jetty Abutments

Asset ID	Approximate Chainage (m)	Asset Type	Condition Rating	Consequence Rating	OCI
SLEFr05 Merv Cowan Park. B06	370-500	Wall	3	3	13

The asset is a vertical limestone blockwall with intermittent panel and post toe protection and some scattered rock rip rap. The wall features multiple jetty abutments and a public concrete path at the rear of crest. The condition of the wall was generally fair, with signs of recent repointing works, however, there was some grout loss in the lower courses. Scheduled maintenance is recommended to maintain the asset to its current condition.

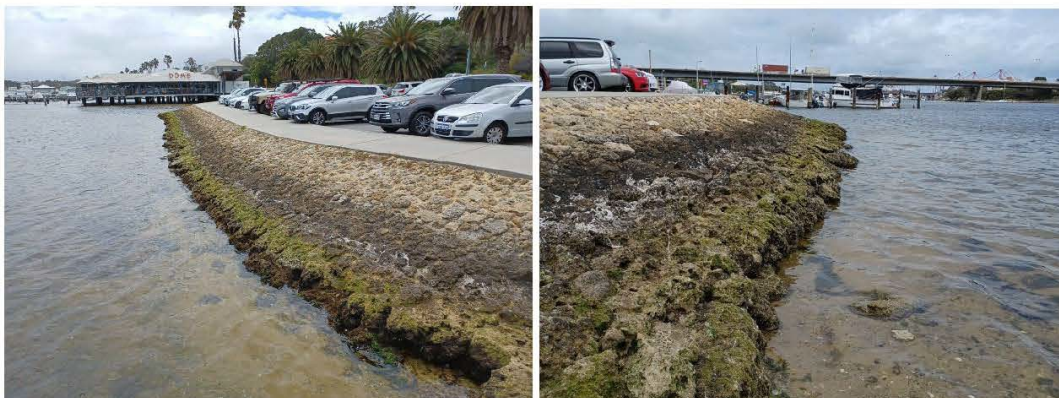
Figure 3.6 Pitched Revetment Looking North (L) & South (R)

Asset ID	Approximate Chainage (m)	Asset Type	Condition Rating	Consequence Rating	OCI
SLEFr05 Merv Cowan Park. B04	500-580	Revetment	3	3	13

The asset is a pitched (grouted) limestone revetment supporting a concrete path and protecting a high use carpark. The top sections were in good condition, with the overall structure in fair condition. Some loss of mortar and rock was evident at the toe. The asset requires toe protection to prevent further undermining. Lack of action could lead to further material loss and development of voids beneath path/carpark.

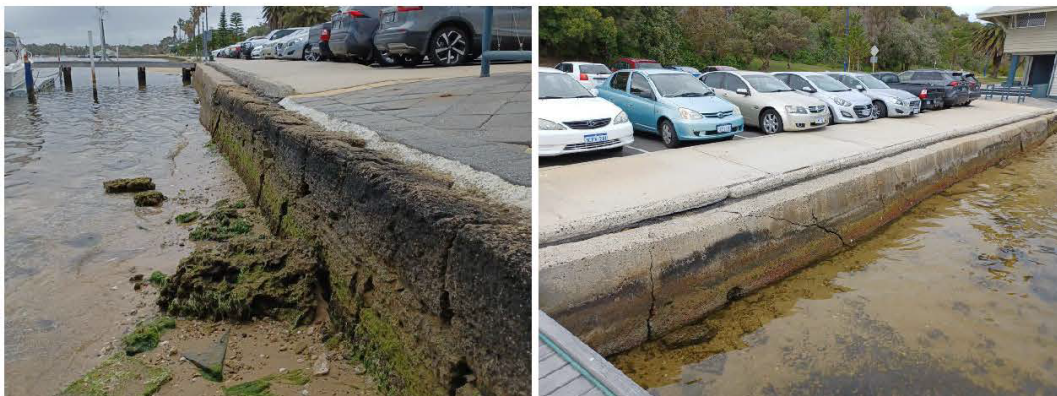
Figure 3.7 Weathered Blockwall (L) & Cracking of Concrete Wall (R)

Asset ID	Approximate Chainage (m)	Asset Type	Condition Rating	Consequence Rating	OCI
SLEFr05 Merv Cowan Park. B04	600-630	Wall	4	4	20

The section of walling on the northern side of the Dome is in poor condition. There is a short limestone blockwall extending from the Dome about 5-10 metres. The blockwall is heavily deteriorated with little mortar still visible, heavily weathered blocks and signs of settlement. There has been significant loss of material behind the wall, settlement, and movement of pavers.

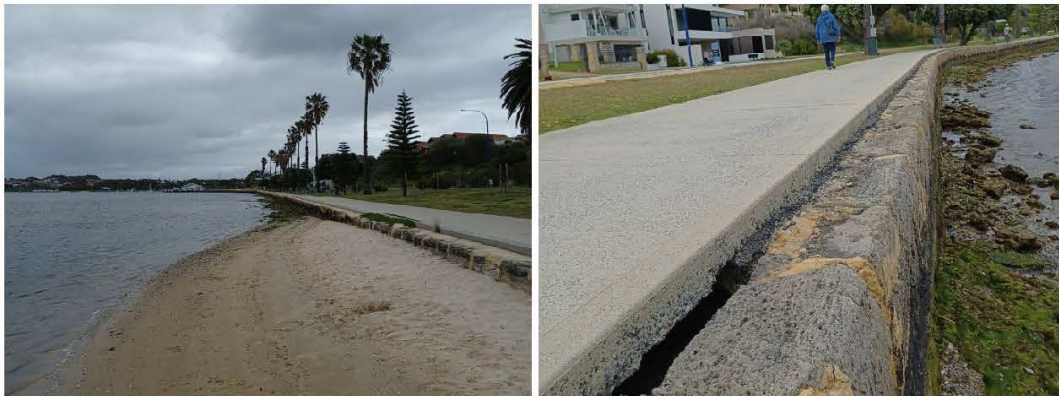
Figure 3.8 Low Limestone Blockwall (L) & Voids Beneath Path (R)

Asset ID	Approximate Chainage (m)	Asset Type	Condition Rating	Consequence Rating	OCI
SLEFr05 Merv Cowan Park. B03	630-940	Wall	4	3	19

The limestone blockwall exhibited signs of recent repointing maintenance. The lower courses of the wall display loss of mortar, and there was evidence of voids behind the wall / below the path. Recent maintenance efforts have helped slow the deterioration, however further works will be required with attention to the lower courses and filling voids behind the wall.

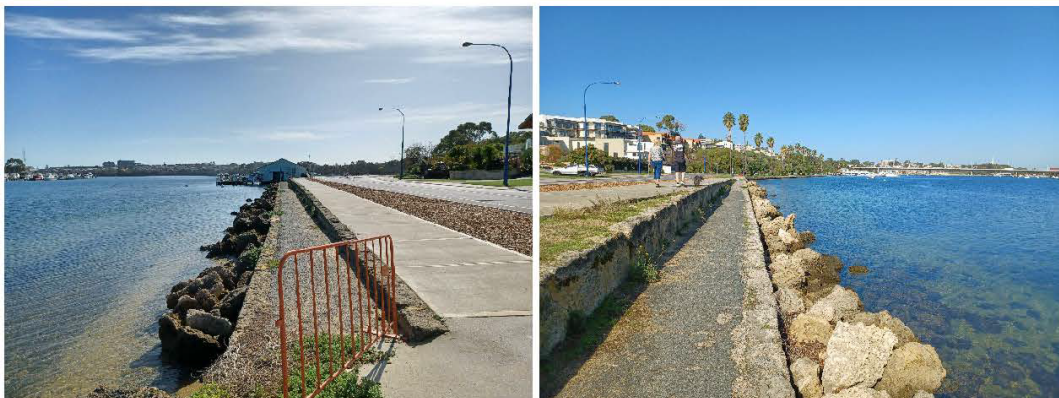
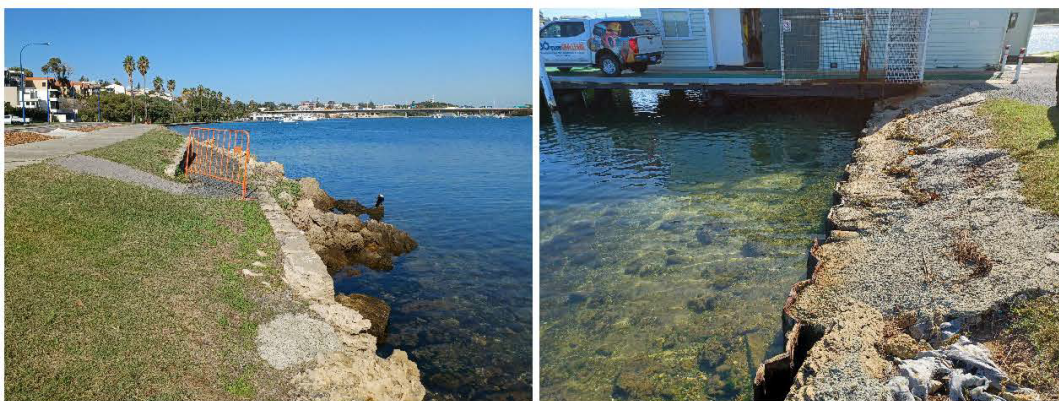
Asset ID	Approximate Chainage (m)	Asset Type	Condition Rating	Consequence Rating	OCI
SLEFr05 Merv Cowan Park. B02	940-1050	Wall	4	3	19

**Figure 3.9a Limestone Armour in Front of Vertical Wall**

**Figure 3.9b Tie In (L) & Sheet Pile Wall (R)**

The asset is a terraced blockwall with a bituminous pavement present on the lower-level landing (now closed off to pedestrians). A concrete path is present behind the top wall, and is in fair condition. Rock armour is present fronting the wall and provides some protection from wave energy. However, the wall is deteriorated with loss of fines and voids opening up behind the crest, resulting in a poor visual aesthetic. Recommended remediation options for this stretch could include adaption measures such as removal of the bitumen, blockwall maintenance and vegetation of the lower level.

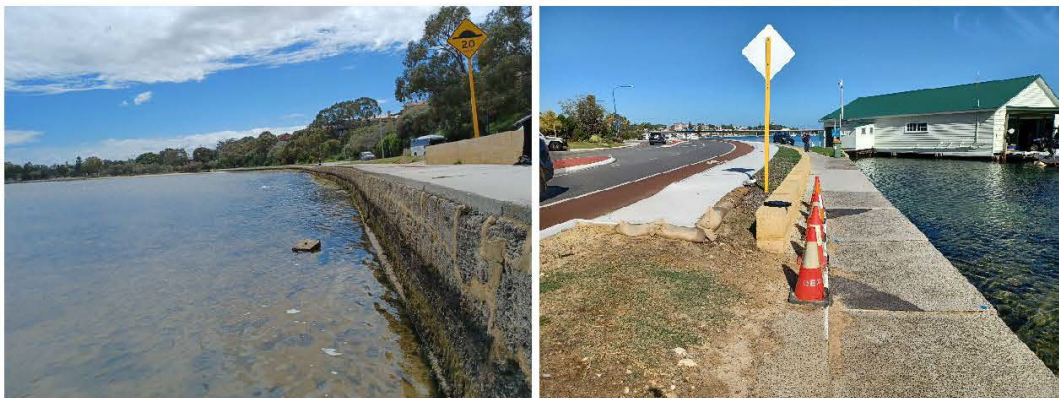
Figure 3.10 Block Wall Section (L) & Settled Path (R)

Asset ID	Approximate Chainage (m)	Asset Type	Condition Rating	Consequence Rating	OCI
SLEFr05 Merv Cowan Park. B01	940-1050	Wall	3	3	13

The asset is a limestone blockwall featuring a concrete path capping and toe scour protection. The wall is generally in a fair condition with signs of recent repointing maintenance. The lower courses require further repointing.

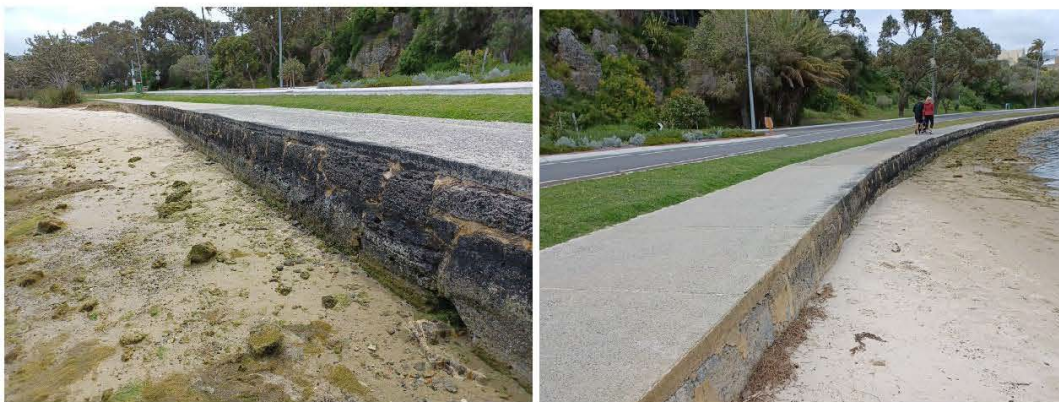
Figure 3.11 Limestone Block Wall & Sandy Beach

Asset ID	Approximate Chainage (m)	Asset Type	Condition Rating	Consequence Rating	OCI
SLEFr04 John Tonkin Park & Preston Point. B11	1330-1380	Wall	2	2	7

The asset is in moderate condition, showing signs of minor deterioration. A sandy beach in front of the wall is protecting the lower courses. Scheduled repointing maintenance is recommended to maintain the asset to its current condition.

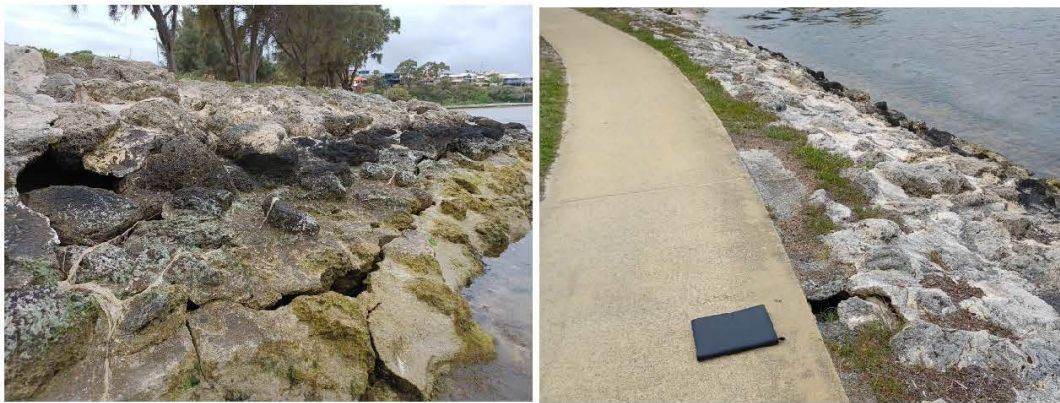
Figure 3.12 Grouted Revetment (L) & Voids Under Path (R)

Asset ID	Approximate Chainage (m)	Asset Type	Condition Rating	Consequence Rating	OCI
SLEFr04 John Tonkin Park & Preston Point. B10	1420-1520	Revetment	4	3	19

The asset is a pitched (mortared) limestone rock revetment in poor condition. The grout has cracked as a result of toe undermining, allowing the lower rocks to settle. Extensive voids were present throughout revetment structure. The path exhibits cracks which is indicative of voids underneath.

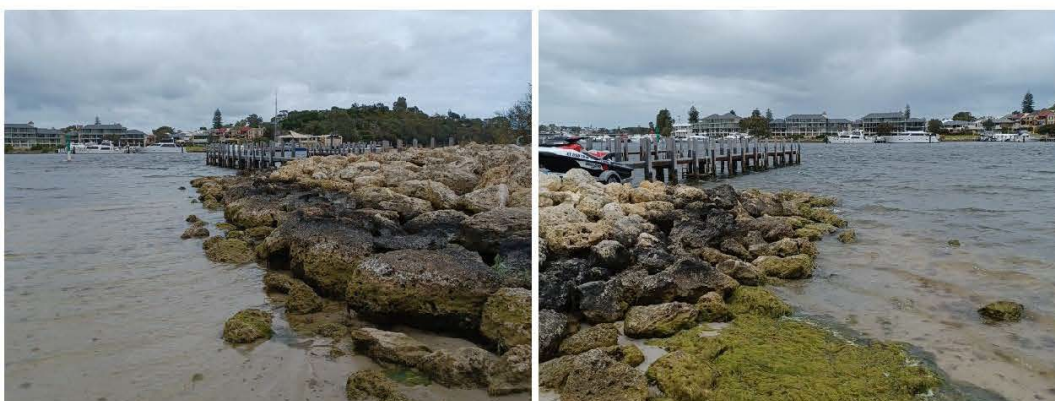
Figure 3.13 Revetment Around Boat Ramp

Asset ID	Approximate Chainage (m)	Asset Type	Condition Rating	Consequence Rating	OCI
SLEFr04 John Tonkin Park & Preston Point. B9	1540-1570	Revetment	3	3	13

The limestone rock revetment around the Leeuwin boat ramp was observed to be in fair condition. Minor maintenance involving repacking of armour and loose material is required.

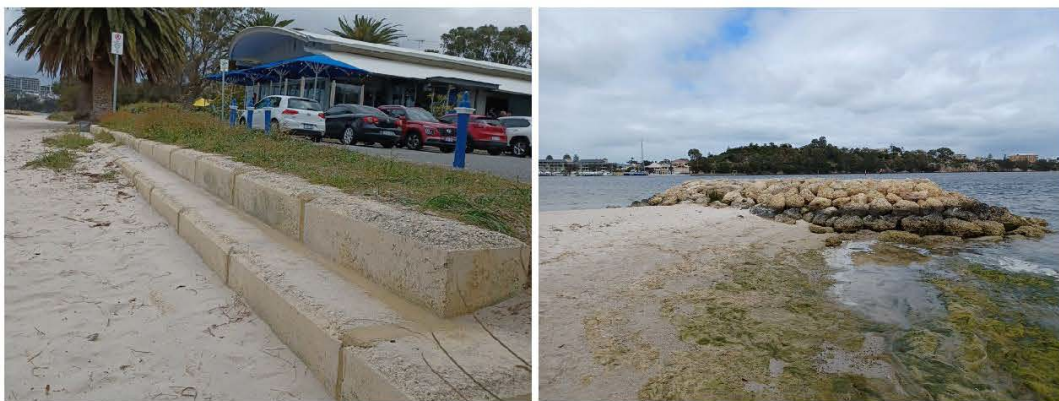
Figure 3.14 Block Wall (L) & Groyne Example (R)

Asset ID	Approximate Chainage (m)	Asset Type	Condition Rating	Consequence Rating	OCI
SLEFr04 John Tonkin Park & Preston Point. B08	1600-1620	Wall	1	3	3
SLEFr04 John Tonkin Park & Preston Point. B07	1600-1620	Groyne	1	2	2
SLEFr04 John Tonkin Park & Preston Point. B06	1640-1660	Groyne	1	2	2
SLEFr04 John Tonkin Park & Preston Point. B05	1700-1720	Groyne	1	2	2
SLEFr04 John Tonkin Park & Preston Point. B04	1740-1760	Groyne	1	2	2
SLEFr04 John Tonkin Park & Preston Point. B03	1800-1820	Groyne	1	2	2

The above assets were all observed to be in good condition. The maintenance requirements include ongoing monitoring.

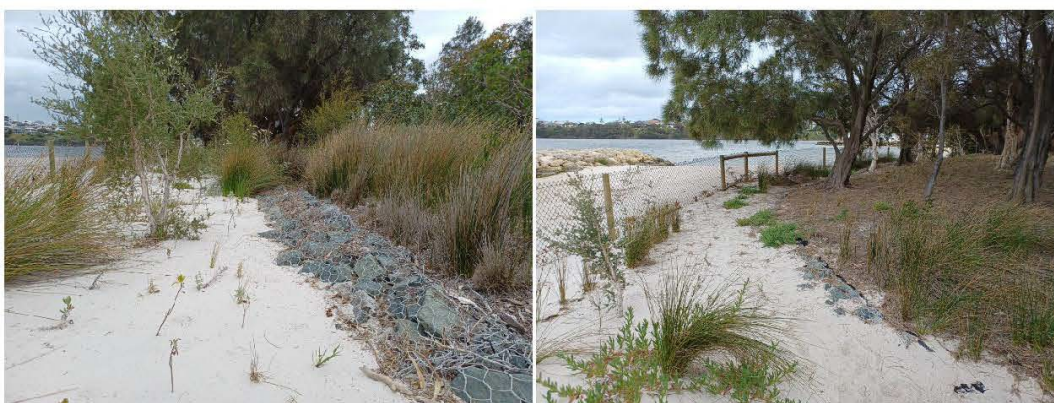
Figure 3.15 Buried Gabion/Reno Mattresses

Asset ID	Approximate Chainage (m)	Asset Type	Condition Rating	Consequence Rating	OCI
SLEFr04 John Tonkin Park & Preston Point. B02	1760-1840	Gabion	2	2	7

The asset is a mostly buried gabion basket/reno mattress, with visible portions in moderate condition. No works required.

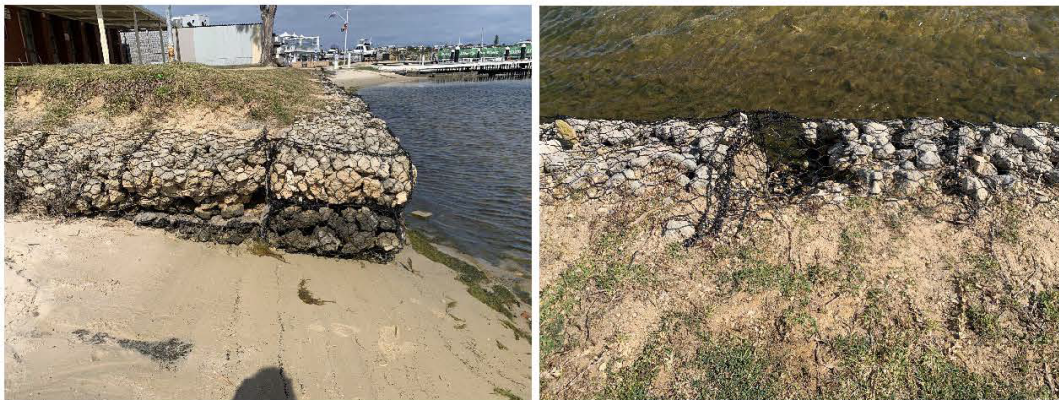
Asset ID	Approximate Chainage (m)	Asset Type	Condition Rating	Consequence Rating	OCI
SLEFr03 Norm McKenzie Reserve. B04	2060-2090	Gabion	4	2	18

Figure 3.18 Limestone Gabions Rotated (L) & Lost Material (R)

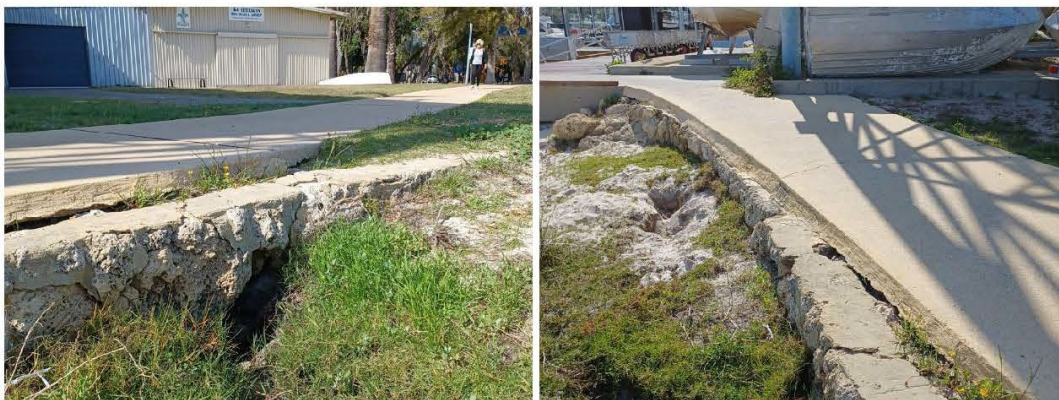
Asset ID	Approximate Chainage (m)	Asset Type	Condition Rating	Consequence Rating	OCI
SLEFr03 Norm McKenzie Reserve. B01	2240-2260	Wall	4	2	18

Figure 3.21 Undermined Limestone Block Wall

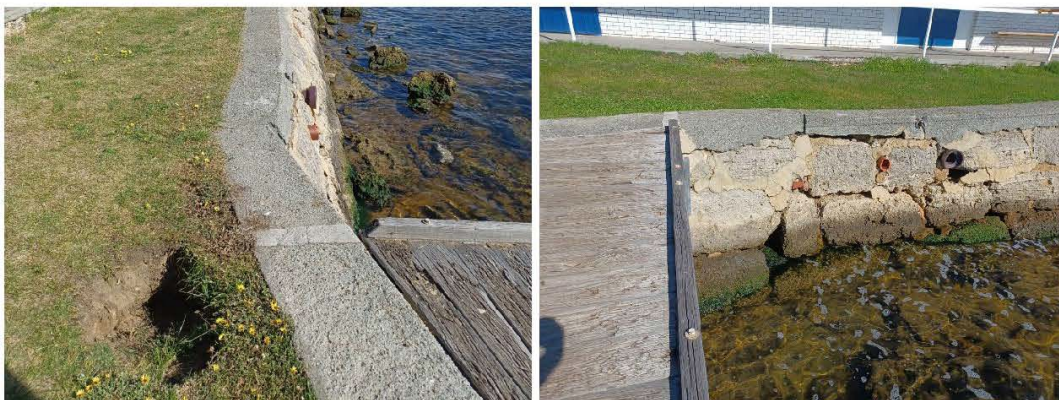
Asset ID	Approximate Chainage (m)	Asset Type	Condition Rating	Consequence Rating	OCI
SLEFr02 Wayman Reserve – Jerrat Drive. B01	2820-2895	Wall	4	3	19

**Figure 3.23 Deteriorated Limestone Block Wall**

The foreshore features a deteriorated limestone block wall fronting Camp Waller Sea Scouts Hall. The blocks are weathered and exhibit a total loss of mortar through the lower courses. There is evidence of material loss through the wall leading to voids opening up behind wall crest. The voids behind wall are a safety hazard with uneven surfaces and potential for unstable ground to give way. Although outside the scope of this assessment, the jetty was also noted to be in poor condition and requires further investigation and monitoring.

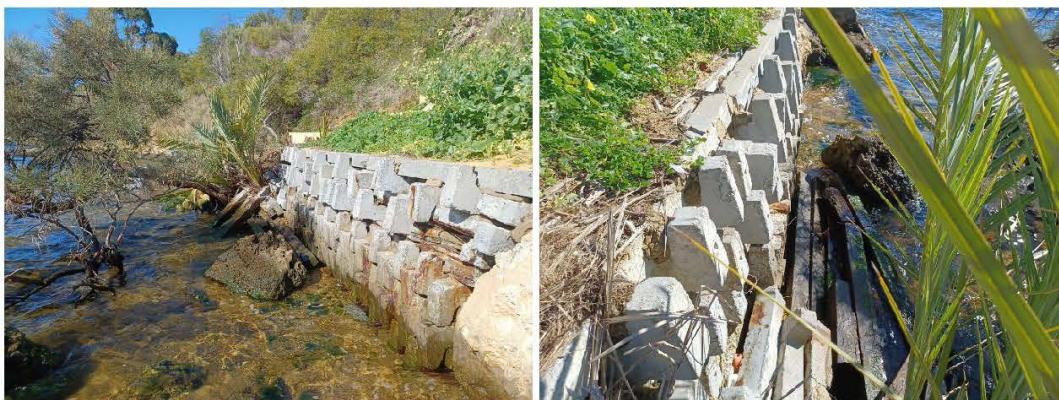
**Figure 3.24 Deteriorated Crib Wall**

The foreshore upstream of the building features a deteriorated crib wall which supports the concrete path behind. Many cracked and dislodged units were observed. It is recommended that the entire foreshore at this site is investigated for future significant upgrade.

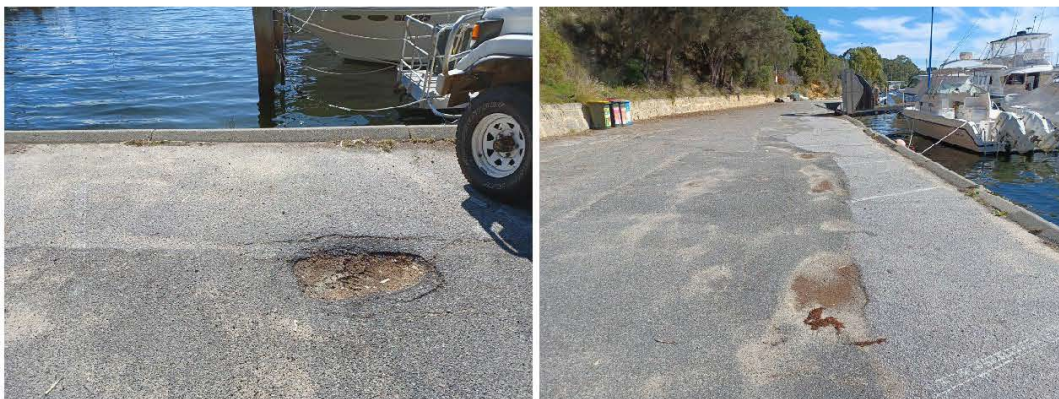
**Figure 3.29 Carpark Pot Holes & Repairs**

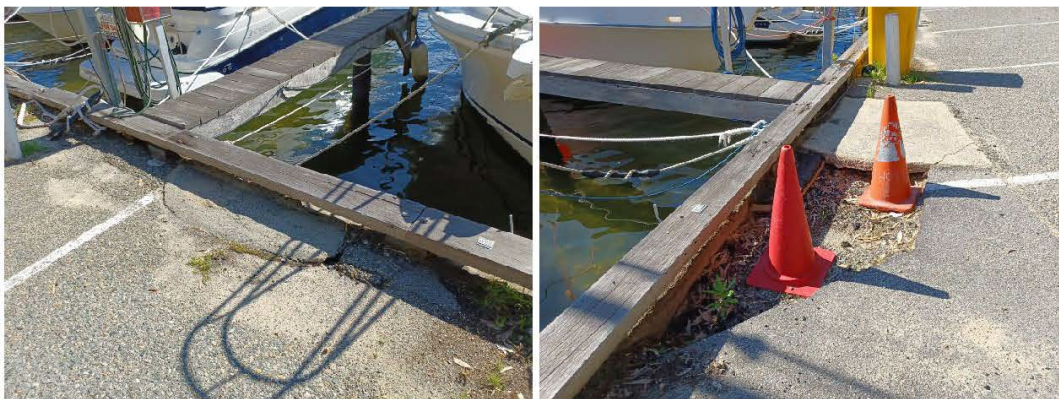
**Figure 3.31 Carpark Bitumen Repairs & Settlement**
