# MINUTES

## Works Committee Meeting Tuesday, 23 August 2022 at 6:30 PM

## MINUTES OF THE ORDINARY MEETING OF THE WORKS COMMITTEE HELD IN THE COUNCIL CHAMBER, 135 CANNING HIGHWAY EAST FREMANTLE ON TUESDAY 23 AUGUST 2022

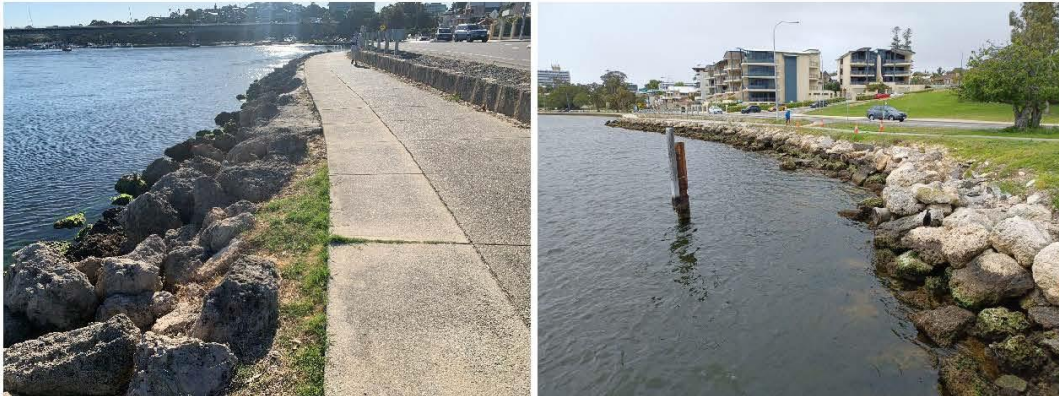
Asset ID	Approximate Chainage (m))	Asset Type	Condition Rating	Consequence Rating	OCI
SLFre01 Fremantle Bridge.B01	0-20	Rock Revetment	4	3	19

**Figure 3.1 Path Behind Revetment (L) & Overtopping Damage (R)**

This asset straddles the boundary of the City of Fremantle and the Town of East Fremantle. It appears that most of the asset is within the City of Fremantle's jurisdiction, however approximately 20 metres appear to lie within the Town's boundary. The asset is a limestone rock revetment in poor condition. It features undersize rock with steep sections, insufficient width and damage from uncontrolled surface runoff. There is evidence of voids and overtopping damage behind the crest.

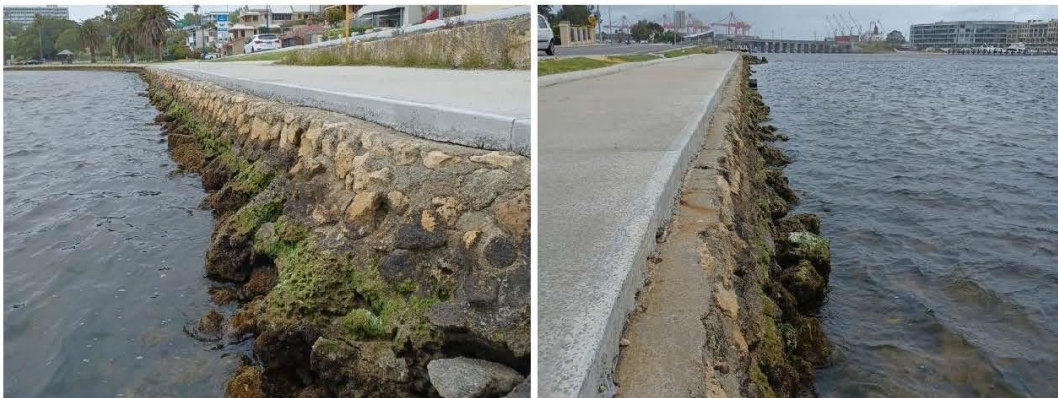
Asset ID	Approximate Chainage (m)	Asset Type	Condition Rating	Consequence Rating	OCI
SLEFr06 Stirling Bridge J Dolan Park.B03	20-80	Wall	3	3	13

**Figure 3.2 J Dolan Park Wall Looking East (L) & Looking West (R)**

The asset is a vertical wall made from mortared natural limestone rock backed by a concrete pedestrian path which serves as a capping. Some mortar decay around the toe is evident, causing voids and loose rock. The path is cracked in places, possibly due to a loss of fines through voids. Repointing and void repair maintenance works are recommended to prevent further damage to the path.

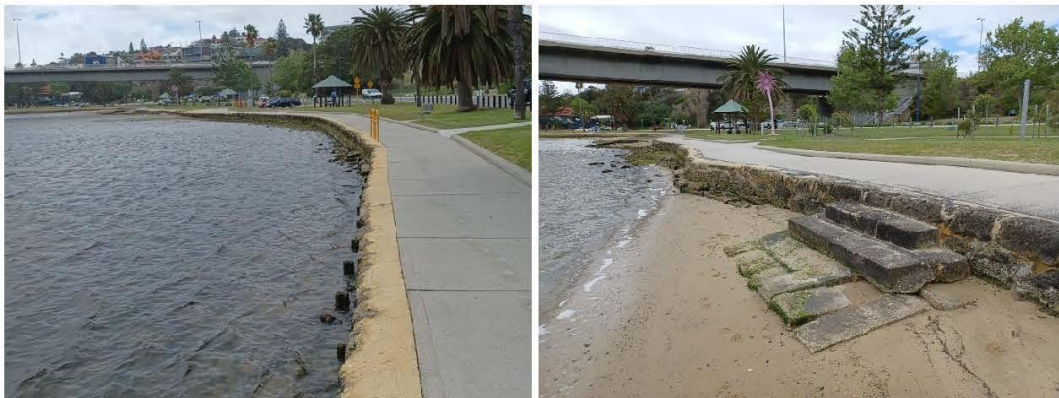
Asset ID	Approximate Chainage (m)	Asset Type	Condition Rating	Consequence Rating	OCI
SLEFr06 Stirling Bridge J Dolan Park. B02	80-240	Wall	3	3	13

**Figure 3.3 Limestone Block Wall (L) & Access Stairs (R)**

The asset is a low vertical limestone block wall backed with a concrete pedestrian path which serves as capping. Panel/post toe protection is present at the upstream and downstream extents. The wall is generally in fair condition, with the face and crest showing signs of recent regrouting. The limestone block steps are in poor condition and require rebuild. The concrete path on crest appears to be relatively new and is in good condition. Scheduled maintenance is recommended to maintain the asset to its current condition.

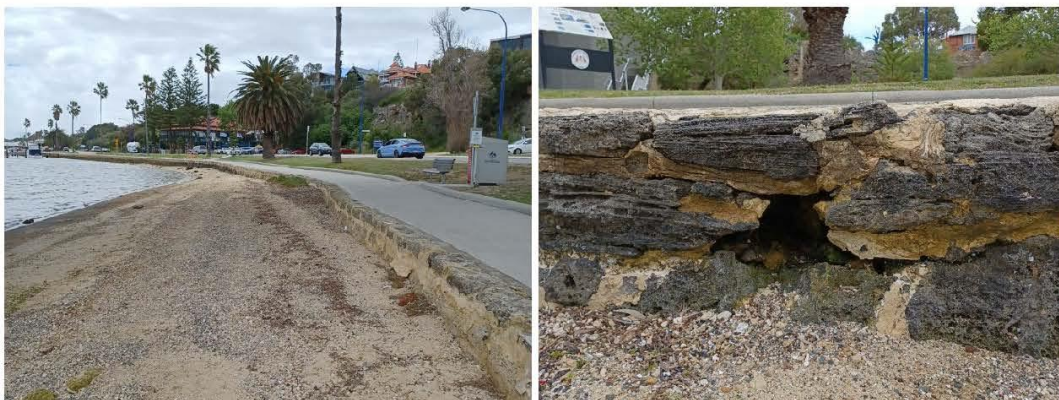
Asset ID	Approximate Chainage (m)	Asset Type	Condition Rating	Consequence Rating	OCI
SLEFr06 Stirling Bridge J Dolan Park. B01	240-370	Wall	3	3	13

**Figure 3.4 Sandy Beach (L) & Downstream Void (R)**

The asset is a low vertical limestone block wall backed with a concrete pedestrian path which serves as a capping. The concrete path is generally in good condition and the wall exhibits signs of recent repointing works. A sandy beach is protecting the lower portion of the wall, with panel and post toe protection visible in parts. Some of the panels were displaced or damaged. One notable void was present at the downstream end which required maintenance. Scheduled maintenance is recommended to maintain the asset to its current condition.

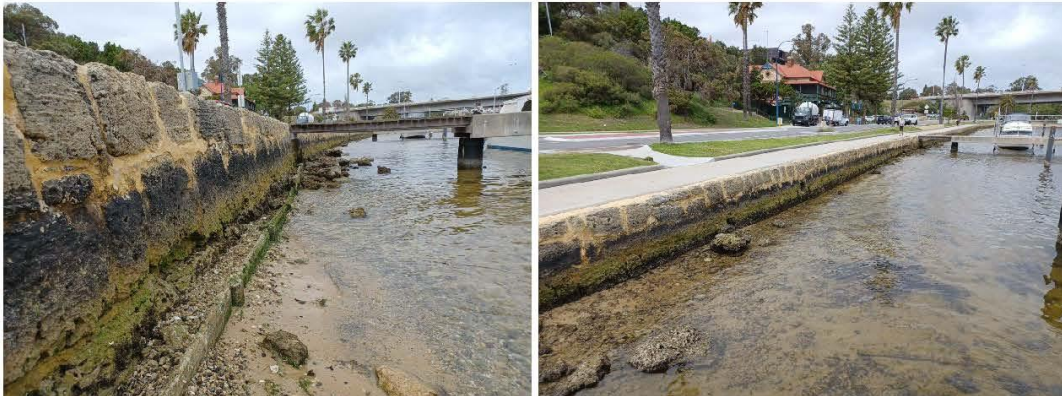
Asset ID	Approximate Chainage (m)	Asset Type	Condition Rating	Consequence Rating	OCI
SLEFr05 Merv Cowan Park. B06	370-500	Wall	3	3	13

**Figure 3.5 Limestone Blockwall with Jetty Abutments**

The asset is a vertical limestone blockwall with intermittent panel and post toe protection and some scattered rock rip rap. The wall features multiple jetty abutments and a public concrete path at the rear of crest. The condition of the wall was generally fair, with signs of recent repointing works, however, there was some grout loss in the lower courses. Scheduled maintenance is recommended to maintain the asset to its current condition.

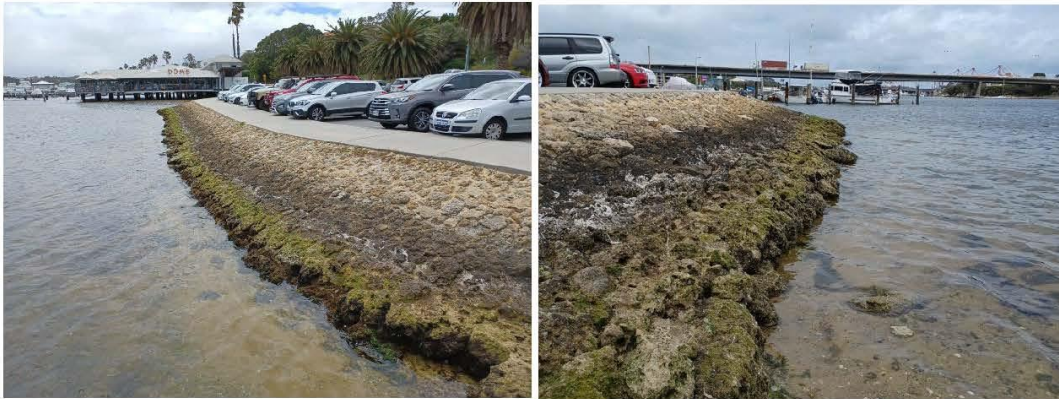
Asset ID	Approximate Chainage (m)	Asset Type	Condition Rating	Consequence Rating	OCI
SLEFr05 Merv Cowan Park. B04	500-580	Revetment	3	3	13

**Figure 3.6 Pitched Revetment Looking North (L) & South (R)**

The asset is a pitched (grouted) limestone revetment supporting a concrete path and protecting a high use carpark. The top sections were in good condition, with the overall structure in fair condition. Some loss of mortar and rock was evident at the toe. The asset requires toe protection to prevent further undermining. Lack of action could lead to further material loss and development of voids beneath path/carpark.

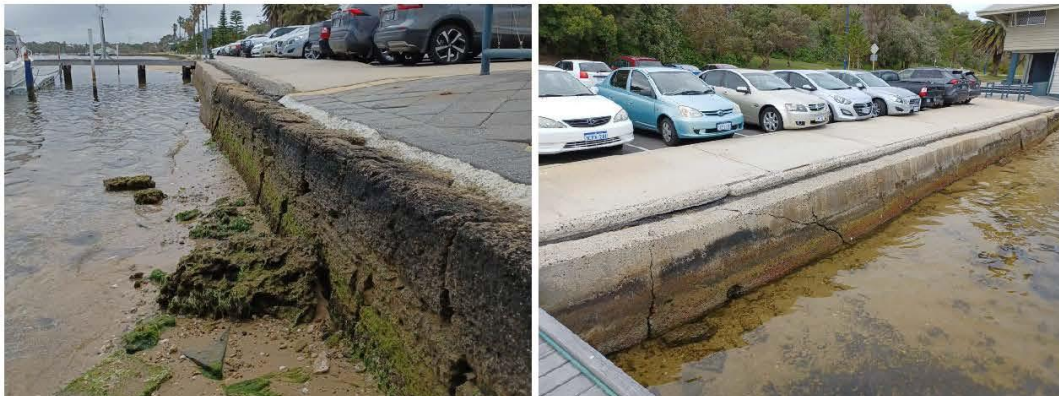
Asset ID	Approximate Chainage (m)	Asset Type	Condition Rating	Consequence Rating	OCI
SLEFr05 Merv Cowan Park. B04	600-630	Wall	4	4	20

**Figure 3.7 Weathered Blockwall (L) & Cracking of Concrete Wall (R)**

The section of walling on the northern side of the Dome is in poor condition. There is a short limestone blockwall extending from the Dome about 5-10 metres. The blockwall is heavily deteriorated with little mortar still visible, heavily weathered blocks and signs of settlement. There has been significant loss of material behind the wall, settlement, and movement of pavers.

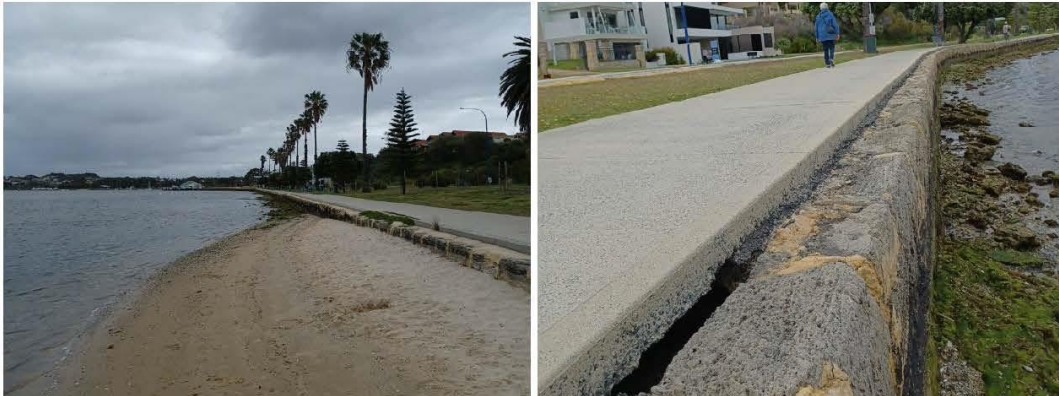
Asset ID	Approximate Chainage (m)	Asset Type	Condition Rating	Consequence Rating	OCI
SLEFr05 Merv Cowan Park. B03	630-940	Wall	4	3	19

**Figure 3.8 Low Limestone Blockwall (L) & Voids Beneath Path (R)**

The limestone blockwall exhibited signs of recent repointing maintenance. The lower courses of the wall display loss of mortar, and there was evidence of voids behind the wall / below the path. Recent maintenance efforts have helped slow the deterioration, however further works will be required with attention to the lower courses and filling voids behind the wall.

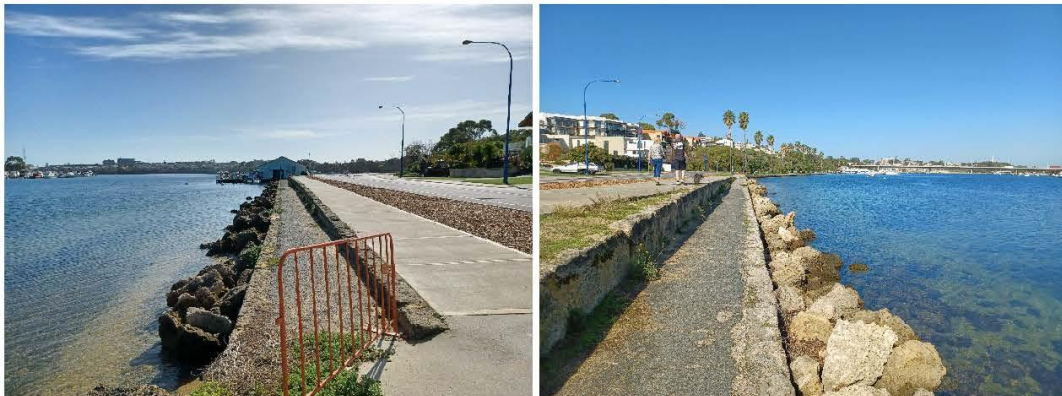
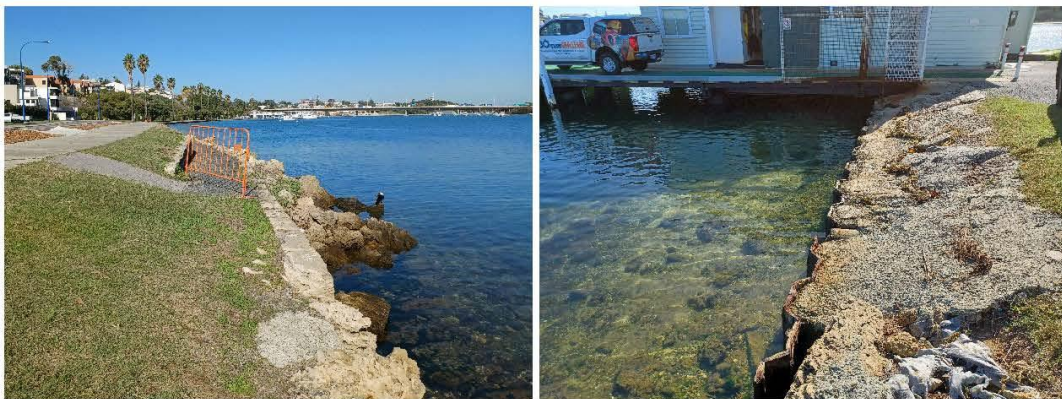
Asset ID	Approximate Chainage (m)	Asset Type	Condition Rating	Consequence Rating	OCI
SLEFr05 Merv Cowan Park. B02	940-1050	Wall	4	3	19

**Figure 3.9a Limestone Armour in Front of Vertical Wall**

**Figure 3.9b Tie In (L) & Sheet Pile Wall (R)**

The asset is a terraced blockwall with a bituminous pavement present on the lower-level landing (now closed off to pedestrians). A concrete path is present behind the top wall, and is in fair condition. Rock armour is present fronting the wall and provides some protection from wave energy. However, the wall is deteriorated with loss of fines and voids opening up behind the crest, resulting in a poor visual aesthetic. Recommended remediation options for this stretch could include adaption measures such as removal of the bitumen, blockwall maintenance and vegetation of the lower level.

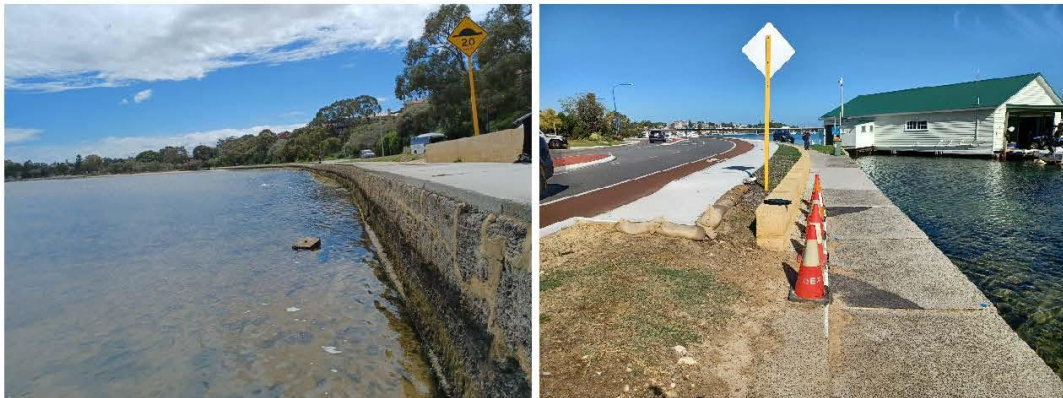
Asset ID	Approximate Chainage (m)	Asset Type	Condition Rating	Consequence Rating	OCI
SLEFr05 Merv Cowan Park. B01	940-1050	Wall	3	3	13

**Figure 3.10 Block Wall Section (L) & Settled Path (R)**

The asset is a limestone blockwall featuring a concrete path capping and toe scour protection. The wall is generally in a fair condition with signs of recent repointing maintenance. The lower courses require further repointing.

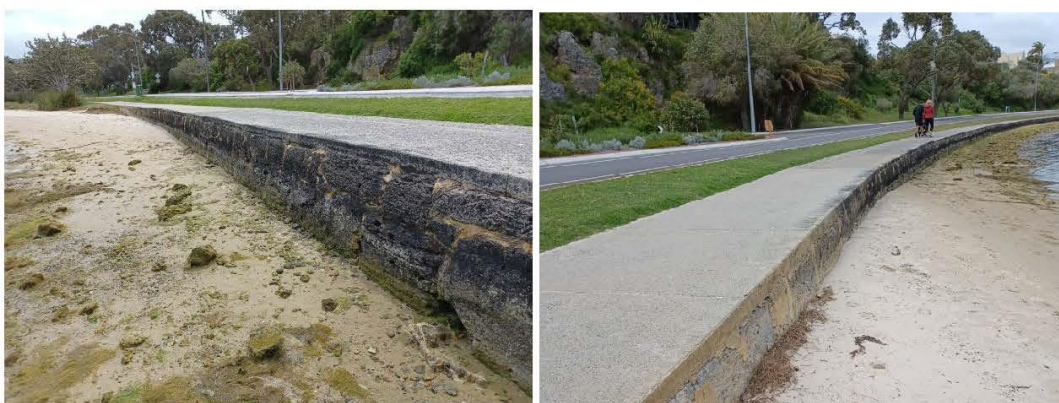
Asset ID	Approximate Chainage (m)	Asset Type	Condition Rating	Consequence Rating	OCI
SLEFr04 John Tonkin Park & Preston Point. B11	1330-1380	Wall	2	2	7

**Figure 3.11 Limestone Block Wall & Sandy Beach**

The asset is in moderate condition, showing signs of minor deterioration. A sandy beach in front of the wall is protecting the lower courses. Scheduled repointing maintenance is recommended to maintain the asset to its current condition.

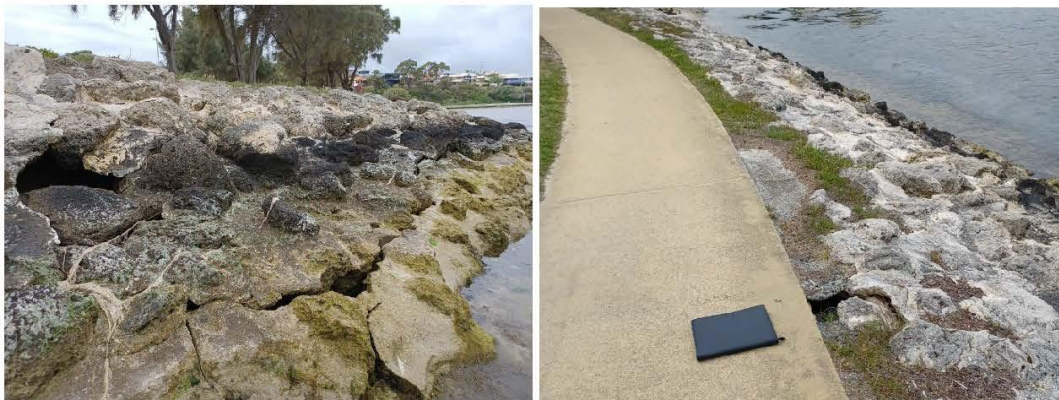
Asset ID	Approximate Chainage (m)	Asset Type	Condition Rating	Consequence Rating	OCI
SLEFr04 John Tonkin Park & Preston Point. B10	1420-1520	Revetment	4	3	19

**Figure 3.12 Grouted Revetment (L) & Voids Under Path (R)**

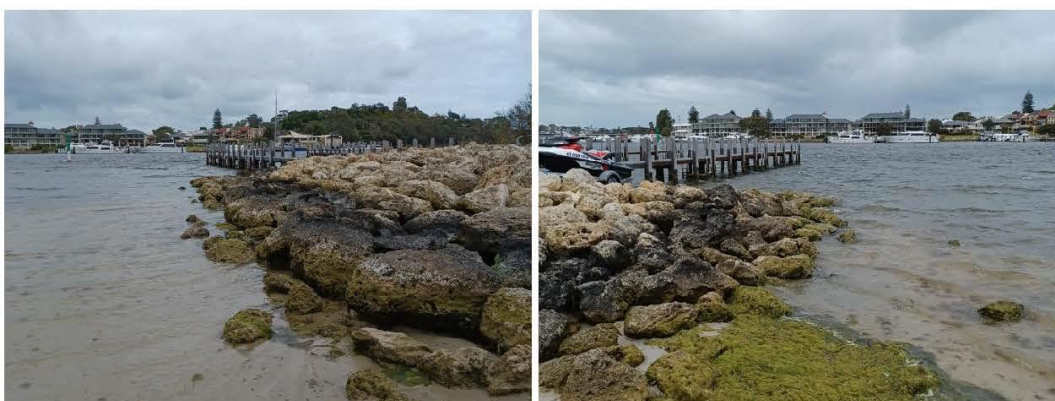
Asset ID	Approximate Chainage (m)	Asset Type	Condition Rating	Consequence Rating	OCI
SLEFr04 John Tonkin Park & Preston Point. B9	1540-1570	Revetment	3	3	13

**Figure 3.13 Revetment Around Boat Ramp**

The limestone rock revetment around the Leeuwin boat ramp was observed to be in fair condition. Minor maintenance involving repacking of armour and loose material is required.

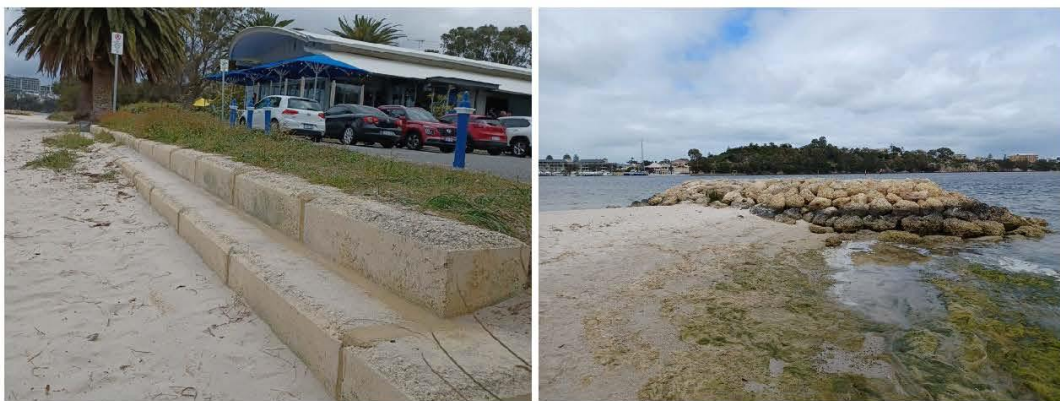
Asset ID	Approximate Chainage (m)	Asset Type	Condition Rating	Consequence Rating	OCI
SLEFr04 John Tonkin Park & Preston Point. B08	1600-1620	Wall	1	3	3
SLEFr04 John Tonkin Park & Preston Point. B07	1600-1620	Groyne	1	2	2
SLEFr04 John Tonkin Park & Preston Point. B06	1640-1660	Groyne	1	2	2
SLEFr04 John Tonkin Park & Preston Point. B05	1700-1720	Groyne	1	2	2
SLEFr04 John Tonkin Park & Preston Point. B04	1740-1760	Groyne	1	2	2
SLEFr04 John Tonkin Park & Preston Point. B03	1800-1820	Groyne	1	2	2

**Figure 3.14 Block Wall (L) & Groyne Example (R)**

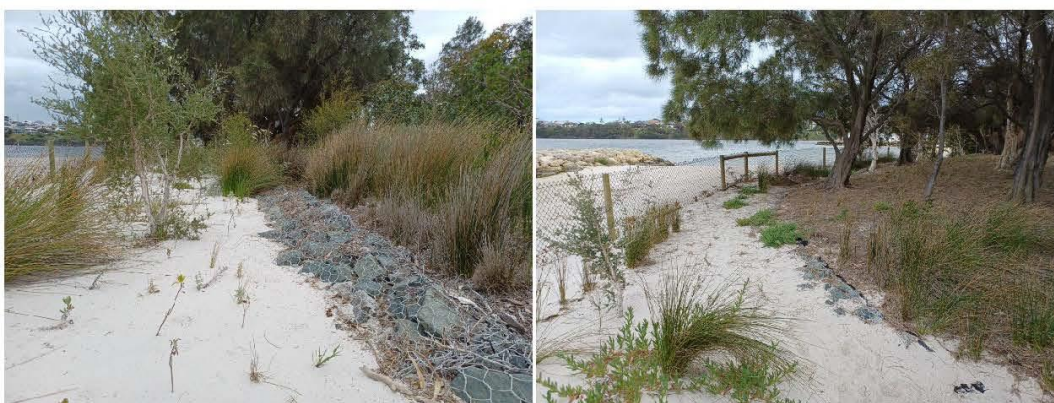
Asset ID	Approximate Chainage (m)	Asset Type	Condition Rating	Consequence Rating	OCI
SLEFr04 John Tonkin Park & Preston Point. B02	1760-1840	Gabion	2	2	7

**Figure 3.15 Buried Gabion/Reno Mattresses**

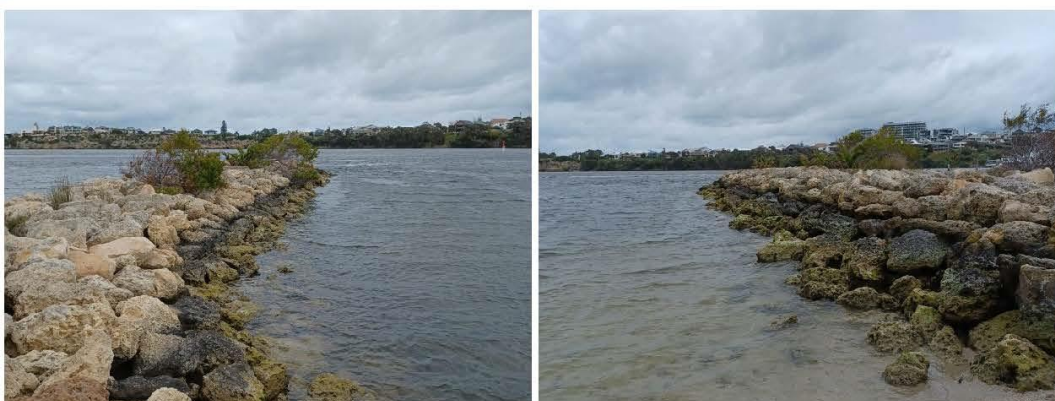
Asset ID	Approximate Chainage (m)	Asset Type	Condition Rating	Consequence Rating	OCI
SLEFr04 John Tonkin Park & Preston Point. B01	1900-1940	Groyne	2	2	7

**Figure 3.16 Preston Point Groyne**

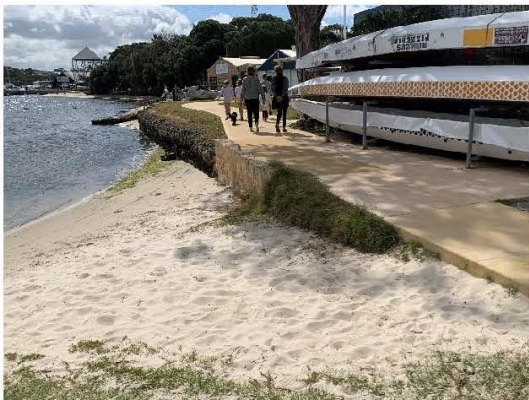
Asset ID	Approximate Chainage (m)	Asset Type	Condition Rating	Consequence Rating	OCI
SLEFr03 Norm McKenzie Reserve. B05	2055-2065	Wall	3	3	13

**Figure 3.17 Limestone Block Wall**

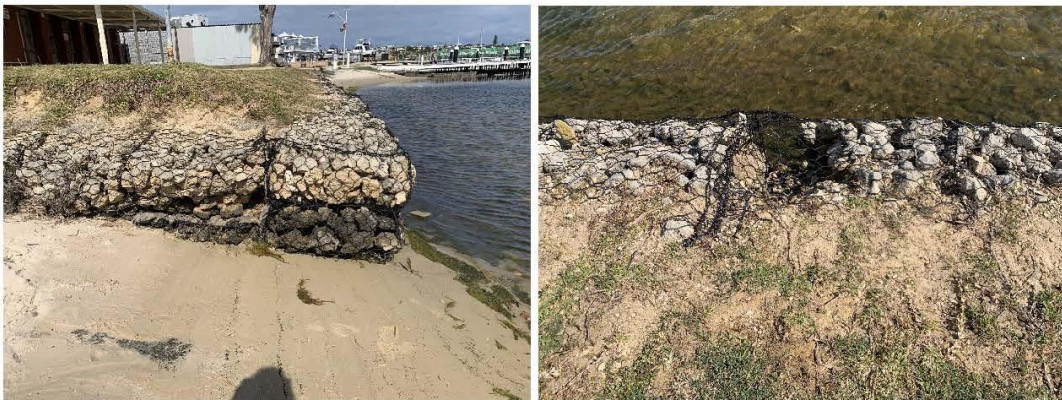
Asset ID	Approximate Chainage (m)	Asset Type	Condition Rating	Consequence Rating	OCI
SLEFr03 Norm McKenzie Reserve. B04	2060-2090	Gabion	4	2	18

**Figure 3.18 Limestone Gabions Rotated (L) & Lost Material (R)**

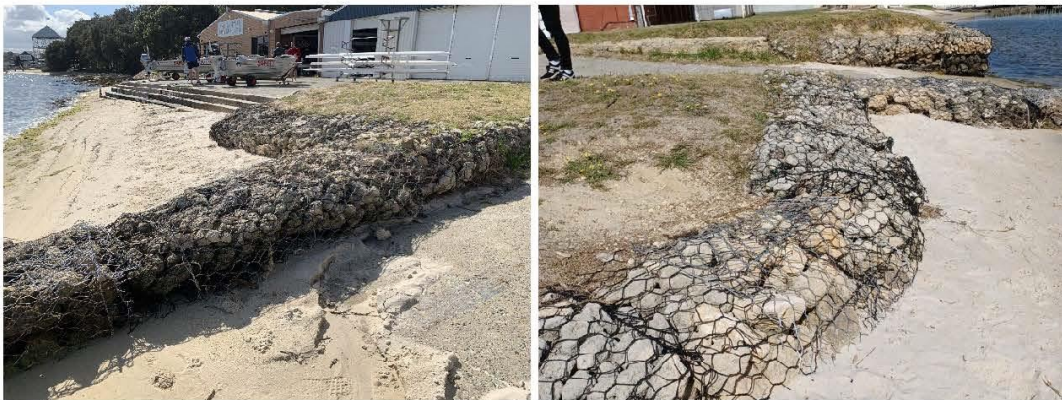
Asset ID	Approximate Chainage (m)	Asset Type	Condition Rating	Consequence Rating	OCI
SLEFr03 Norm McKenzie Reserve. B03	2090-2100	Gabion	3	2	12

**Figure 3.19 Limestone Gabions**

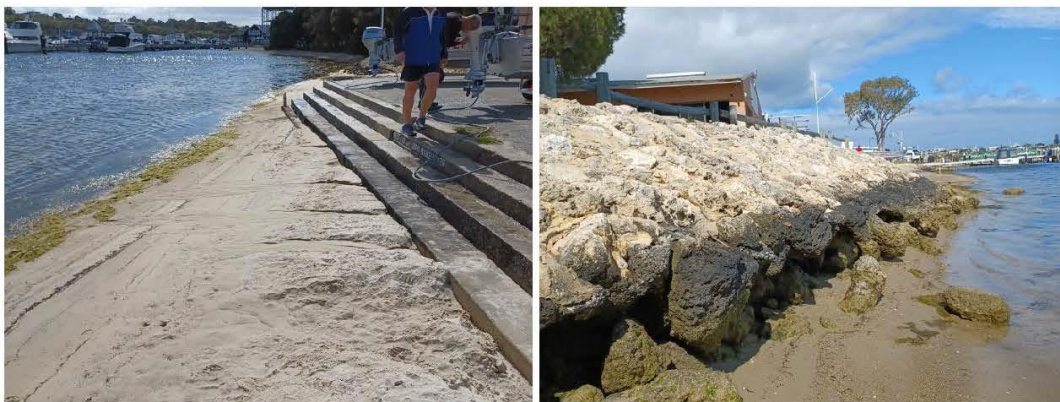
Asset ID	Approximate Chainage (m)	Asset Type	Condition Rating	Consequence Rating	OCI
SLEFr03 Norm McKenzie Reserve. B02	2100-2155	Revetment	3	3	13

**Figure 3.20 Steps (L) & Pitched Revetment (R)**

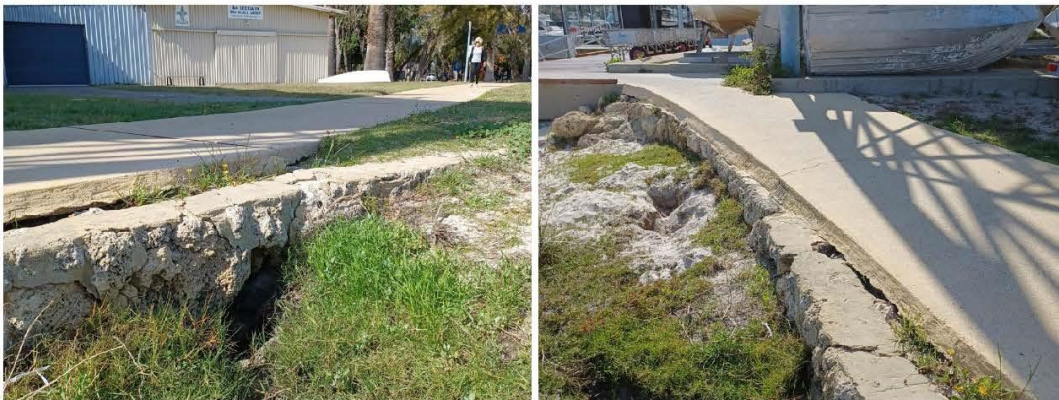
Asset ID	Approximate Chainage (m)	Asset Type	Condition Rating	Consequence Rating	OCI
SLEFr03 Norm McKenzie Reserve. B01	2240-2260	Wall	4	2	18

**Figure 3.21 Undermined Limestone Block Wall**

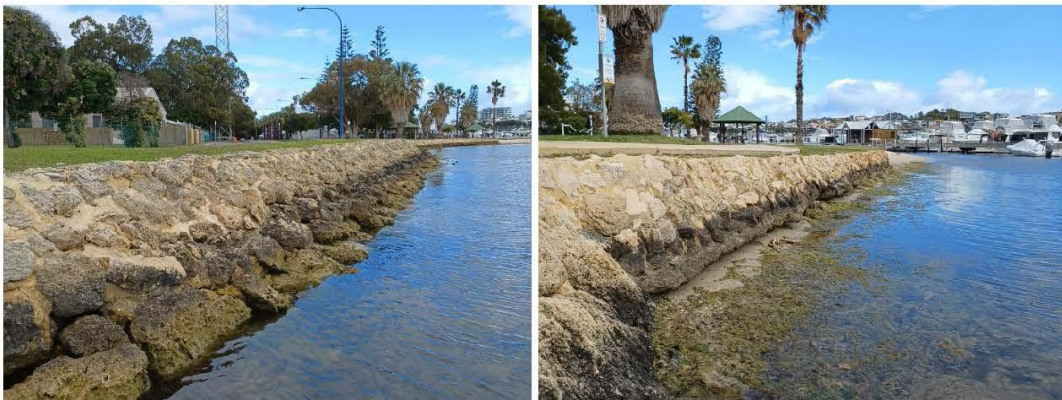
Asset ID	Approximate Chainage (m)	Asset Type	Condition Rating	Consequence Rating	OCI
SLEFr02 Wayman Reserve – Jerrat Drive. B02	2425-2550	Revetment	3	2	12

**Figure 3.22 Pitched Limestone Revetment**

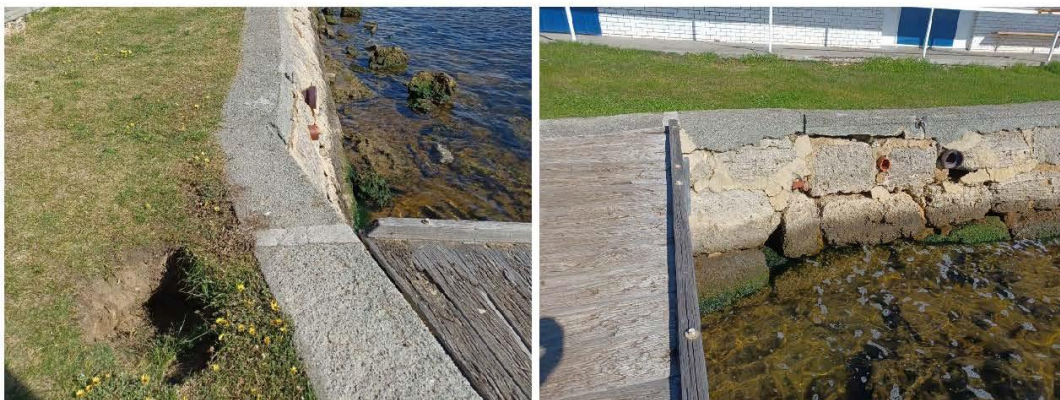
Asset ID	Approximate Chainage (m)	Asset Type	Condition Rating	Consequence Rating	OCI
SLEFr02 Wayman Reserve – Jerrat Drive. B01	2820-2895	Wall	4	3	19

**Figure 3.23 Deteriorated Limestone Block Wall**

The foreshore features a deteriorated limestone block wall fronting Camp Waller Sea Scouts Hall. The blocks are weathered and exhibit a total loss of mortar through the lower courses. There is evidence of material loss through the wall leading to voids opening up behind wall crest. The voids behind wall are a safety hazard with uneven surfaces and potential for unstable ground to give way. Although outside the scope of this assessment, the jetty was also noted to be in poor condition and requires further investigation and monitoring.

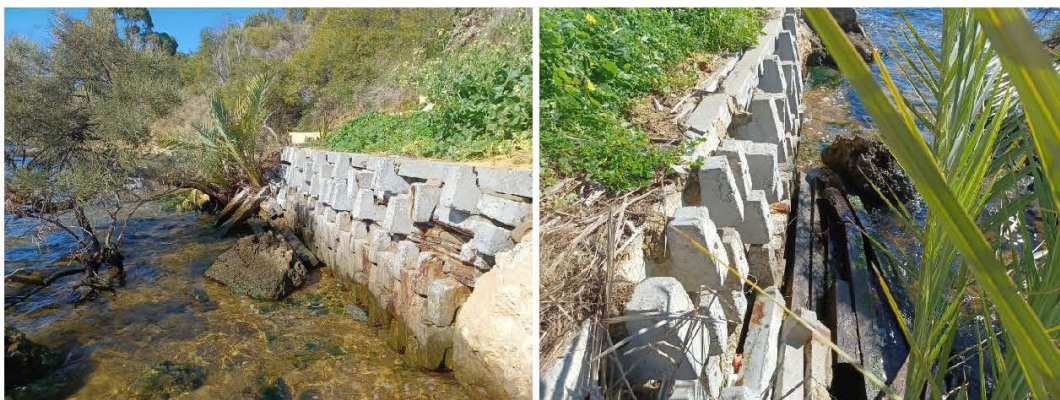
**Figure 3.24 Deteriorated Crib Wall**

The foreshore upstream of the building features a deteriorated crib wall which supports the concrete path behind. Many cracked and dislodged units were observed. It is recommended that the entire foreshore at this site is investigated for future significant upgrade.

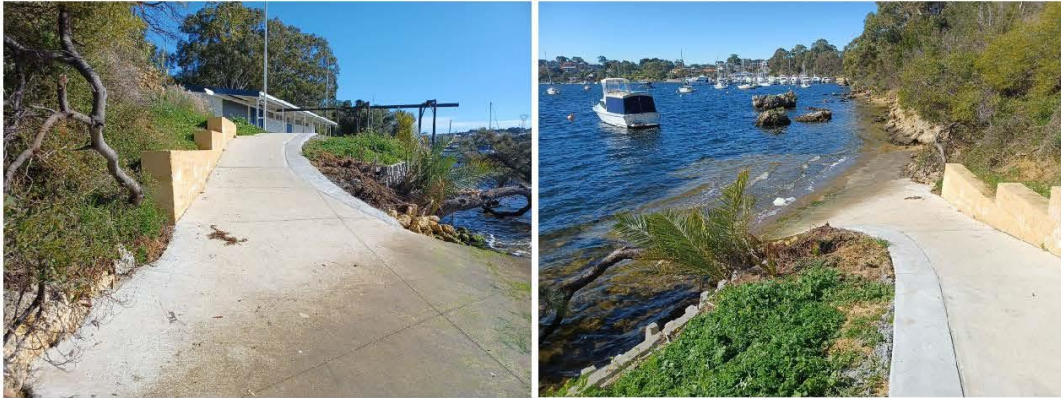
**Figure 3.25 Limestone Block Wall & Concrete Apron**

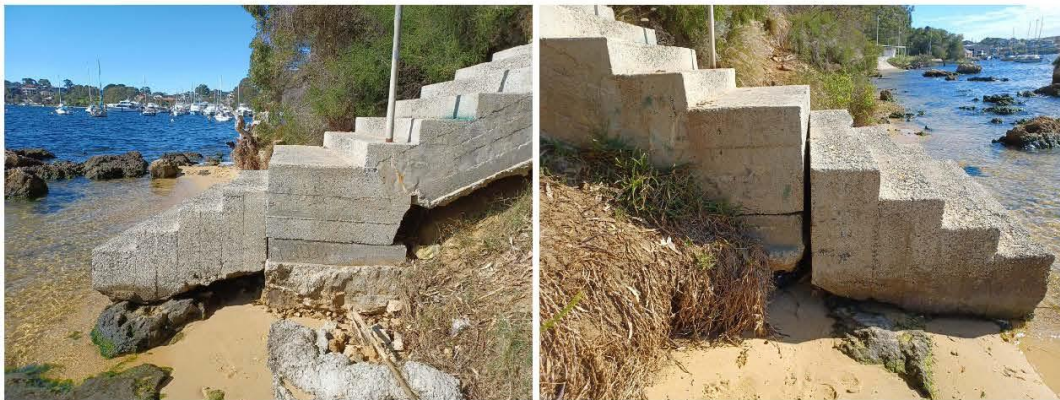
Asset ID	Approximate Chainage (m)	Asset Type	Condition Rating	Consequence Rating	OCI
SLEFr02 Wayman Reserve – Jerrat Drive. B03	2970	Abutment	3	2	12

**Figure 3.26 Concrete Stair Abutment**

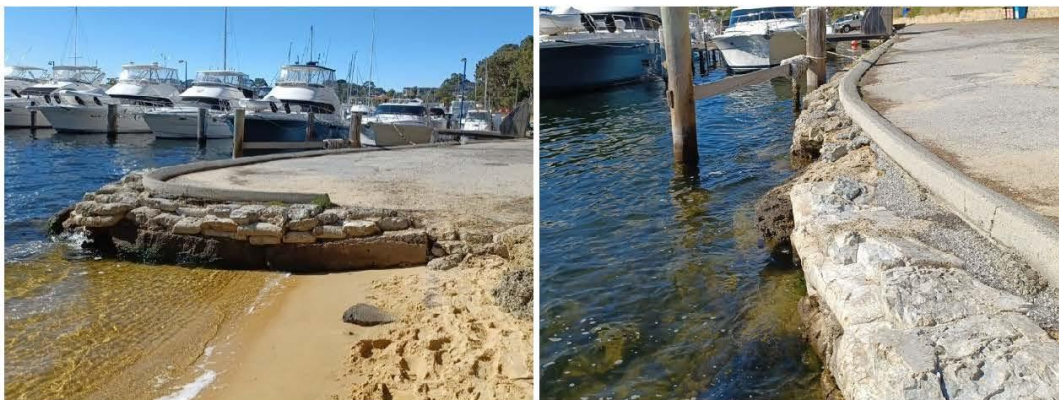
Asset ID	Approximate Chainage (m)	Asset Type	Condition Rating	Consequence Rating	OCI
EFYC 01	3100-3120	Wall	3	3	13

**Figure 3.27 Grout Filled Bags**

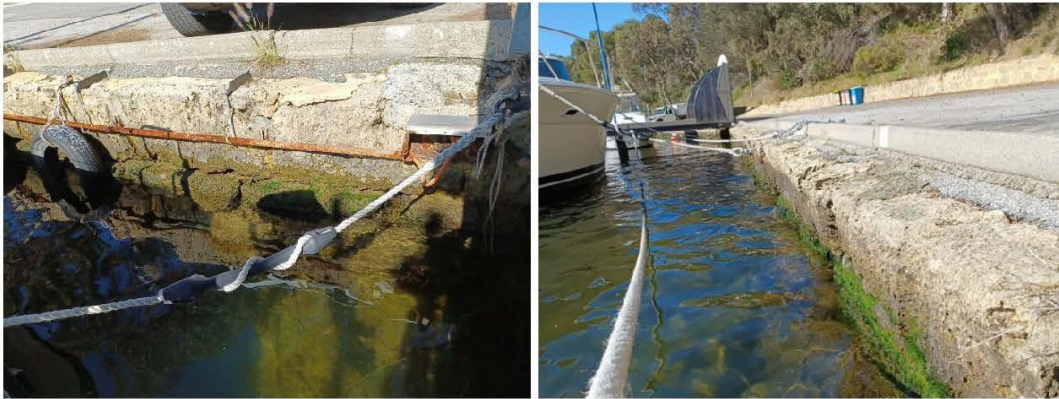
Asset ID	Approximate Chainage (m)	Asset Type	Condition Rating	Consequence Rating	OCI
EFYC 02	3120-3200	Wall	4	4	20

**Figure 3.28 Limestone Blockwall**

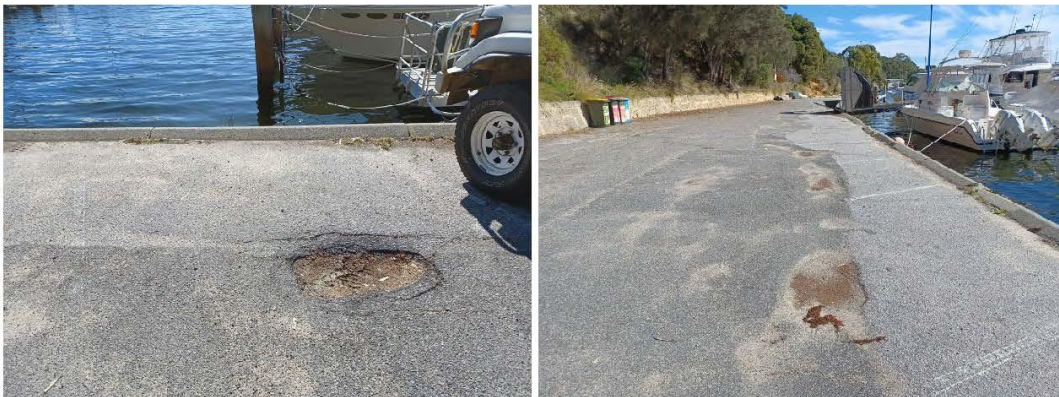
**Figure 3.29 Carpark Pot Holes & Repairs**

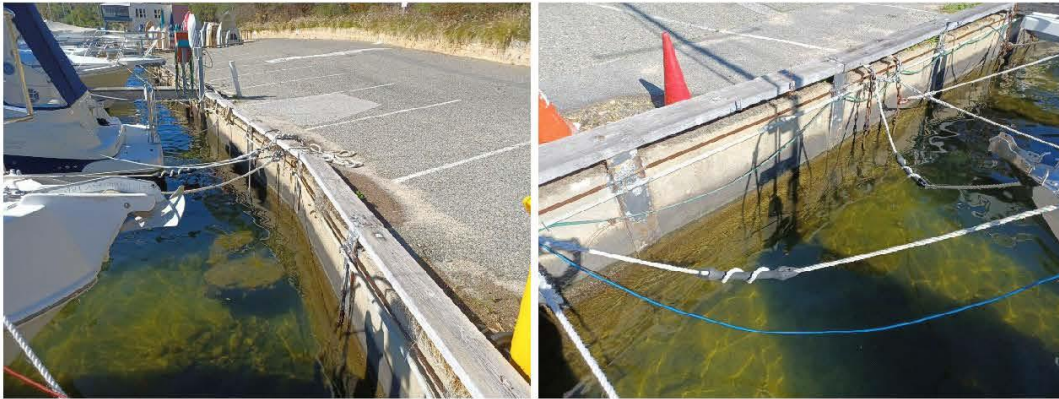
Asset ID	Approximate Chainage (m)	Asset Type	Condition Rating	Consequence Rating	OCI
EFYC 03	3200-3260	Wall	3	4	14

**Figure 3.30 Concrete Panel & Steel Pile Wall**

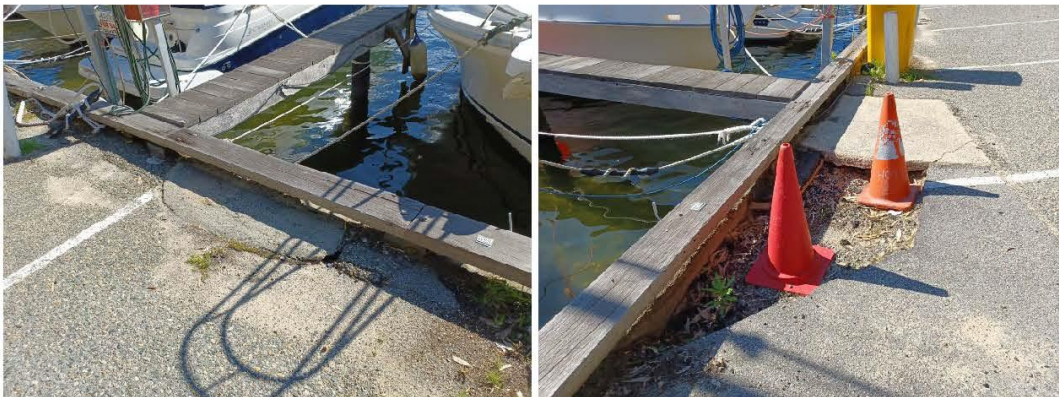
**Figure 3.31 Carpark Bitumen Repairs & Settlement**

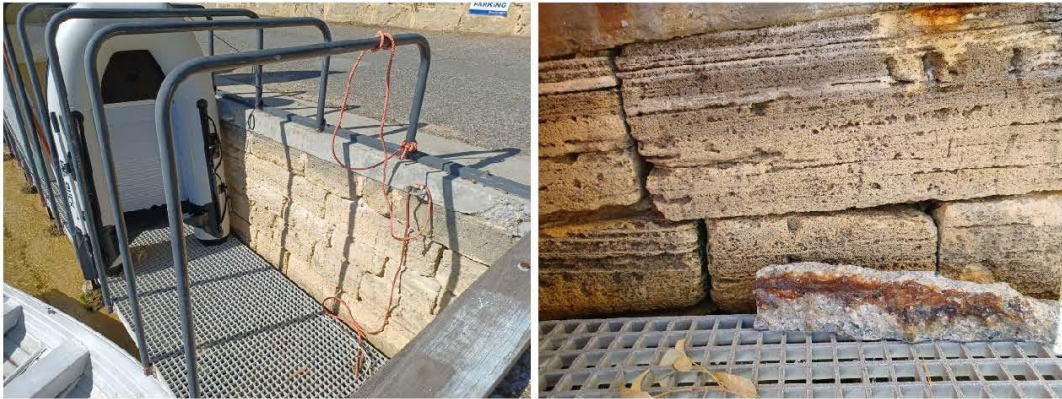
Asset ID	Approximate Chainage (m)	Asset Type	Condition Rating	Consequence Rating	OCI
EFYC 04	3260-3280	Wall	3	4	14

**Figure 3.32 Limestone Blockwall with Dinghy Rack**

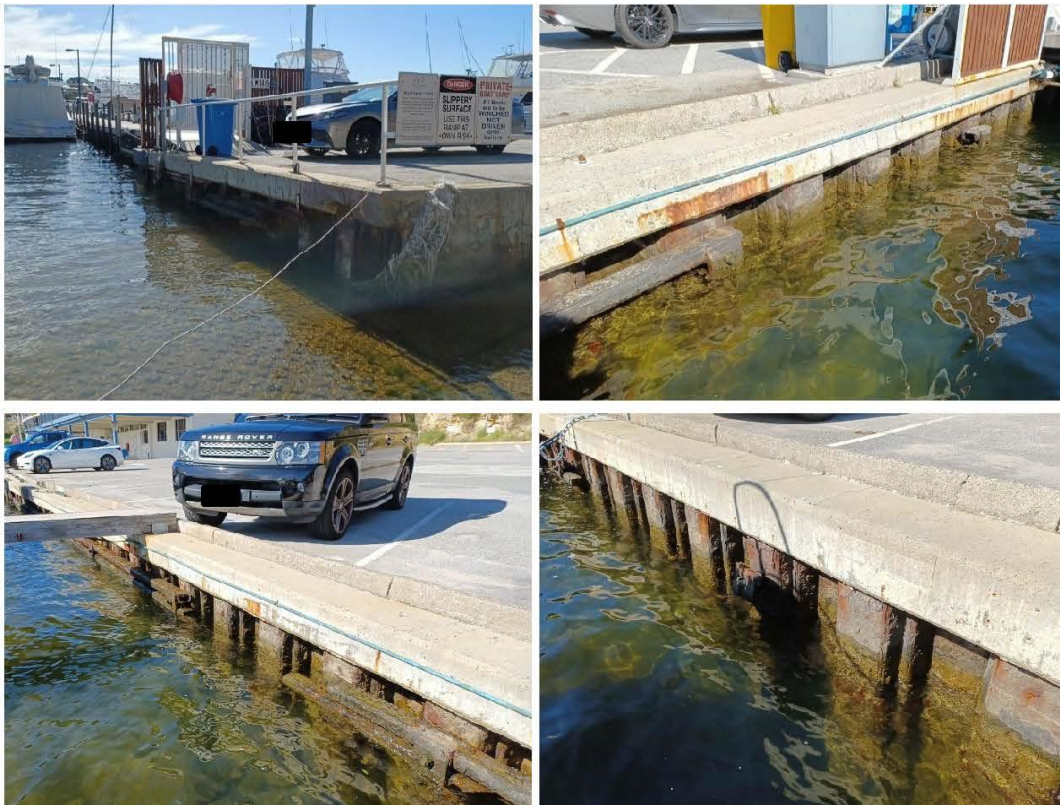
Asset ID	Approximate Chainage (m)	Asset Type	Condition Rating	Consequence Rating	OCI
EFYC 05	3300-3340	Wall	4	4	20

**Figure 3.33 Sheet Pile Wall with Concrete Pile Cap**

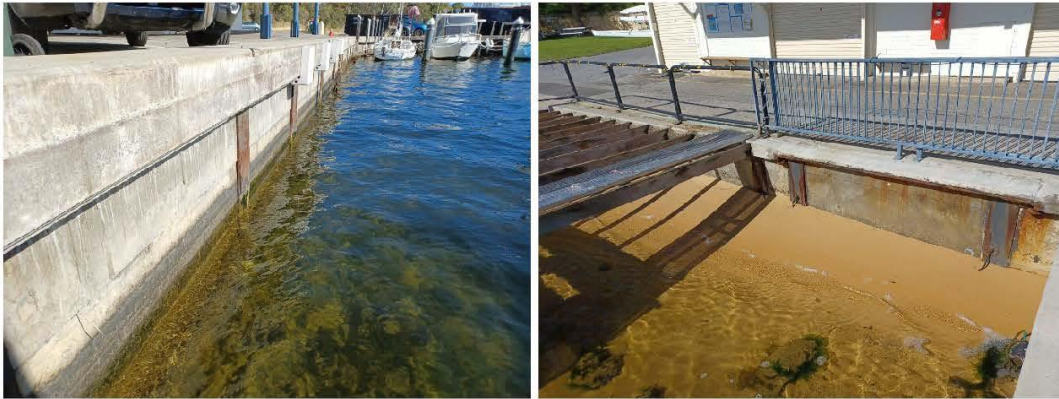
Asset ID	Approximate Chainage (m)	Asset Type	Condition Rating	Consequence Rating	OCI
EFYC 06	3340-3400	Wall	2	4	9

**Figure 3.34 Concrete Panel & Steel H-Pile Wall**

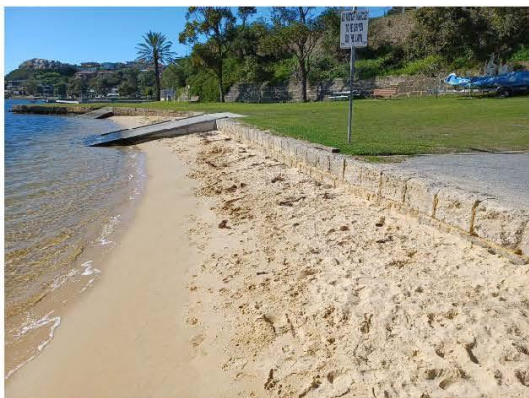
Asset ID	Approximate Chainage (m)	Asset Type	Condition Rating	Consequence Rating	OCI
EFYC 07	3400-3420	Wall	2	2	7

**Figure 3.35 Limestone Blockwall**
