Works Committee Minutes Tuesday, 27 September 2022 6:30:00 PM

MINUTES OF THE ORDINARY MEETING OF THE WORKS COMMITTEE HELD IN THE COUNCIL CHAMBER, 135 CANNING HIGHWAY EAST FREMANTLE ON TUESDAY 27 SEPTEMBER 2022

The Town of East Fremantle (Town) has engaged specialist coastal and port engineers, M P Rogers & Associates Pty Ltd (MRA) to prepare a 10-year riverwall maintenance priority plan. The Town manages approximately 3.5 km of foreshore which is comprised of mixed built, natural and private foreshore assets. The riverwalls and other built foreshore assets managed by the Town are the focus of this maintenance priority plan. It should be noted that while most of the Town's foreshore built assets can be classified as vertical block walls, some other built assets such as mortared rock revetments and groynes also exist and have been included the development of this riverwall maintenance priority plan. The foreshore managed by the Town extends from East Street in the west to Petra Street in the east as shown Figure 1.1.

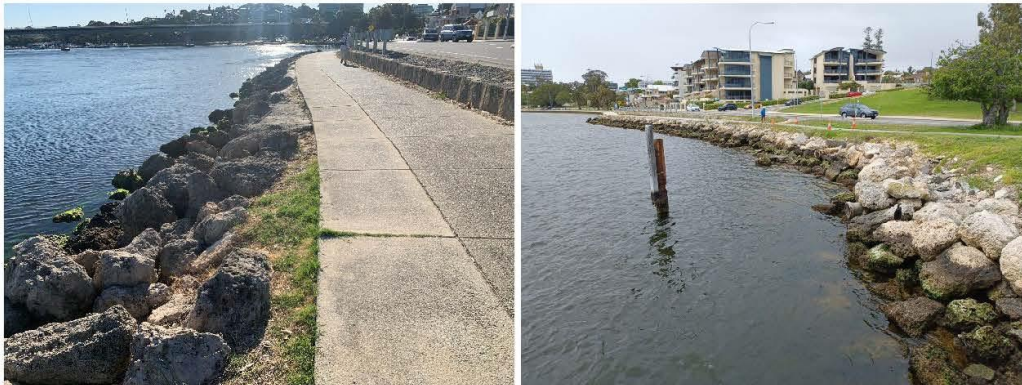
SLFr01 Fremantle Bridge. B01

Asset ID	Approximate Chainage (m)	Asset Type	Condition Rating	Consequence Rating	OCI
SLFre01 Fremantle Bridge.B01	0-20	Rock Revetment	4	3	19

Figure 3.1 Path Behind Revetment (L) & Overtopping Damage (R)

This asset straddles the boundary of the City of Fremantle and the Town of East Fremantle. It appears that most of the asset is within the City of Fremantle's jurisdiction, however approximately 20 metres appear to lie within the Town's boundary. The asset is a limestone rock revetment in poor condition. It features undersize rock with steep sections, insufficient width and damage from uncontrolled surface runoff. There is evidence of voids and overtopping damage behind the crest.

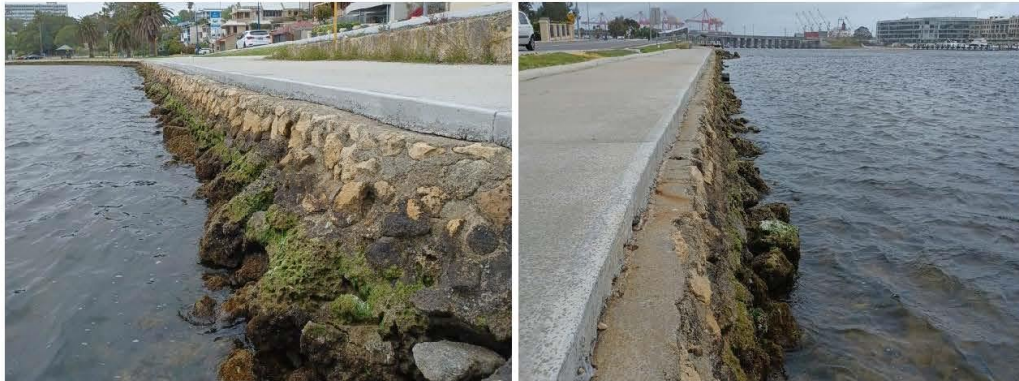
Asset ID	Approximate Chainage (m)	Asset Type	Condition Rating	Consequence Rating	OCI
SLEFr06 Stirling Bridge J Dolan Park.B03	20-80	Wall	3	3	13

Figure 3.2 J Dolan Park Wall Looking East (L) & Looking West (R)

The asset is a vertical wall made from mortared natural limestone rock backed by a concrete pedestrian path which serves as a capping. Some mortar decay around the toe is evident, causing voids and loose rock. The path is cracked in places, possibly due to a loss of fines through voids. Repointing and void repair maintenance works are recommended to prevent further damage to the path.

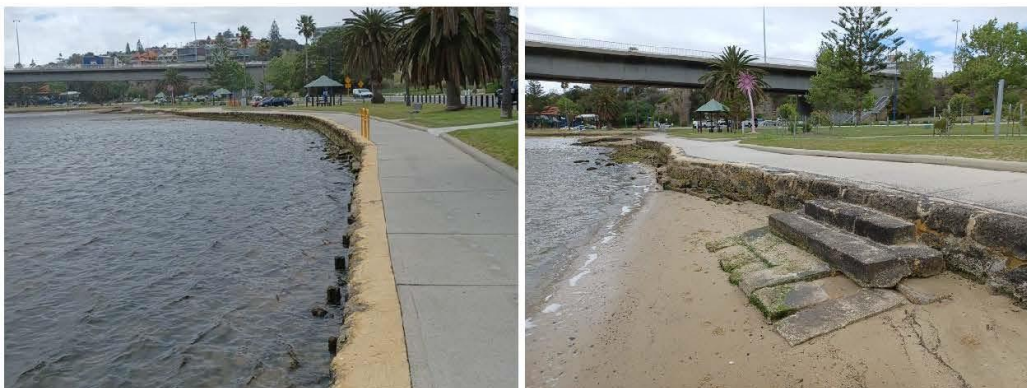
Asset ID	Approximate Chainage (m)	Asset Type	Condition Rating	Consequence Rating	OCI
SLEFr06 Stirling Bridge J Dolan Park. B02	80-240	Wall	3	3	13

Figure 3.3 Limestone Block Wall (L) & Access Stairs (R)

The asset is a low vertical limestone block wall backed with a concrete pedestrian path which serves as capping. Panel/post toe protection is present at the upstream and downstream extents. The wall is generally in fair condition, with the face and crest showing signs of recent regrouting. The limestone block steps are in poor condition and require rebuild. The concrete path on crest appears to be relatively new and is in good condition. Scheduled maintenance is recommended to maintain the asset to its current condition.

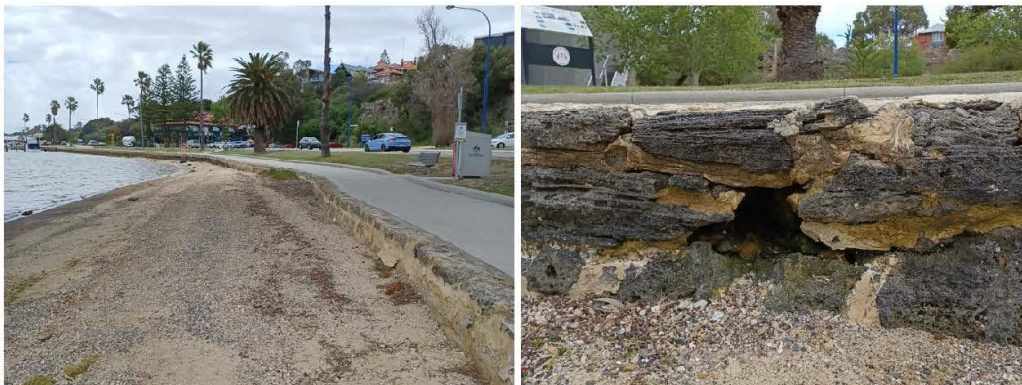
Asset ID	Approximate Chainage (m)	Asset Type	Condition Rating	Consequence Rating	OCI
SLEFr06 Stirling Bridge J Dolan Park. B01	240-370	Wall	3	3	13

Figure 3.4 Sandy Beach (L) & Downstream Void (R)

The asset is a low vertical limestone block wall backed with a concrete pedestrian path which serves as a capping. The concrete path is generally in good condition and the wall exhibits signs of recent repointing works. A sandy beach is protecting the lower portion of the wall, with panel and post toe protection visible in parts. Some of the panels were displaced or damaged. One notable void was present at the downstream end which required maintenance. Scheduled maintenance is recommended to maintain the asset to its current condition.

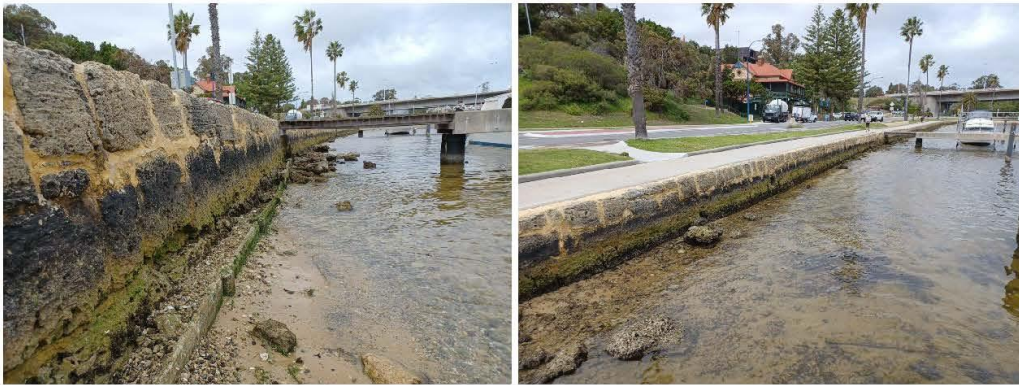
Asset ID	Approximate Chainage (m)	Asset Type	Condition Rating	Consequence Rating	OCI
SLEFr05 Merv Cowan Park. B06	370-500	Wall	3	3	13

Figure 3.5 Limestone Blockwall with Jetty Abutments

The asset is a vertical limestone blockwall with intermittent panel and post toe protection and some scattered rock rip rap. The wall features multiple jetty abutments and a public concrete path at the rear of crest. The condition of the wall was generally fair, with signs of recent repointing works, however, there was some grout loss in the lower courses. Scheduled maintenance is recommended to maintain the asset to its current condition.

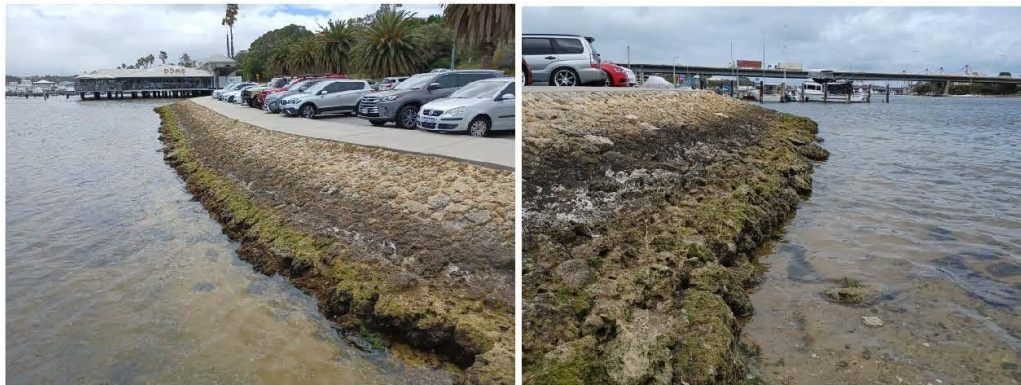
Asset ID	Approximate Chainage (m)	Asset Type	Condition Rating	Consequence Rating	OCI
SLEFr05 Merv Cowan Park. B04	500-580	Revetment	3	3	13

Figure 3.6 Pitched Revetment Looking North (L) & South (R)

The asset is a pitched (grouted) limestone revetment supporting a concrete path and protecting a high use carpark. The top sections were in good condition, with the overall structure in fair condition. Some loss of mortar and rock was evident at the toe. The asset requires toe protection to prevent further undermining. Lack of action could lead to further material loss and development of voids beneath path/carpark.

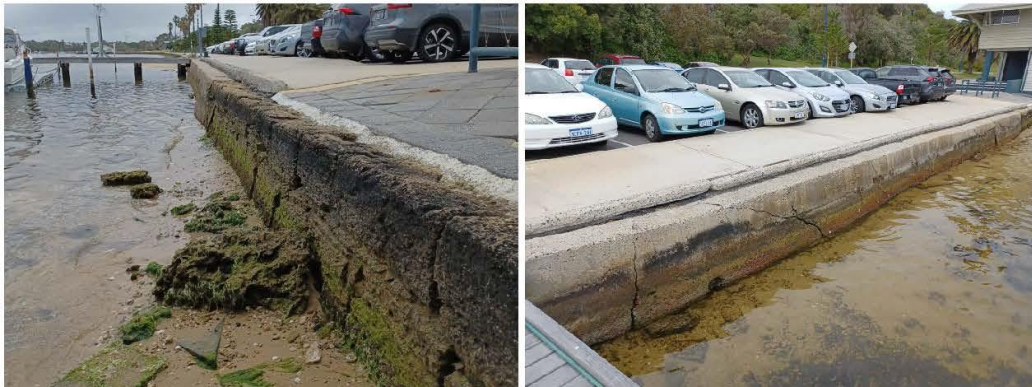
Asset ID	Approximate Chainage (m)	Asset Type	Condition Rating	Consequence Rating	OCI
SLEFr05 Merv Cowan Park. B04	600-630	Wall	4	4	20

Figure 3.7 Weathered Blockwall (L) & Cracking of Concrete Wall (R)

The section of walling on the northern side of the Dome is in poor condition. There is a short limestone blockwall extending from the Dome about 5-10 metres. The blockwall is heavily deteriorated with little mortar still visible, heavily weathered blocks and signs of settlement. There has been significant loss of material behind the wall, settlement, and movement of pavers.

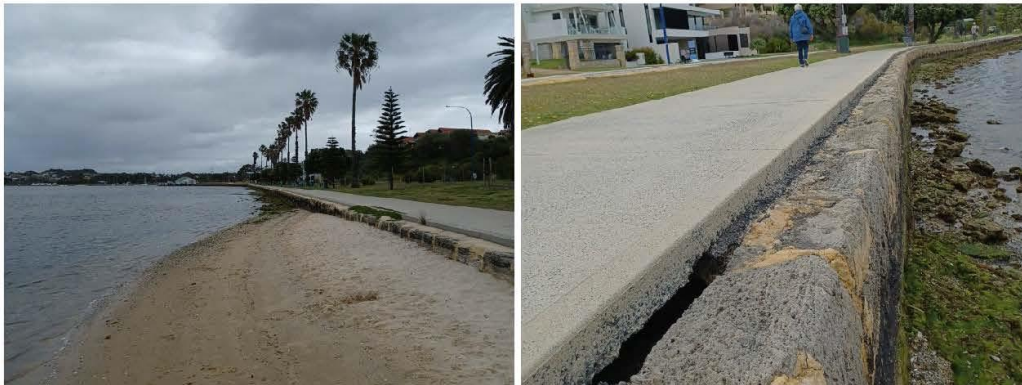
Asset ID	Approximate Chainage (m)	Asset Type	Condition Rating	Consequence Rating	OCI
SLEFr05 Merv Cowan Park. B03	630-940	Wall	4	3	19

Figure 3.8 Low Limestone Blockwall (L) & Voids Beneath Path (R)

The limestone blockwall exhibited signs of recent repointing maintenance. The lower courses of the wall display loss of mortar, and there was evidence of voids behind the wall / below the path. Recent maintenance efforts have helped slow the deterioration, however further works will be required with attention to the lower courses and filling voids behind the wall.

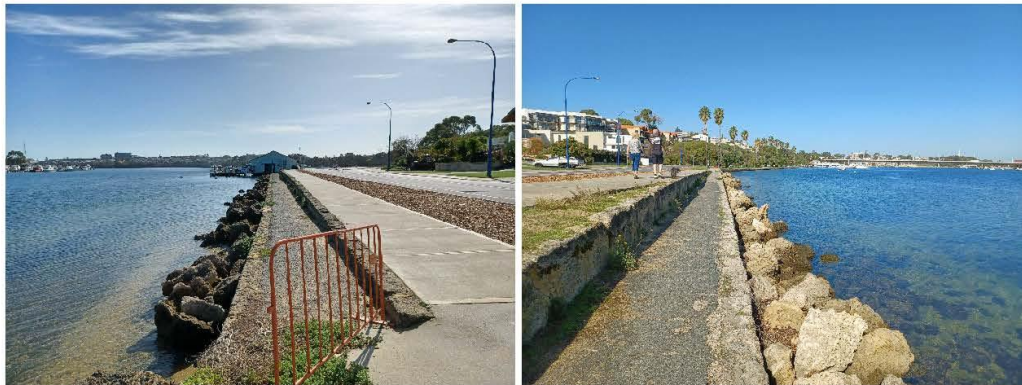
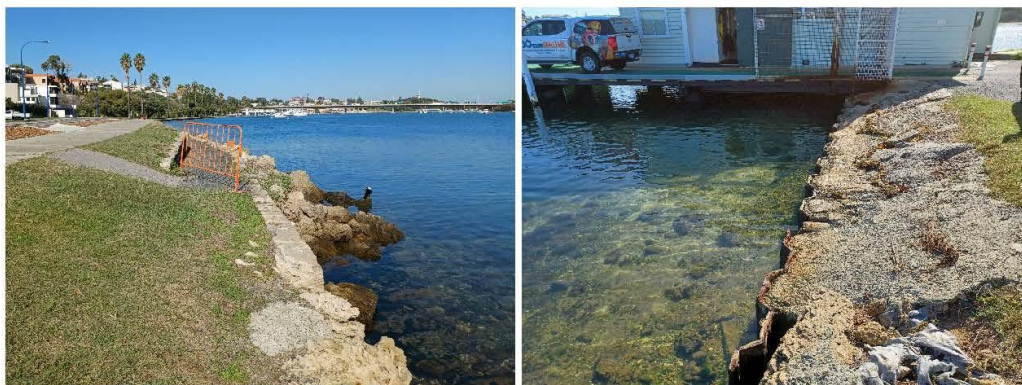
Asset ID	Approximate Chainage (m)	Asset Type	Condition Rating	Consequence Rating	OCI
SLEFr05 Merv Cowan Park. B02	940-1050	Wall	4	3	19

Figure 3.9a Limestone Armour in Front of Vertical Wall

Figure 3.9b Tie In (L) & Sheet Pile Wall (R)

The asset is a terraced blockwall with a bituminous pavement present on the lower-level landing (now closed off to pedestrians). A concrete path is present behind the top wall, and is in fair condition. Rock armour is present fronting the wall and provides some protection from wave energy. However, the wall is deteriorated with loss of fines and voids opening up behind the crest, resulting in a poor visual aesthetic. Recommended remediation options for this stretch could include adaption measures such as removal of the bitumen, blockwall maintenance and vegetation of the lower level.

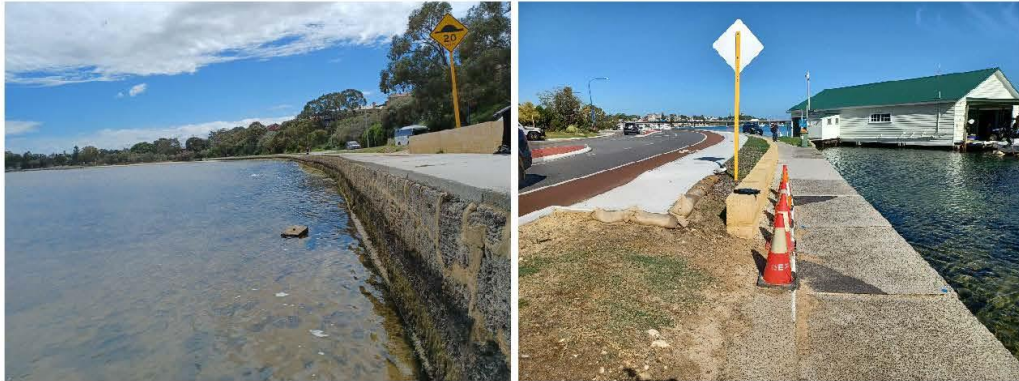
Asset ID	Approximate Chainage (m)	Asset Type	Condition Rating	Consequence Rating	OCI
SLEFr05 Merv Cowan Park. B01	940-1050	Wall	3	3	13

Figure 3.10 Block Wall Section (L) & Settled Path (R)

The asset is a limestone blockwall featuring a concrete path capping and toe scour protection. The wall is generally in a fair condition with signs of recent repointing maintenance. The lower courses require further repointing.

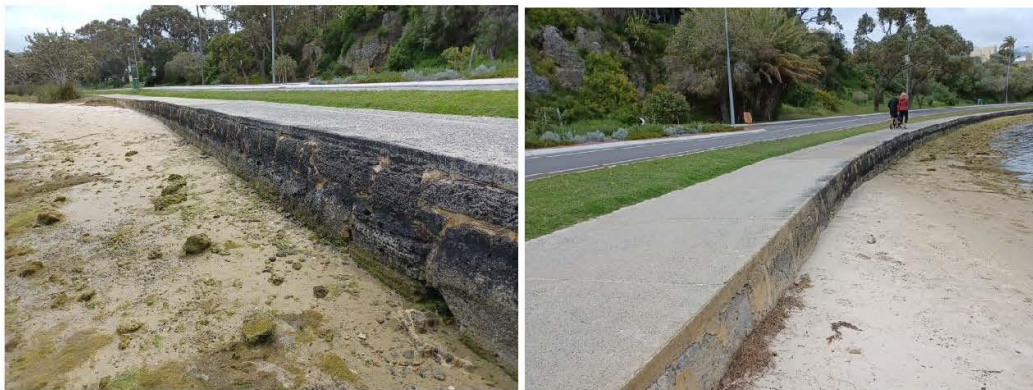
Asset ID	Approximate Chainage (m)	Asset Type	Condition Rating	Consequence Rating	OCI
SLEFr04 John Tonkin Park & Preston Point. B11	1330-1380	Wall	2	2	7

Figure 3.11 Limestone Block Wall & Sandy Beach

The asset is in moderate condition, showing signs of minor deterioration. A sandy beach in front of the wall is protecting the lower courses. Scheduled repointing maintenance is recommended to maintain the asset to its current condition.

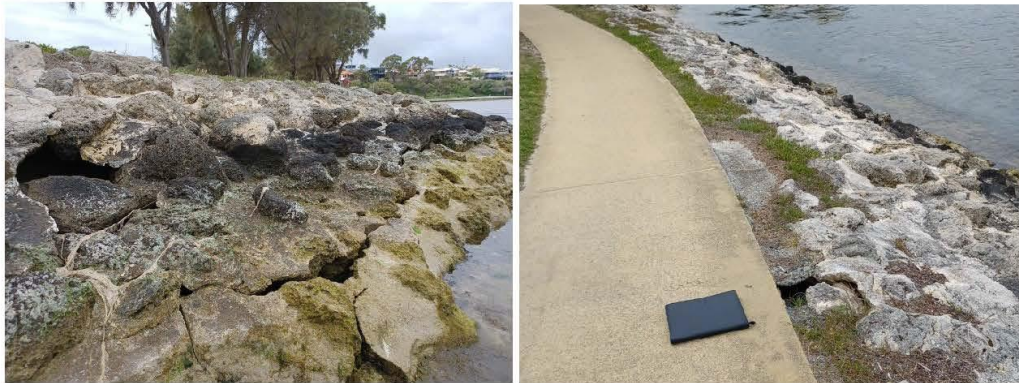
Asset ID	Approximate Chainage (m)	Asset Type	Condition Rating	Consequence Rating	OCI
SLEFr04 John Tonkin Park & Preston Point. B10	1420-1520	Revetment	4	3	19

Figure 3.12 Grouted Revetment (L) & Voids Under Path (R)

The asset is a pitched (mortared) limestone rock revetment in poor condition. The grout has cracked as a result of toe undermining, allowing the lower rocks to settle. Extensive voids were present throughout revetment structure. The path exhibits cracks which is indicative of voids underneath.

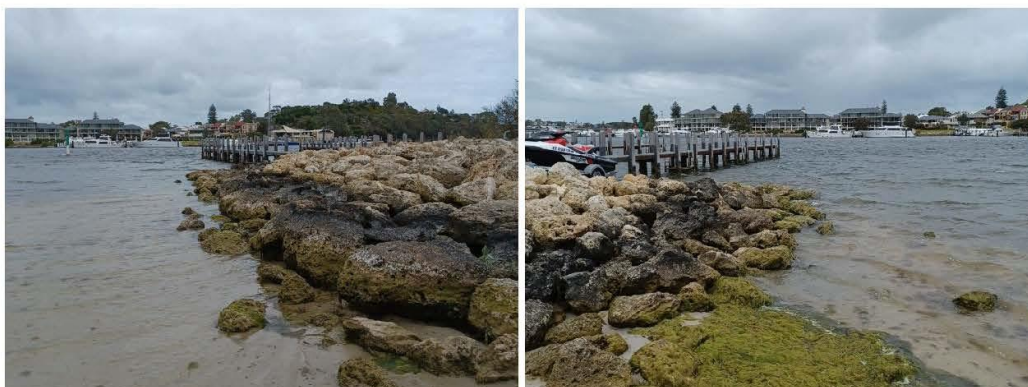
Asset ID	Approximate Chainage (m)	Asset Type	Condition Rating	Consequence Rating	OCI
SLEFr04 John Tonkin Park & Preston Point. B9	1540-1570	Revetment	3	3	13

Figure 3.13 Revetment Around Boat Ramp

The limestone rock revetment around the Leeuwin boat ramp was observed to be in fair condition. Minor maintenance involving repacking of armour and loose material is required.

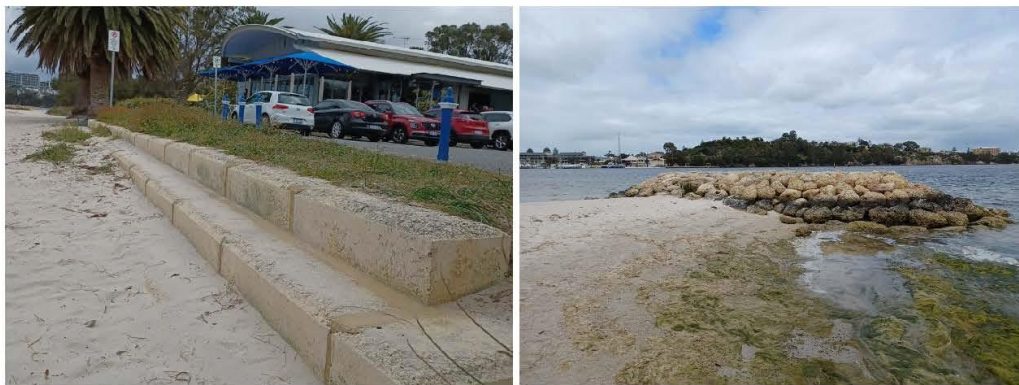
Asset ID	Approximate Chainage (m)	Asset Type	Condition Rating	Consequence Rating	OCI
SLEFr04 John Tonkin Park & Preston Point. B08	1600-1620	Wall	1	3	3
SLEFr04 John Tonkin Park & Preston Point. B07	1600-1620	Groyne	1	2	2
SLEFr04 John Tonkin Park & Preston Point. B06	1640-1660	Groyne	1	2	2
SLEFr04 John Tonkin Park & Preston Point. B05	1700-1720	Groyne	1	2	2
SLEFr04 John Tonkin Park & Preston Point. B04	1740-1760	Groyne	1	2	2
SLEFr04 John Tonkin Park & Preston Point. B03	1800-1820	Groyne	1	2	2

Figure 3.14 Block Wall (L) & Groyne Example (R)

The above assets were all observed to be in good condition. The maintenance requirements include ongoing monitoring.

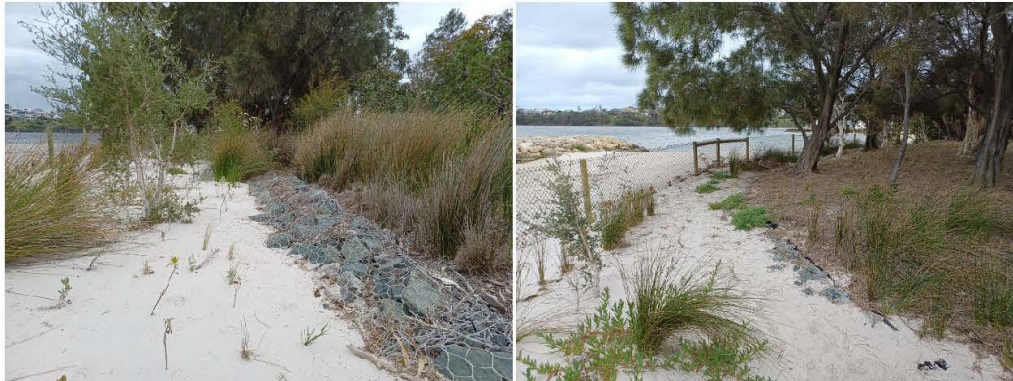
Asset ID	Approximate Chainage (m)	Asset Type	Condition Rating	Consequence Rating	OCI
SLEFr04 John Tonkin Park & Preston Point. B02	1760-1840	Gabion	2	2	7

Figure 3.15 Buried Gabion/Reno Mattresses

The asset is a mostly buried gabion basket/reno mattress, with visible portions in moderate condition. No works required.

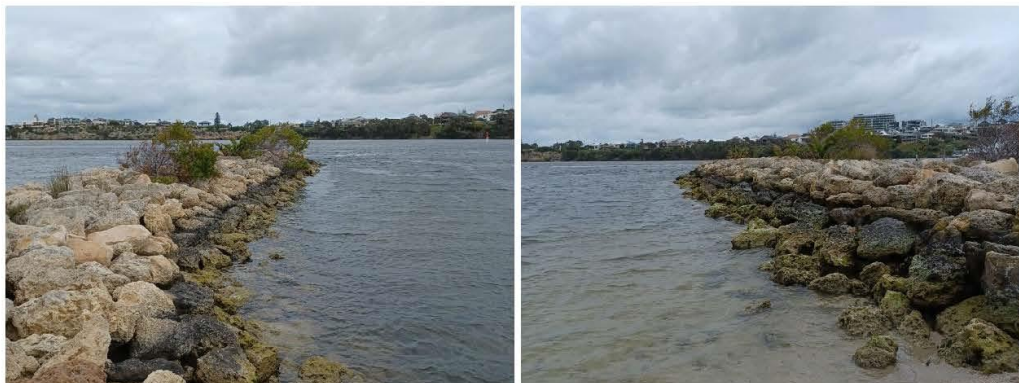
Asset ID	Approximate Chainage (m)	Asset Type	Condition Rating	Consequence Rating	OCI
SLEFr04 John Tonkin Park & Preston Point. B01	1900-1940	Groyne	2	2	7

Figure 3.16 Preston Point Groyne

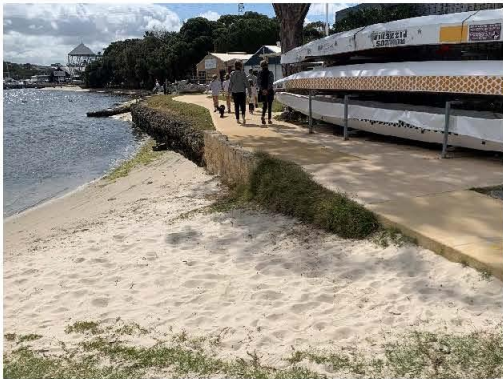
Asset ID	Approximate Chainage (m)	Asset Type	Condition Rating	Consequence Rating	OCI
SLEFr03 Norm McKenzie Reserve. B05	2055-2065	Wall	3	3	13

Figure 3.17 Limestone Block Wall

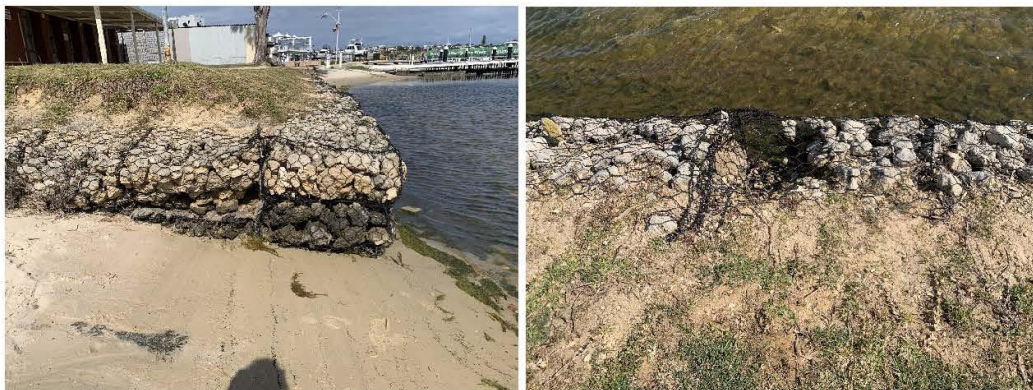
Asset ID	Approximate Chainage (m)	Asset Type	Condition Rating	Consequence Rating	OCI
SLEFr03 Norm McKenzie Reserve. B04	2060-2090	Gabion	4	2	18

Figure 3.18 Limestone Gabions Rotated (L) & Lost Material (R)

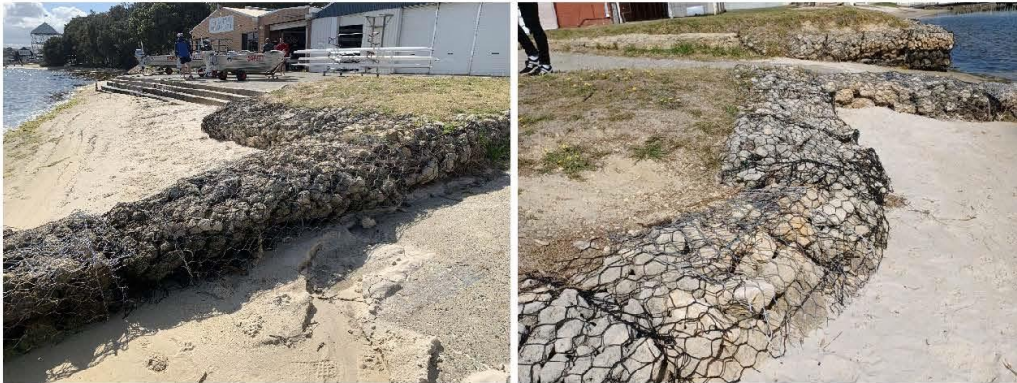
Asset ID	Approximate Chainage (m)	Asset Type	Condition Rating	Consequence Rating	OCI
SLEFr03 Norm McKenzie Reserve. B03	2090-2100	Gabion	3	2	12

Figure 3.19 Limestone Gabions

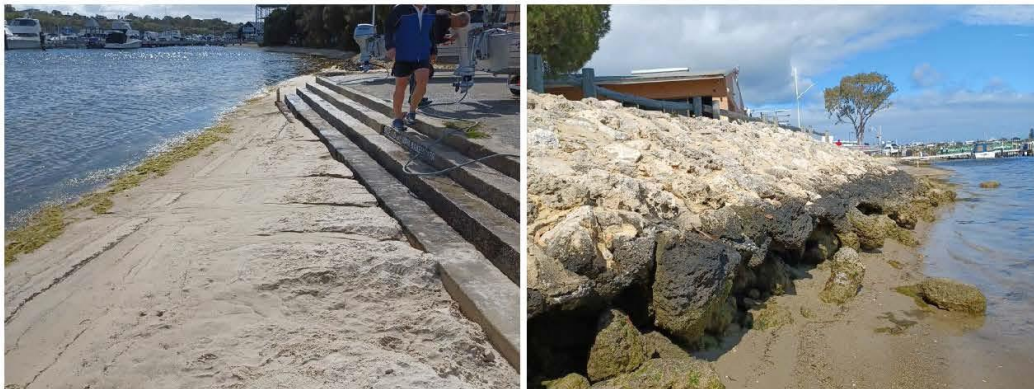
Asset ID	Approximate Chainage (m)	Asset Type	Condition Rating	Consequence Rating	OCI
SLEFr03 Norm McKenzie Reserve. B02	2100-2155	Revetment	3	3	13

Figure 3.20 Steps (L) & Pitched Revetment (R)

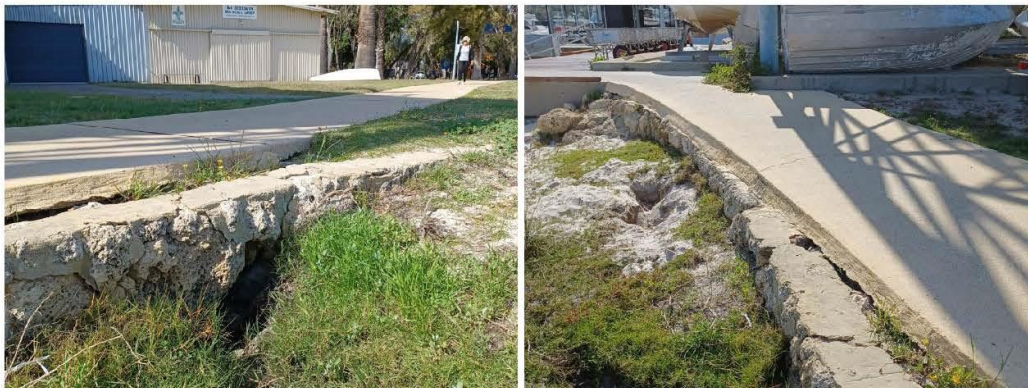
Asset ID	Approximate Chainage (m)	Asset Type	Condition Rating	Consequence Rating	OCI
SLEFr03 Norm McKenzie Reserve. B01	2240-2260	Wall	4	2	18

Figure 3.21 Undermined Limestone Block Wall

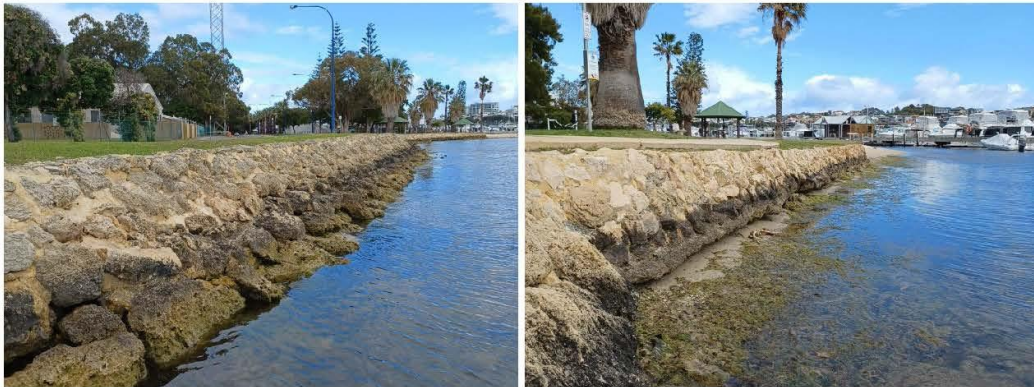
Asset ID	Approximate Chainage (m)	Asset Type	Condition Rating	Consequence Rating	OCI
SLEFr02 Wayman Reserve – Jerrat Drive. B02	2425-2550	Revetment	3	2	12

Figure 3.22 Pitched Limestone Revetment

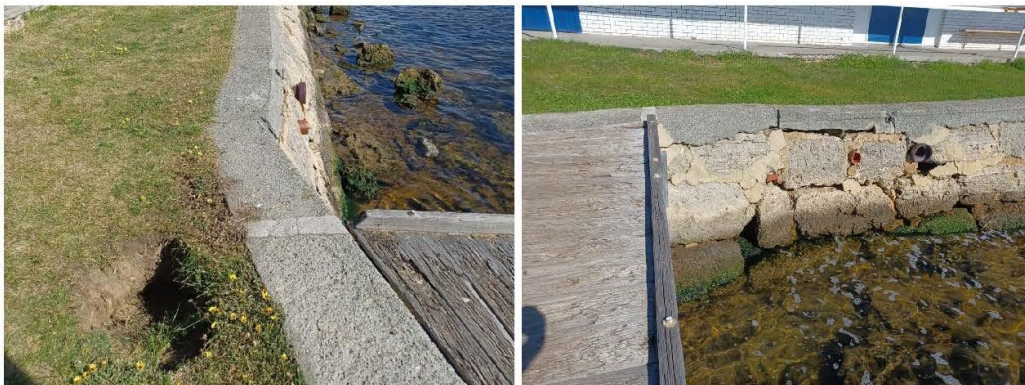
Asset ID	Approximate Chainage (m)	Asset Type	Condition Rating	Consequence Rating	OCI
SLEFr02 Wayman Reserve – Jerrat Drive. B01	2820-2895	Wall	4	3	19

Figure 3.23 Deteriorated Limestone Block Wall

The foreshore features a deteriorated limestone block wall fronting Camp Waller Sea Scouts Hall. The blocks are weathered and exhibit a total loss of mortar through the lower courses. There is evidence of material loss through the wall leading to voids opening up behind wall crest. The voids behind wall are a safety hazard with uneven surfaces and potential for unstable ground to give way. Although outside the scope of this assessment, the jetty was also noted to be in poor condition and requires further investigation and monitoring.

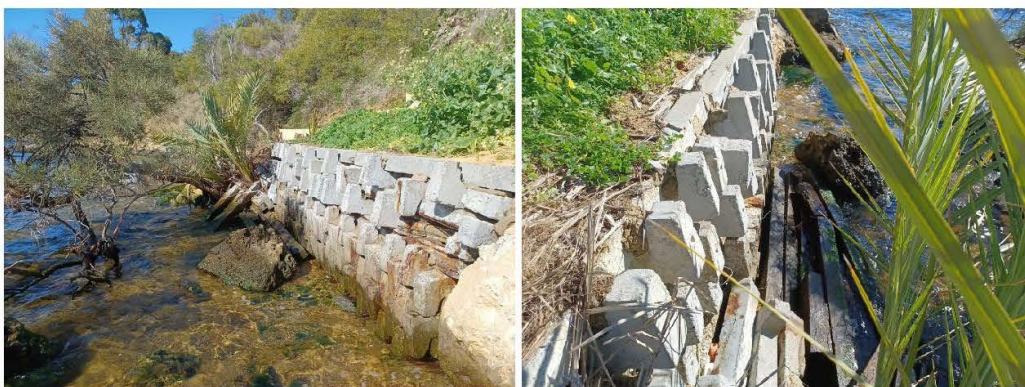
Figure 3.24 Deteriorated Crib Wall

The foreshore upstream of the building features a deteriorated crib wall which supports the concrete path behind. Many cracked and dislodged units were observed. It is recommended that the entire foreshore at this site is investigated for future significant upgrade.

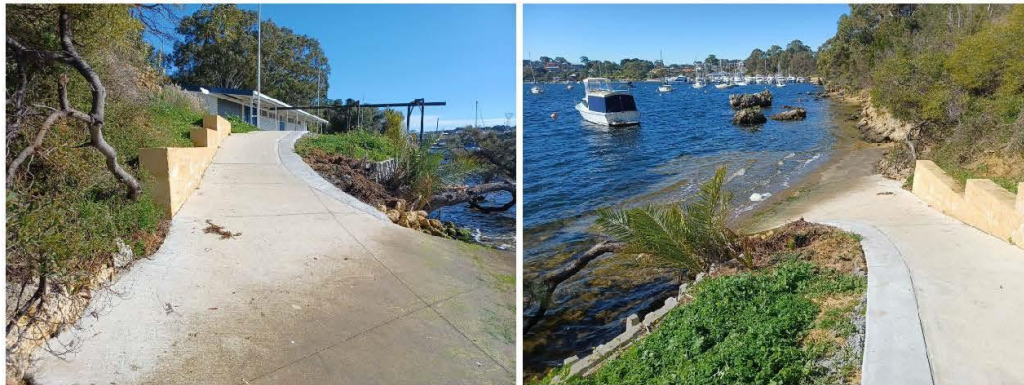
Figure 3.25 Limestone Block Wall & Concrete Apron

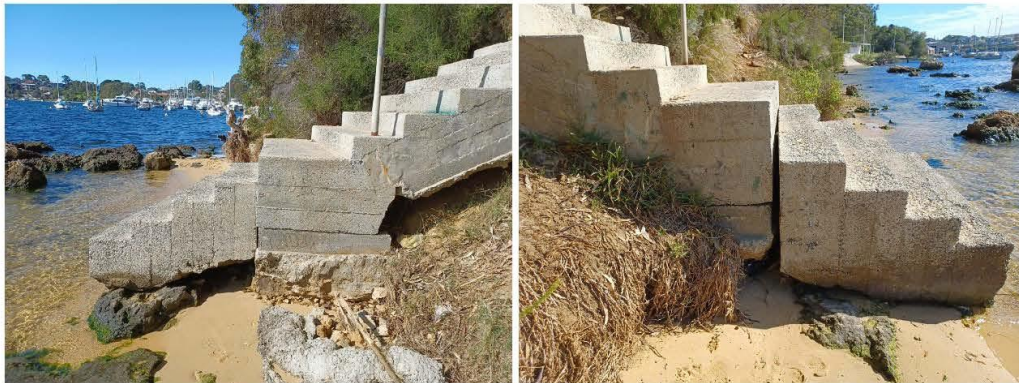
Asset ID	Approximate Chainage (m)	Asset Type	Condition Rating	Consequence Rating	OCI
SLEFr02 Wayman Reserve – Jerrat Drive. B03	2970	Abutment	3	2	12

Figure 3.26 Concrete Stair Abutment

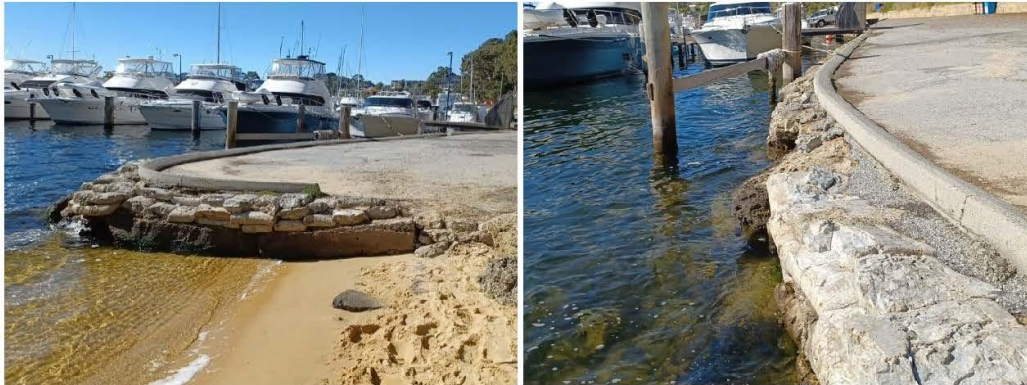
Asset ID	Approximate Chainage (m)	Asset Type	Condition Rating	Consequence Rating	OCI
EFYC 01	3100-3120	Wall	3	3	13

Figure 3.27 Grout Filled Bags

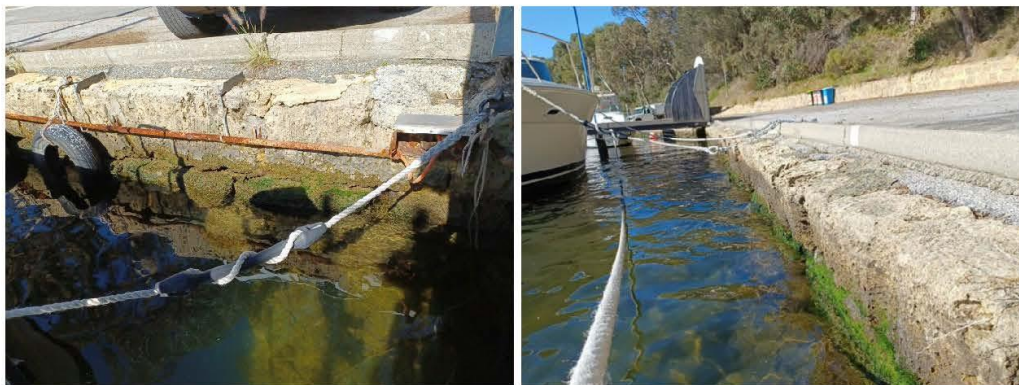
Asset ID	Approximate Chainage (m)	Asset Type	Condition Rating	Consequence Rating	OCI
EFYC 02	3120-3200	Wall	4	4	20

Figure 3.28 Limestone Blockwall

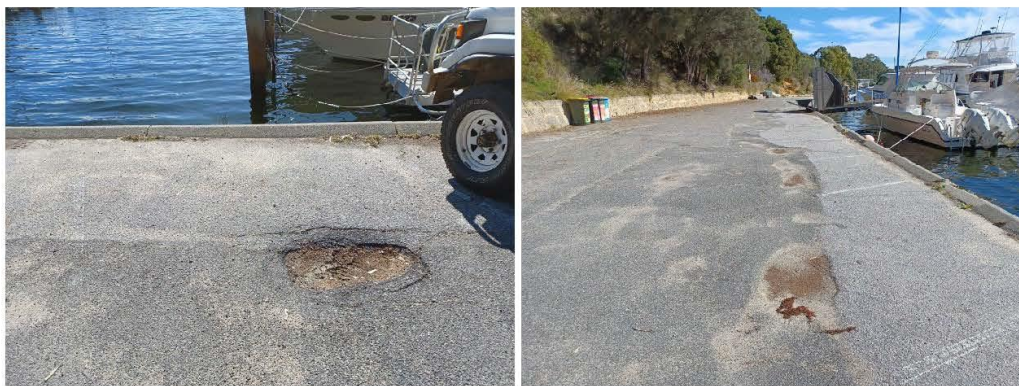
Figure 3.29 Carpark Pot Holes & Repairs

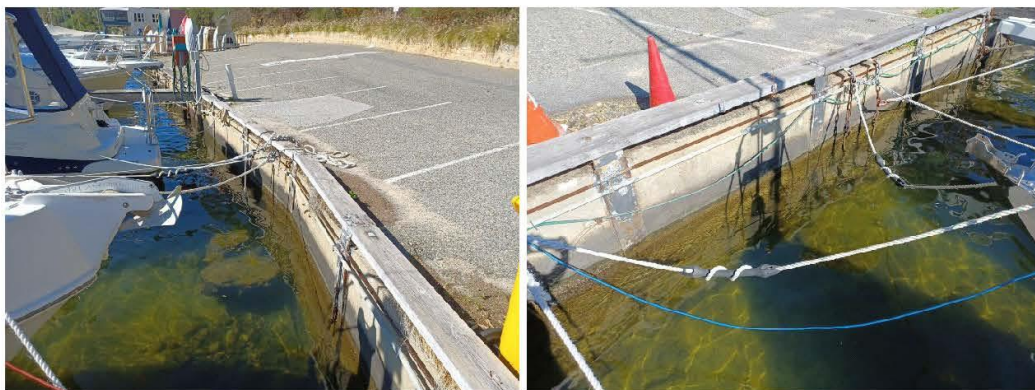
Asset ID	Approximate Chainage (m)	Asset Type	Condition Rating	Consequence Rating	OCI
EFYC 03	3200-3260	Wall	3	4	14

Figure 3.30 Concrete Panel & Steel Pile Wall

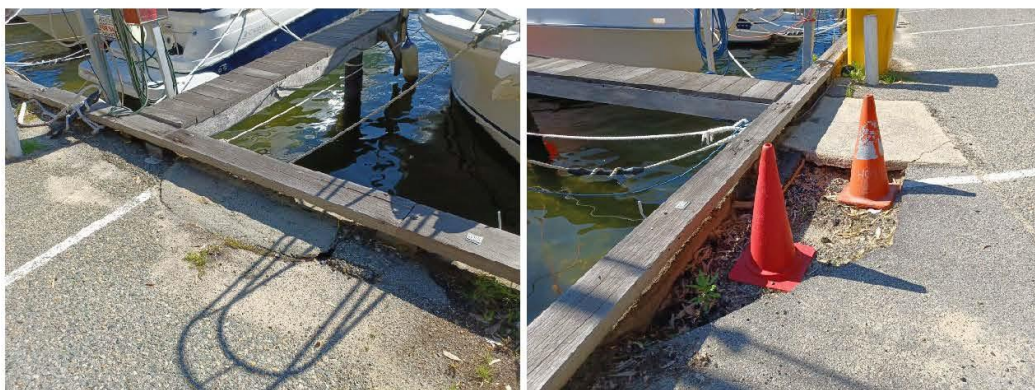
Figure 3.31 Carpark Bitumen Repairs & Settlement

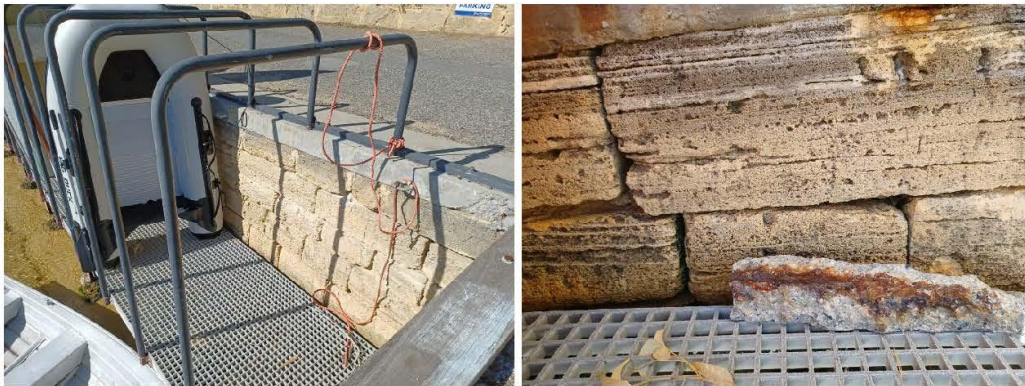
Asset ID	Approximate Chainage (m)	Asset Type	Condition Rating	Consequence Rating	OCI
EFYC 04	3260-3280	Wall	3	4	14

Figure 3.32 Limestone Blockwall with Dinghy Rack

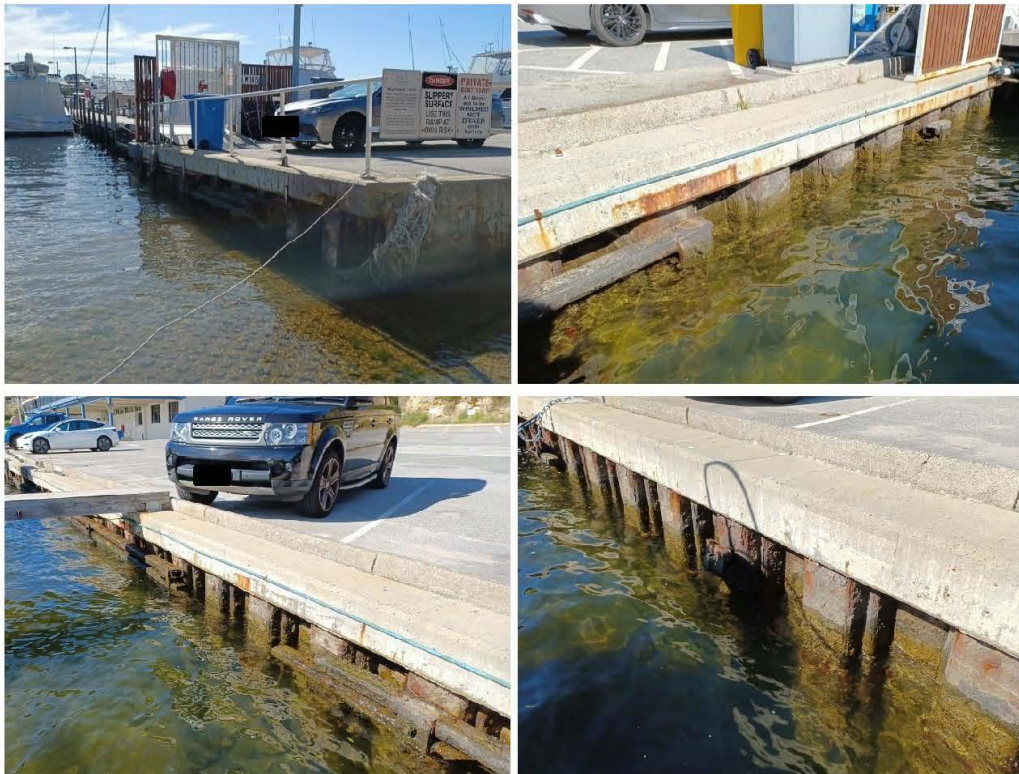
Asset ID	Approximate Chainage (m)	Asset Type	Condition Rating	Consequence Rating	OCI
EFYC 05	3300-3340	Wall	4	4	20

Figure 3.33 Sheet Pile Wall with Concrete Pile Cap

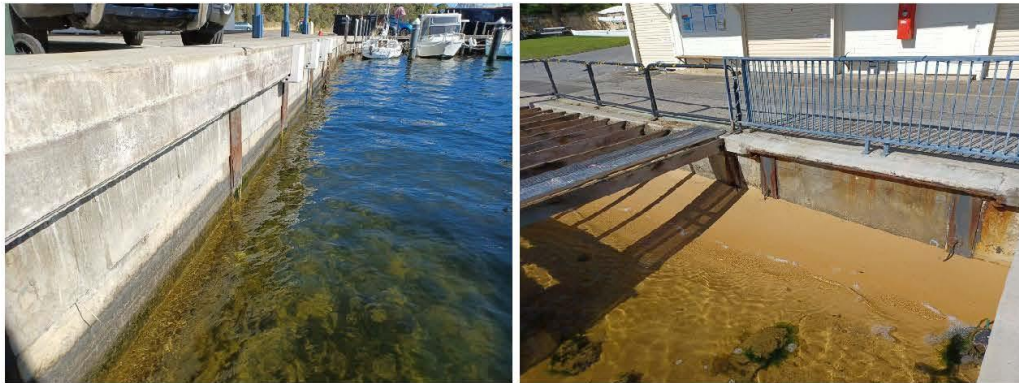
Asset ID	Approximate Chainage (m)	Asset Type	Condition Rating	Consequence Rating	OCI
EFYC 06	3340-3400	Wall	2	4	9

Figure 3.34 Concrete Panel & Steel H-Pile Wall

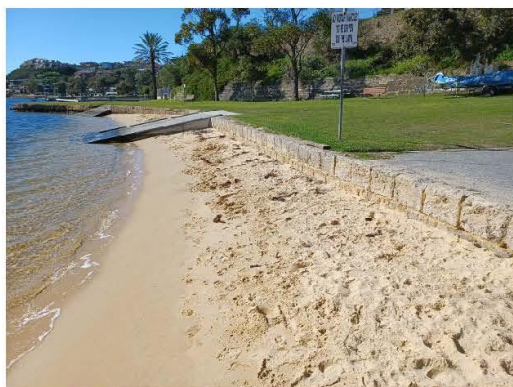
Asset ID	Approximate Chainage (m)	Asset Type	Condition Rating	Consequence Rating	OCI
EFYC 07	3400-3420	Wall	2	2	7

Figure 3.35 Limestone Blockwall
