Works Committee Agenda Tuesday, 27 September 2022 6:30:00 PM

The Town of East Fremantle (Town) has engaged specialist coastal and port engineers, M P Rogers & Associates Pty Ltd (MRA) to prepare a 10-year riverwall maintenance priority plan. The Town manages approximately 3.5 km of foreshore which is comprised of mixed built, natural and private foreshore assets. The riverwalls and other built foreshore assets managed by the Town are the focus of this maintenance priority plan. It should be noted that while most of the Town's foreshore built assets can be classified as vertical block walls, some other built assets such as mortared rock revetments and groynes also exist and have been included the development of this riverwall maintenance priority plan. The foreshore managed by the Town extends from East Street in the west to Petra Street in the east as shown Figure 1.1.

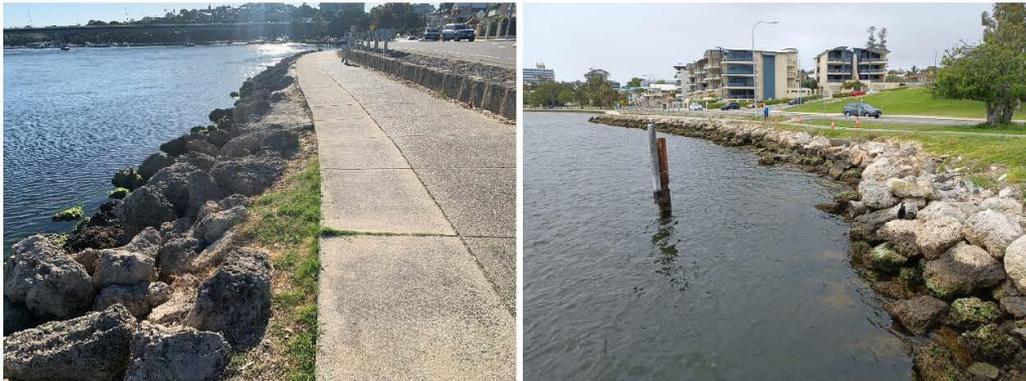
Figure 3.1 Path Behind Revetment (L) & Overtopping Damage (R)

This asset straddles the boundary of the City of Fremantle and the Town of East Fremantle. It appears that most of the asset is within the City of Fremantle's jurisdiction, however approximately 20 metres appear to lie within the Town's boundary. The asset is a limestone rock revetment in poor condition. It features undersize rock with steep sections, insufficient width and damage from uncontrolled surface runoff. There is evidence of voids and overtopping damage behind the crest.

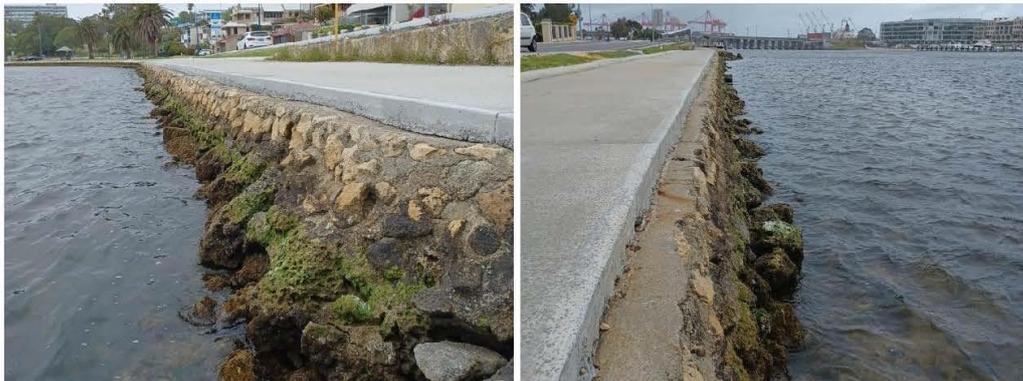
Figure 3.2 J Dolan Park Wall Looking East (L) & Looking West (R)

The asset is a vertical wall made from mortared natural limestone rock backed by a concrete pedestrian path which serves as a capping. Some mortar decay around the toe is evident, causing voids and loose rock. The path is cracked in places, possibly due to a loss of fines through voids. Repointing and void repair maintenance works are recommended to prevent further damage to the path.

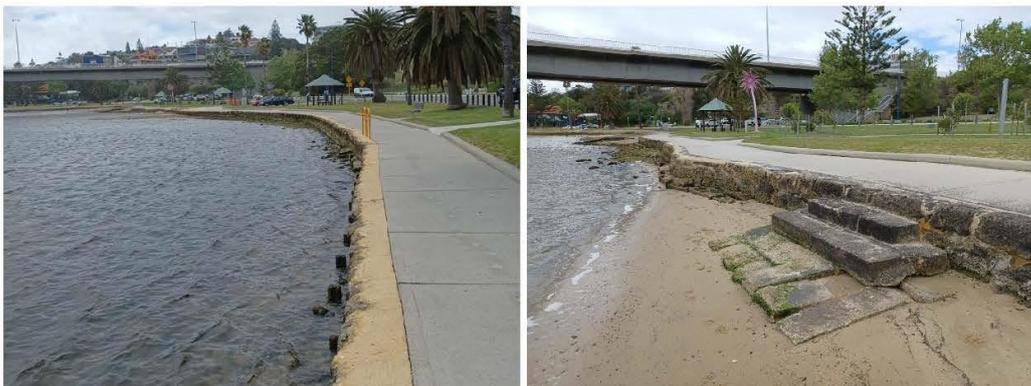
Figure 3.3 Limestone Block Wall (L) & Access Stairs (R)

The asset is a low vertical limestone block wall backed with a concrete pedestrian path which serves as capping. Panel/post toe protection is present at the upstream and downstream extents. The wall is generally in fair condition, with the face and crest showing signs of recent regrouting. The limestone block steps are in poor condition and require rebuild. The concrete path on crest appears to be relatively new and is in good condition. Scheduled maintenance is recommended to maintain the asset to its current condition.

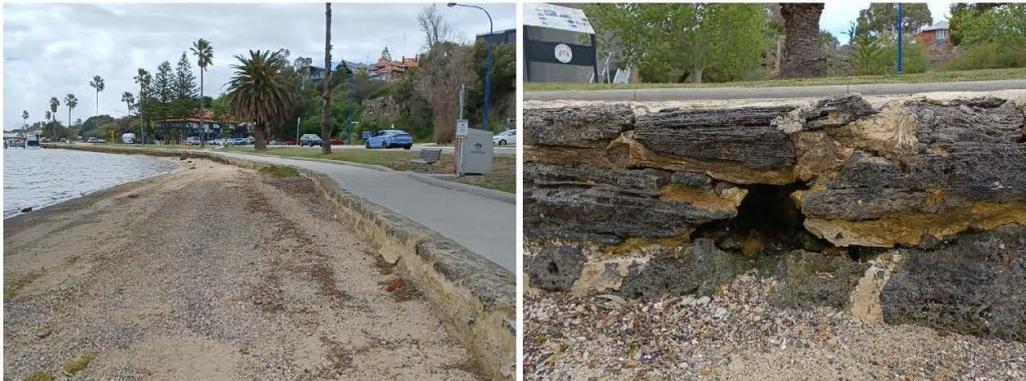
Figure 3.4 Sandy Beach (L) & Downstream Void (R)

The asset is a low vertical limestone block wall backed with a concrete pedestrian path which serves as a capping. The concrete path is generally in good condition and the wall exhibits signs of recent repointing works. A sandy beach is protecting the lower portion of the wall, with panel and post toe protection visible in parts. Some of the panels were displaced or damaged. One notable void was present at the downstream end which required maintenance. Scheduled maintenance is recommended to maintain the asset to its current condition.

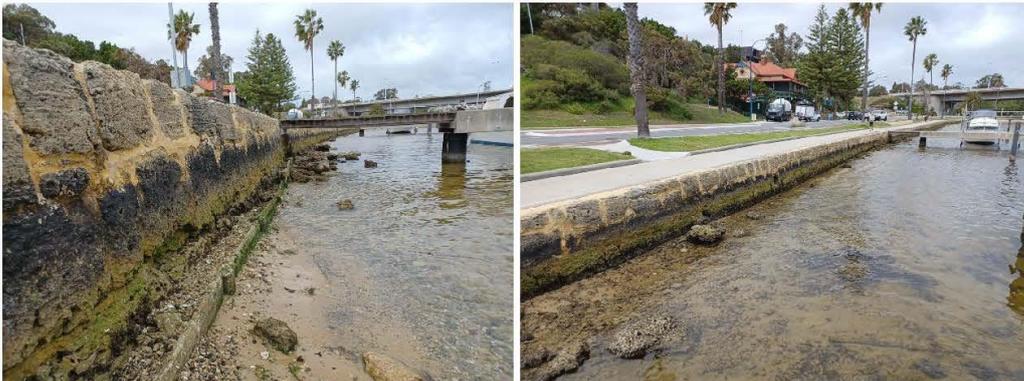
Figure 3.5 Limestone Blockwall with Jetty Abutments

The asset is a vertical limestone blockwall with intermittent panel and post toe protection and some scattered rock rip rap. The wall features multiple jetty abutments and a public concrete path at the rear of crest. The condition of the wall was generally fair, with signs of recent repointing works, however, there was some grout loss in the lower courses. Scheduled maintenance is recommended to maintain the asset to its current condition.

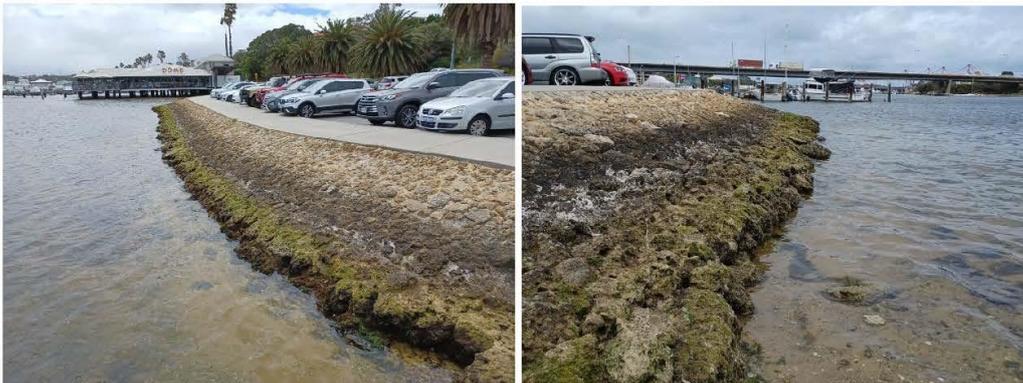
Figure 3.6 Pitched Revetment Looking North (L) & South (R)

The asset is a pitched (grouted) limestone revetment supporting a concrete path and protecting a high use carpark. The top sections were in good condition, with the overall structure in fair condition. Some loss of mortar and rock was evident at the toe. The asset requires toe protection to prevent further undermining. Lack of action could lead to further material loss and development of voids beneath path/carpark.

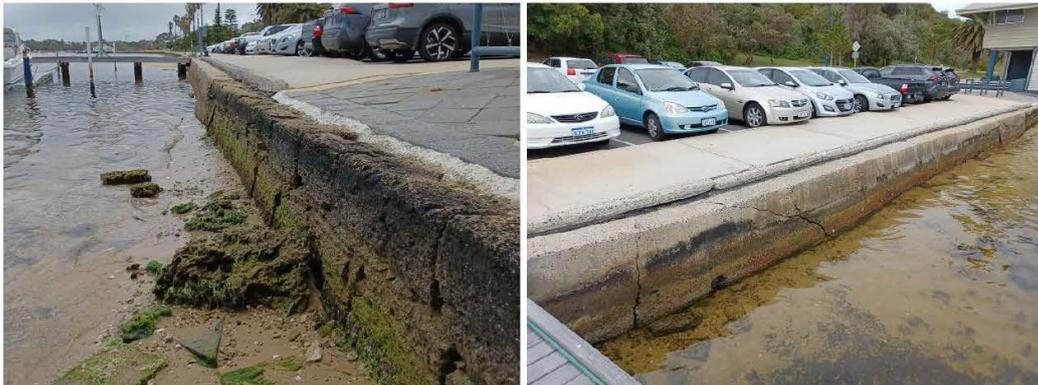
Figure 3.7 Weathered Blockwall (L) & Cracking of Concrete Wall (R)

The section of walling on the northern side of the Dome is in poor condition. There is a short limestone blockwall extending from the Dome about 5-10 metres. The blockwall is heavily deteriorated with little mortar still visible, heavily weathered blocks and signs of settlement. There has been significant loss of material behind the wall, settlement, and movement of pavers.

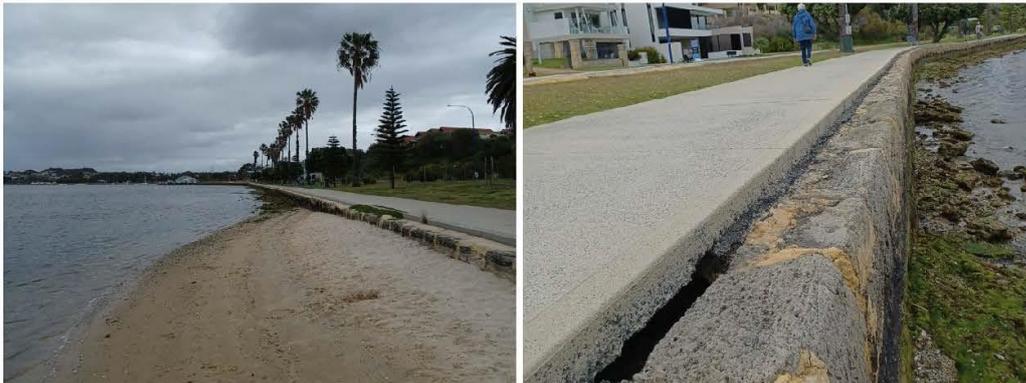
Figure 3.8 Low Limestone Blockwall (L) & Voids Beneath Path (R)

The limestone blockwall exhibited signs of recent repointing maintenance. The lower courses of the wall display loss of mortar, and there was evidence of voids behind the wall / below the path. Recent maintenance efforts have helped slow the deterioration, however further works will be required with attention to the lower courses and filling voids behind the wall.

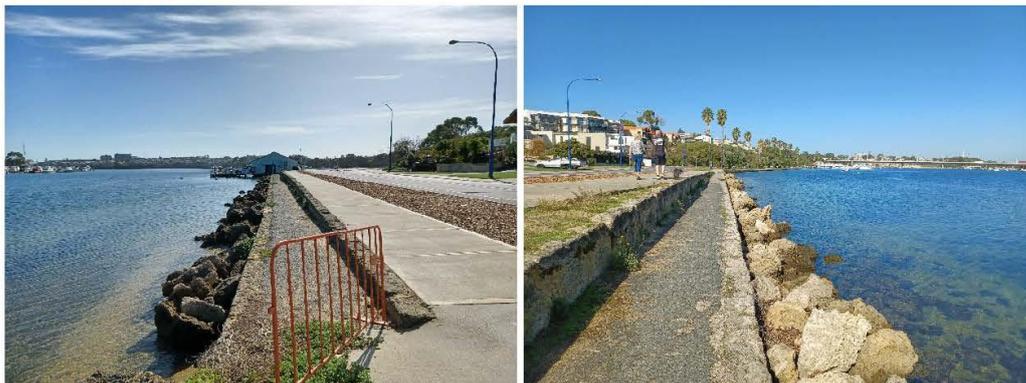
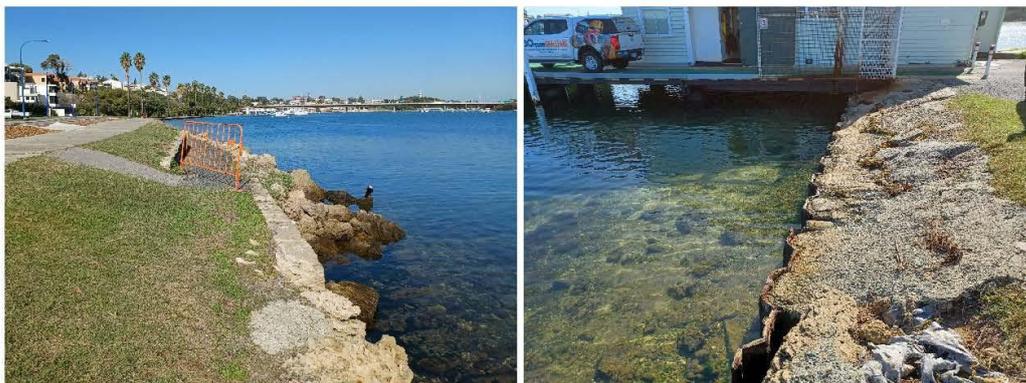
Figure 3.9a Limestone Armour in Front of Vertical Wall

Figure 3.9b Tie In (L) & Sheet Pile Wall (R)

The asset is a terraced blockwall with a bituminous pavement present on the lower-level landing (now closed off to pedestrians). A concrete path is present behind the top wall, and is in fair condition. Rock armour is present fronting the wall and provides some protection from wave energy. However, the wall is deteriorated with loss of fines and voids opening up behind the crest, resulting in a poor visual aesthetic. Recommended remediation options for this stretch could include adaption measures such as removal of the bitumen, blockwall maintenance and vegetation of the lower level.

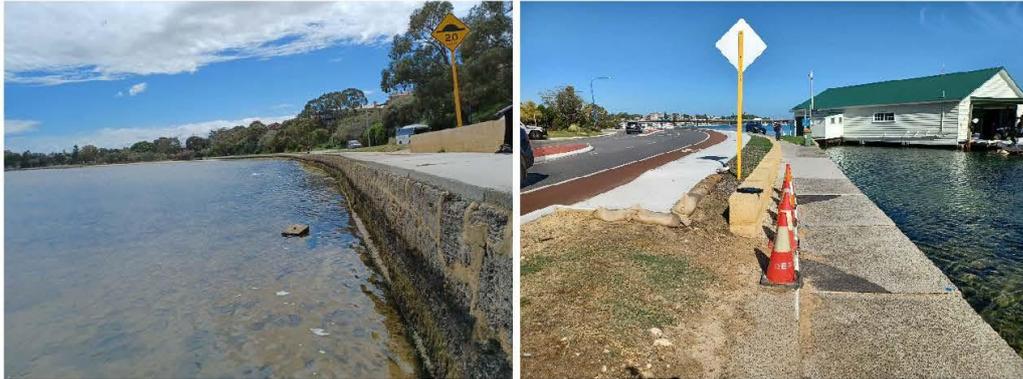
Figure 3.10 Block Wall Section (L) & Settled Path (R)

The asset is a limestone blockwall featuring a concrete path capping and toe scour protection. The wall is generally in a fair condition with signs of recent repointing maintenance. The lower courses require further repointing.

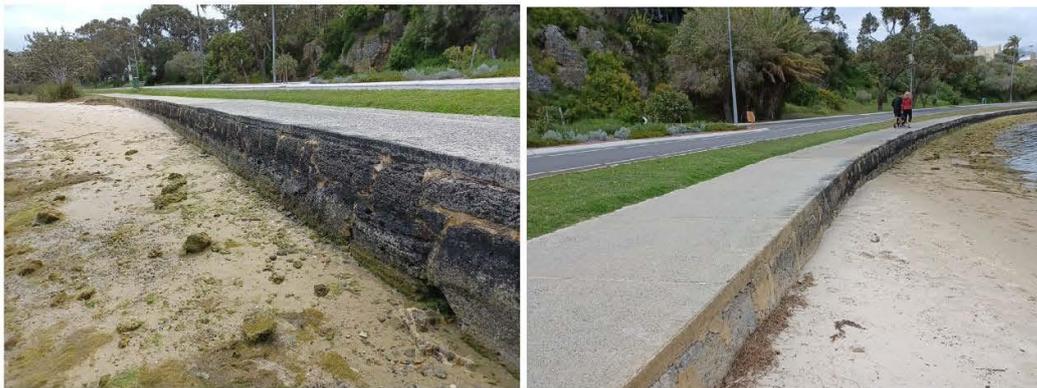
Figure 3.11 Limestone Block Wall & Sandy Beach

The asset is in moderate condition, showing signs of minor deterioration. A sandy beach in front of the wall is protecting the lower courses. Scheduled repointing maintenance is recommended to maintain the asset to its current condition.

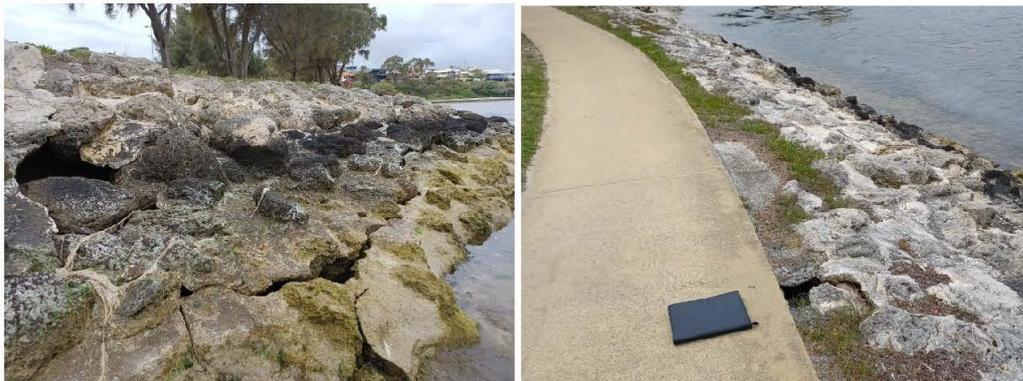
Figure 3.12 Grouted Revetment (L) & Voids Under Path (R)

The asset is a pitched (mortared) limestone rock revetment in poor condition. The grout has cracked as a result of toe undermining, allowing the lower rocks to settle. Extensive voids were present throughout revetment structure. The path exhibits cracks which is indicative of voids underneath.

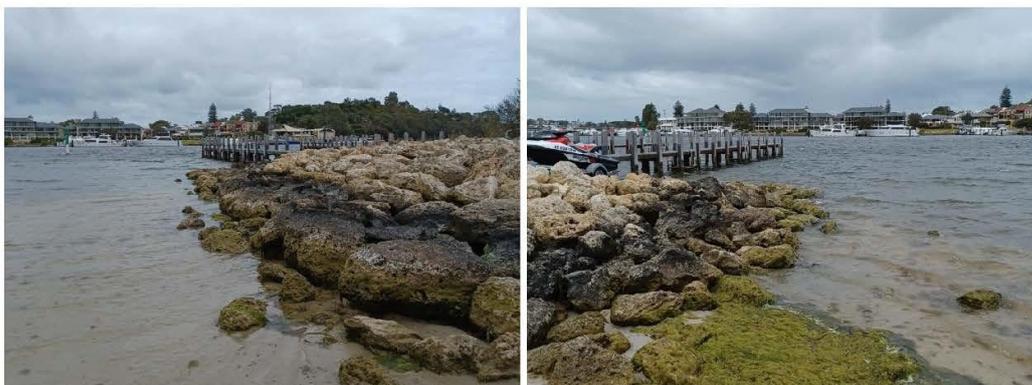
Figure 3.13 Revetment Around Boat Ramp

The limestone rock revetment around the Leeuwin boat ramp was observed to be in fair condition. Minor maintenance involving repacking of armour and loose material is required.

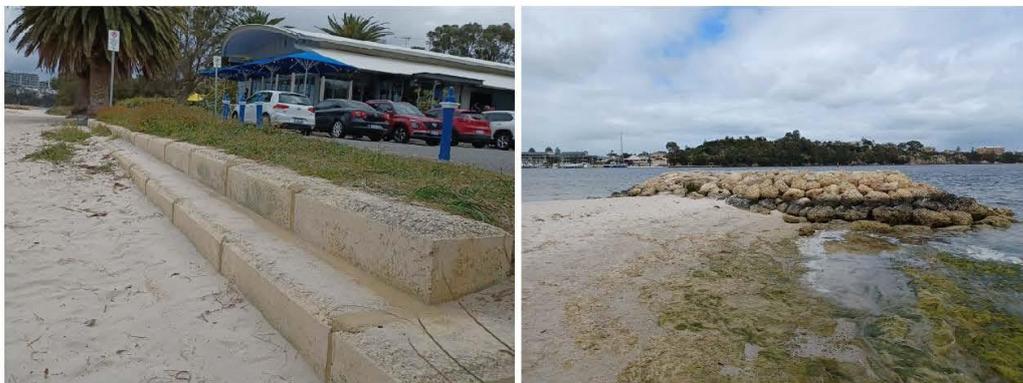
Figure 3.14 Block Wall (L) & Groyne Example (R)

The above assets were all observed to be in good condition. The maintenance requirements include ongoing monitoring.

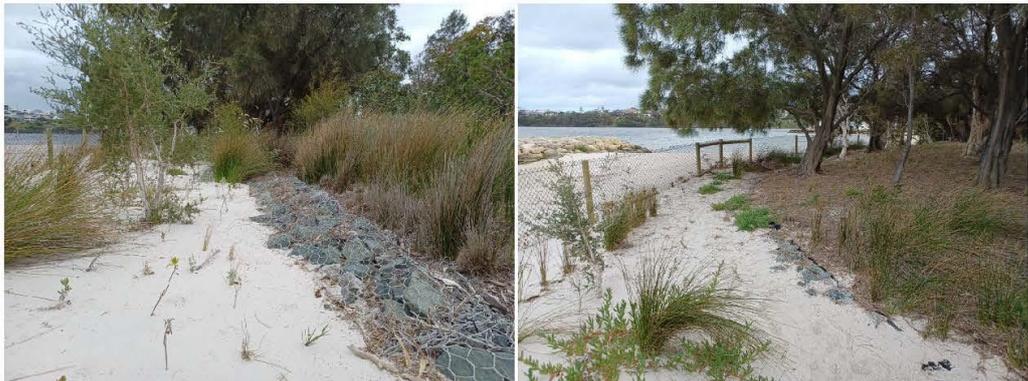
Figure 3.15 Buried Gabion/Reno Mattresses

The asset is a mostly buried gabion basket/reno mattress, with visible portions in moderate condition. No works required.

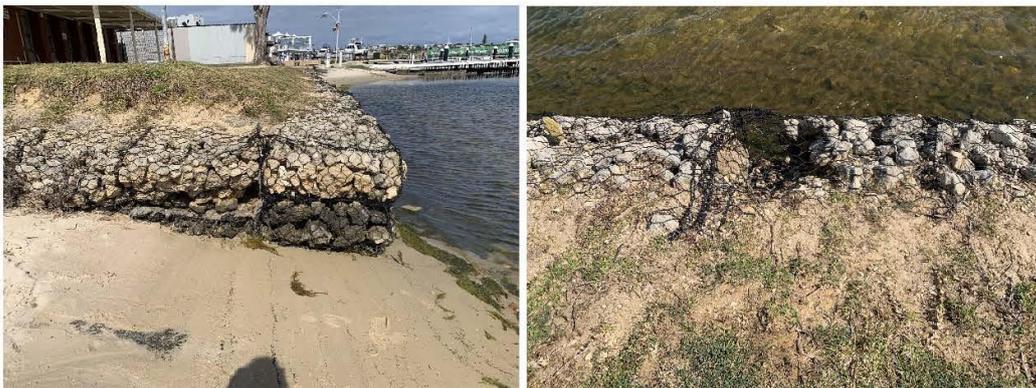
Figure 3.18 Limestone Gabions Rotated (L) & Lost Material (R)

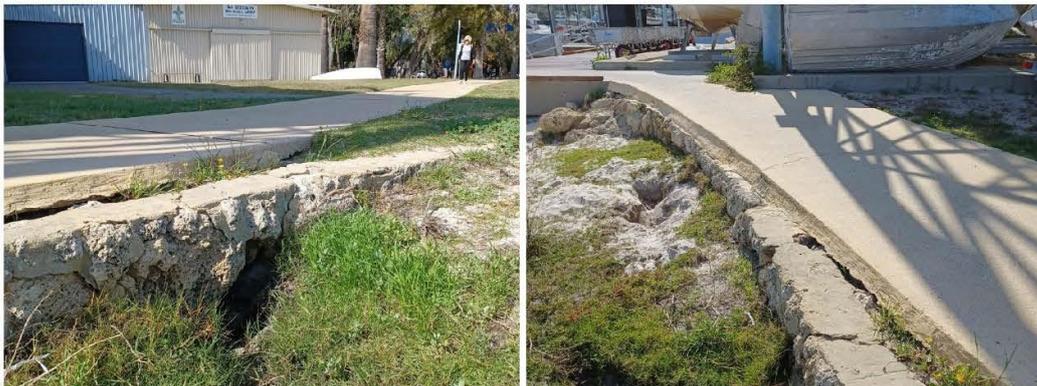
Figure 3.21 Undermined Limestone Block Wall

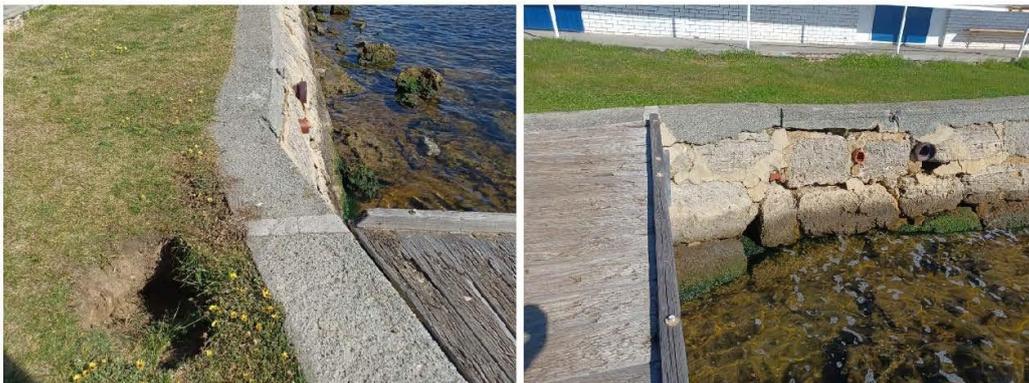
Figure 3.23 Deteriorated Limestone Block Wall

The foreshore features a deteriorated limestone block wall fronting Camp Waller Sea Scouts Hall. The blocks are weathered and exhibit a total loss of mortar through the lower courses. There is evidence of material loss through the wall leading to voids opening up behind wall crest. The voids behind wall are a safety hazard with uneven surfaces and potential for unstable ground to give way. Although outside the scope of this assessment, the jetty was also noted to be in poor condition and requires further investigation and monitoring.

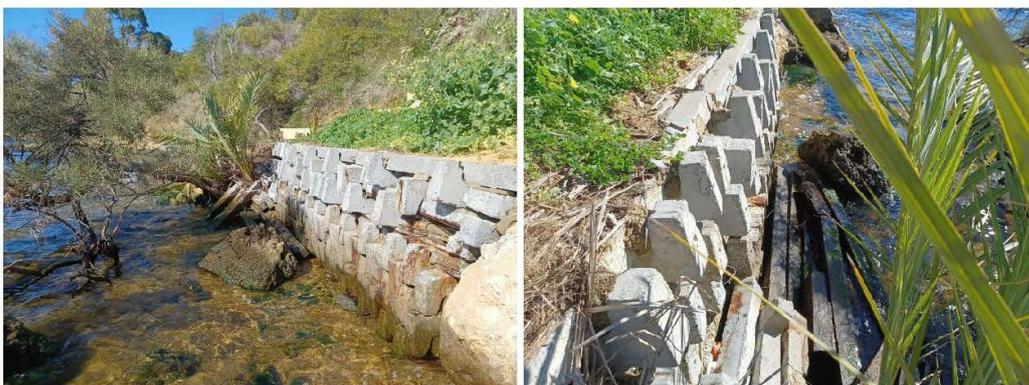
Figure 3.24 Deteriorated Crib Wall

The foreshore upstream of the building features a deteriorated crib wall which supports the concrete path behind. Many cracked and dislodged units were observed. It is recommended that the entire foreshore at this site is investigated for future significant upgrade.

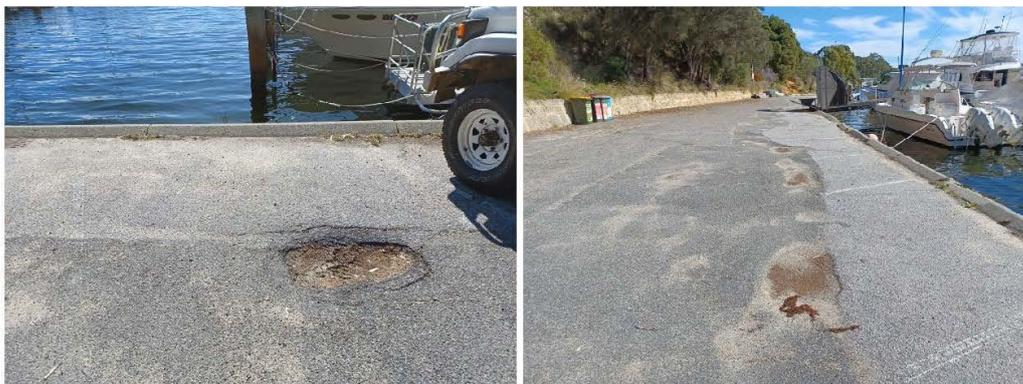
Figure 3.29 Carpark Pot Holes & Repairs

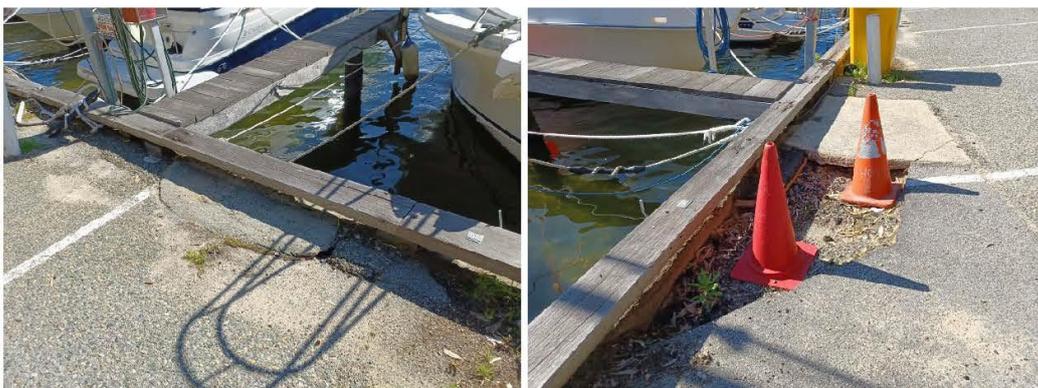
Figure 3.31 Carpark Bitumen Repairs & Settlement
