38 STATON ROAD, EAST FREMANTLE

LANDSCAPE CONCEPT

Rev C - 27.01.2022

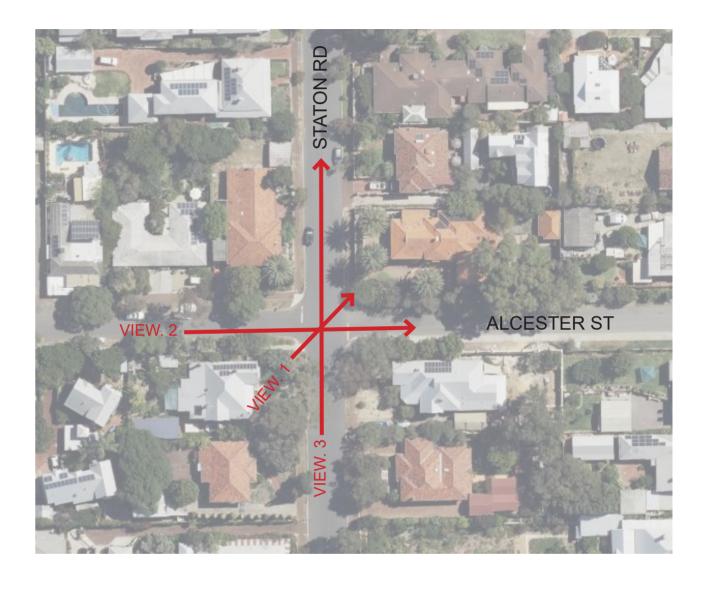
The aesthetic and heritage value of this Interwar - Federation bungalow is diminished, as the view to south side is obscured.

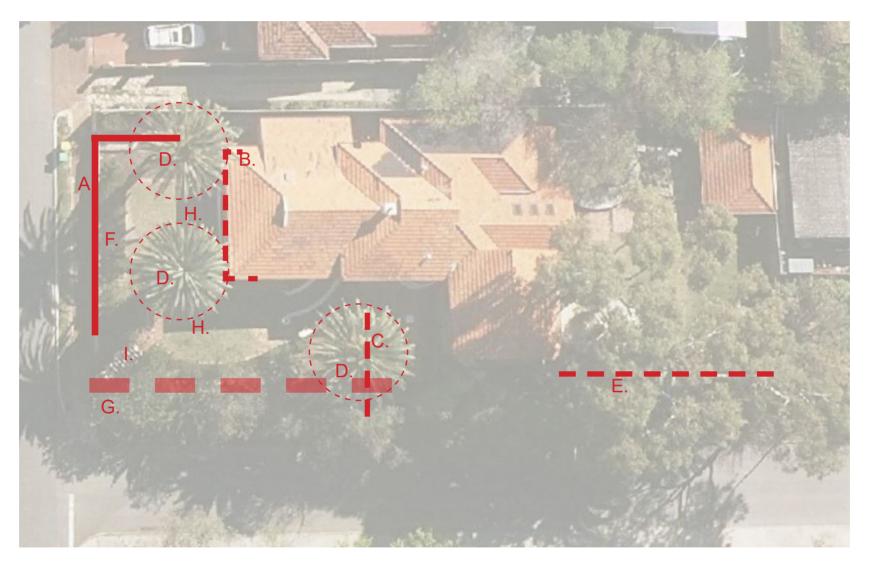
A. Front boundary wall Retaining walls' structural stability is undermined by ongoing pressure of palm roots:

Wall requires significant rectification/ rebuild to prevent public safety hazard; (refer to Structural & Heritage Engineer's assessment 16.09.2021)

B. Internal house damage Roots from palm have penetrated through to internal house tiles (refer to Structural & Heritage Engineer's assessment 16.09.2021)

C. Garage walls

Pressure from palm roots have undermined structural stability of garage; Garage will need to be replaced.; Necessary construction works will undermine stability of palm tree due to proximity of the two elements; (refer to Arboricultural assessment- TreeCare WA Feb 2021,Structural & Heritage Engineer's assessment 16.09.2021)

E. Verge palms

Self seeded palms in verge have undermined limestone wall and present a safety hazard; Damaged limestone wall to be repaired.

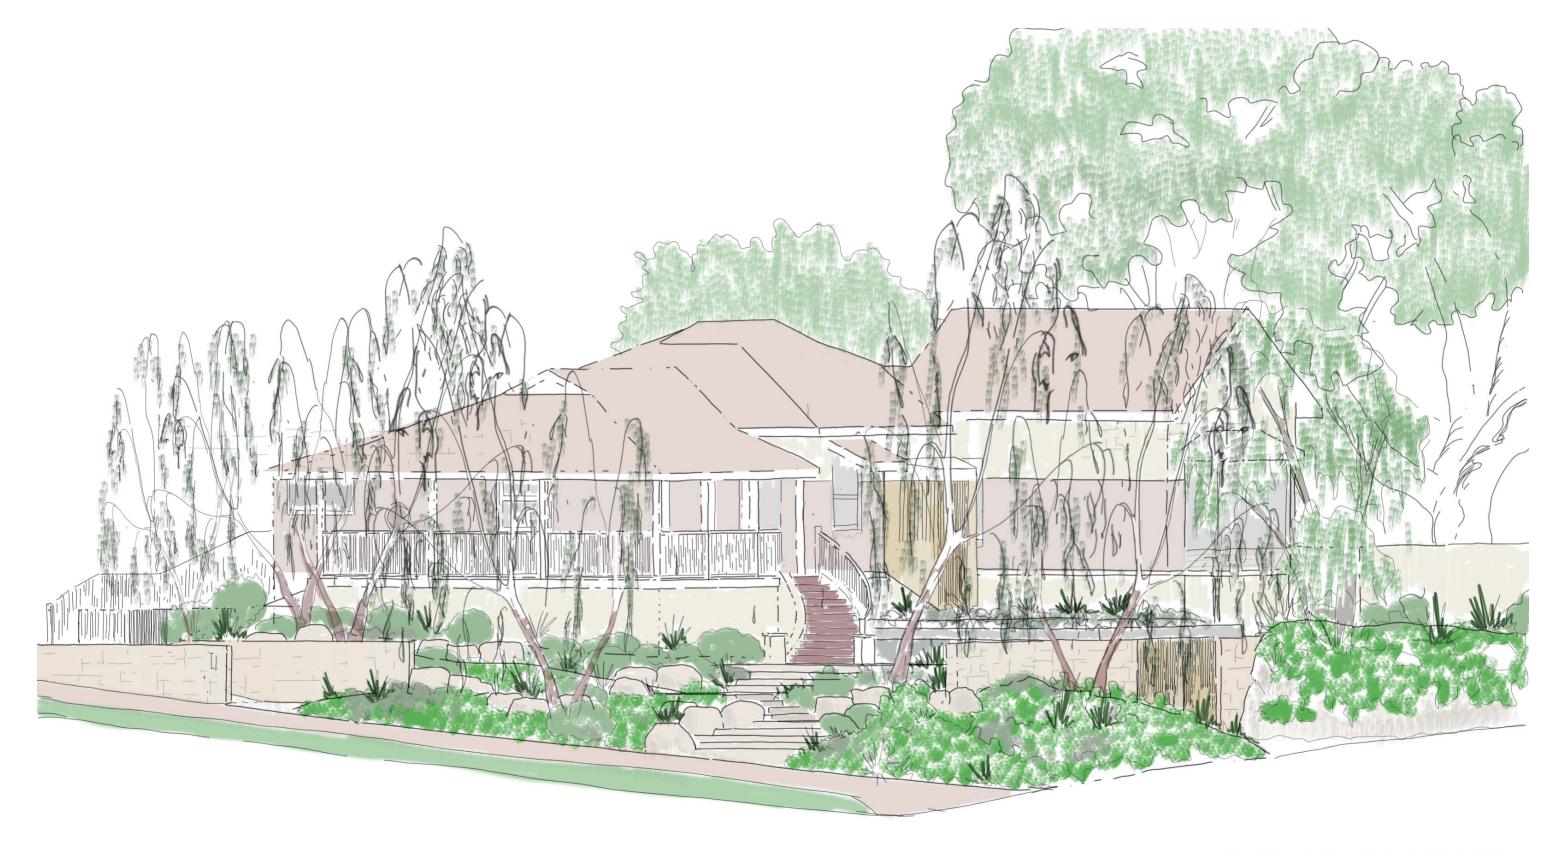
SKETCH VIEW OF STATON ROAD & ALCESTER ST ELEVATION LOOKING NORTH-EAST

Note: Refer to Architectural drawings by Philip Stejskal Architecture for house, garage and garage wall proposals

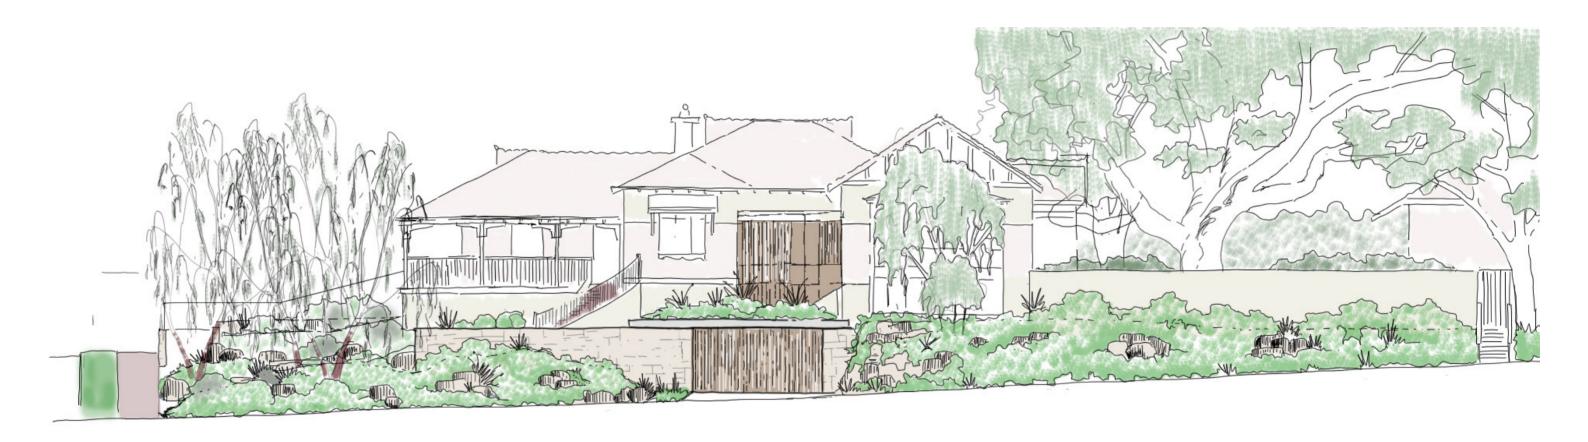
SKETCH VIEW OF ALCESTER ST ELEVATION LOOKING NORTH

Note: Refer to Architectural drawings by Philip Stejskal Architecture for house, garage and garage wall proposals
