AGENDA

Works Committee Meeting Tuesday, 23 August 2022 at 6:30 PM

The Town of East Fremantle (Town) has engaged specialist coastal and port engineers, M P Rogers & Associates Pty Ltd (MRA) to prepare a 10-year riverwall maintenance priority plan. The Town manages approximately 3.5 km of foreshore which is comprised of mixed built, natural and private foreshore assets. The riverwalls and other built foreshore assets managed by the Town are the focus of this maintenance priority plan. It should be noted that while most of the Town's foreshore built assets can be classified as vertical block walls, some other built assets such as mortared rock revetments and groynes also exist and have been included the development of this riverwall maintenance priority plan. The foreshore managed by the Town extends from East Street in the west to Petra Street in the east as shown Figure 1.1.

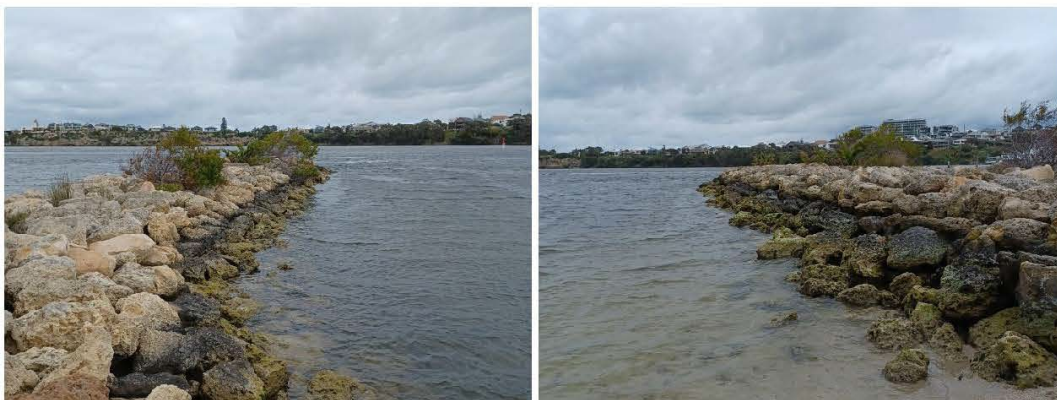
**Figure 3.16 Preston Point Groyne**

Asset ID	Approximate Chainage (m)	Asset Type	Condition Rating	Consequence Rating	OCI
SLEFr04 John Tonkin Park & Preston Point. B01	1900-1940	Groyne	2	2	7

The asset is a low limestone rock groyne and was observed to be in moderate condition. Minor repacking of loose rock is required. However, this is not considered to be a high priority maintenance item.

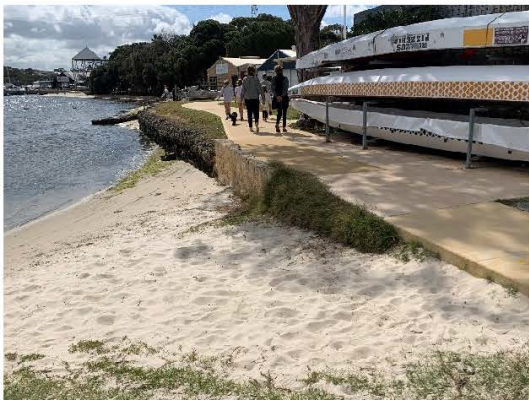
**Figure 3.17 Limestone Block Wall**

Asset ID	Approximate Chainage (m)	Asset Type	Condition Rating	Consequence Rating	OCI
SLEFr03 Norm McKenzie Reserve. B05	2055-2065	Wall	3	3	13

The asset is a short (approx. 5-10m long) limestone block wall. The wall supports a high use public path and protects the foreshore immediately in front of a building. Some weathering of the face evident and wall is slightly rotated, but overall the asset is in reasonable condition. The wall should be upgraded with improved tie-ins to the neighbouring structures in the long term.

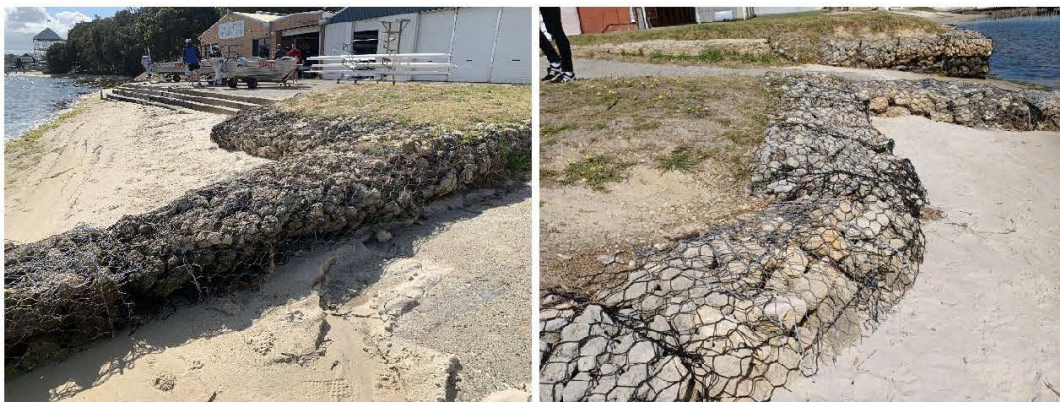
**Figure 3.19 Limestone Gabions**

Asset ID	Approximate Chainage (m)	Asset Type	Condition Rating	Consequence Rating	OCI
SLEFr03 Norm McKenzie Reserve. B03	2090-2100	Gabion	3	2	12

The gabion baskets protect the beach area and kayak ramp. Some deformation and damage of the baskets was evident, and the baskets appeared to have been previously repaired. Asset requires additional maintenance in the short term to maintain serviceability. Long term planning should include upgrading this entire stretch of foreshore.

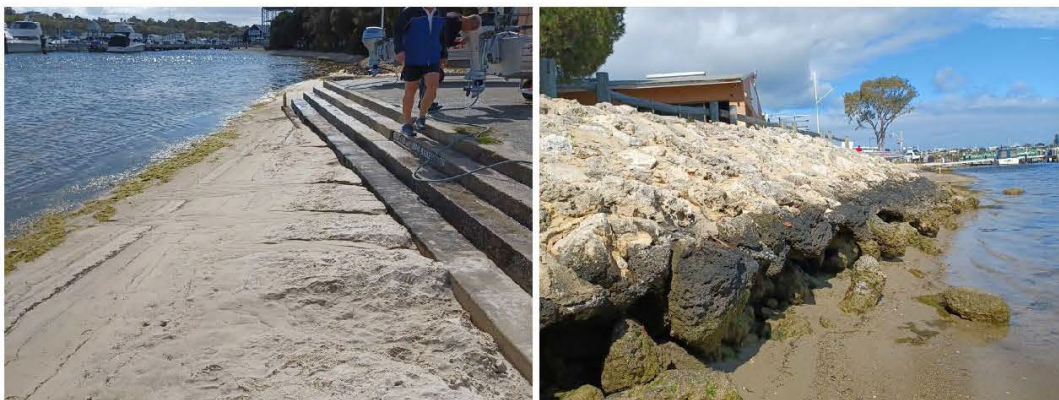
Figure 3.20 Steps (L) & Pitched Revetment (R)

Asset ID	Approximate Chainage (m)	Asset Type	Condition Rating	Consequence Rating	OCI
SLEFr03 Norm McKenzie Reserve. B02	2100-2155	Revetment	3	3	13

The asset here includes a pitched limestone revetment, steps and a ramp that service the Fremantle Rowing Club. The steps appear to be in good condition, and are partially buried by the beach. The crest of the revetment also appears to be in good condition, however the toe is severely undercut. Overall, the pitched revetment is in average condition. The mortar here has cracked and limestone material has settled and/or been lost offshore.

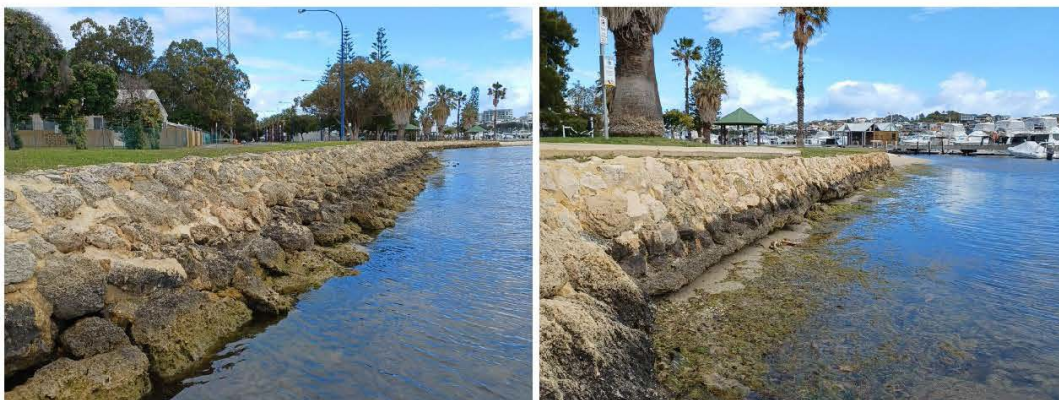
**Figure 3.22 Pitched Limestone Revetment**

Asset ID	Approximate Chainage (m)	Asset Type	Condition Rating	Consequence Rating	OCI
SLEFr02 Wayman Reserve – Jerrat Drive. B02	2425-2550	Revetment	3	2	12

The asset is a pitched limestone revetment protecting a grassy foreshore reserve and public path in places. The wall is generally in fair condition, with some loss of mortar observed through the lower sections. The toe is undercut throughout the western extent and requires maintenance.

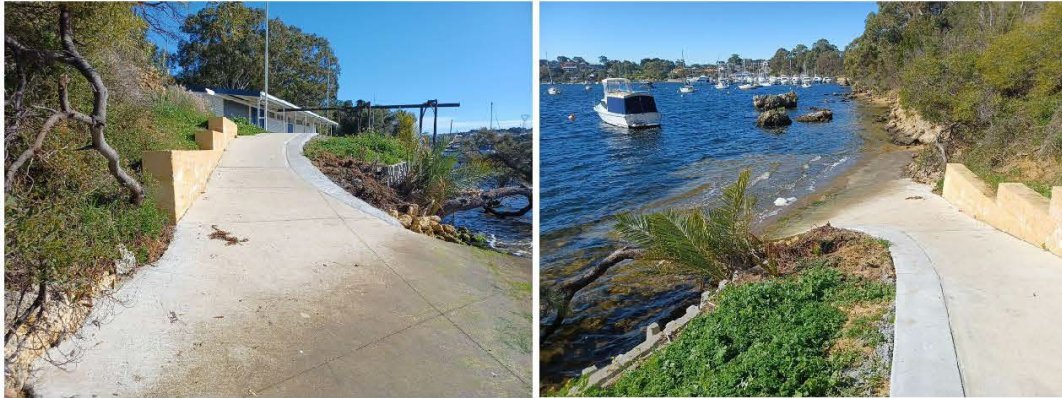
Figure 3.25 Limestone Block Wall & Concrete Apron

The asset consists of a recently constructed limestone retaining wall and a recently repaired concrete apron and path. The condition of the asset is as new. The concrete path is supported by deteriorated crib wall (aforementioned) which requires rebuild.

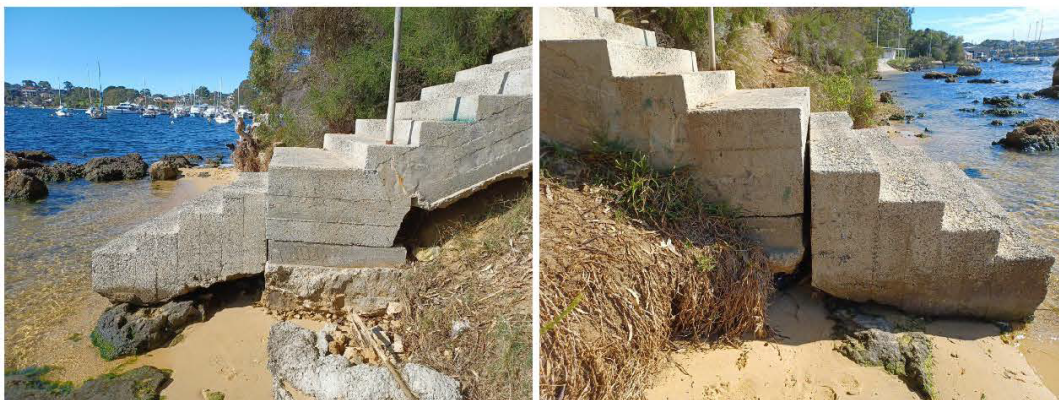
**Figure 3.26 Concrete Stair Abutment**

Asset ID	Approximate Chainage (m)	Asset Type	Condition Rating	Consequence Rating	OCI
SLEFr02 Wayman Reserve – Jerrat Drive. B03	2970	Abutment	3	2	12

The asset is the concrete stair abutment at the base of the accessway. It is noted that the assessment does not directly include the stairs further up the slope.

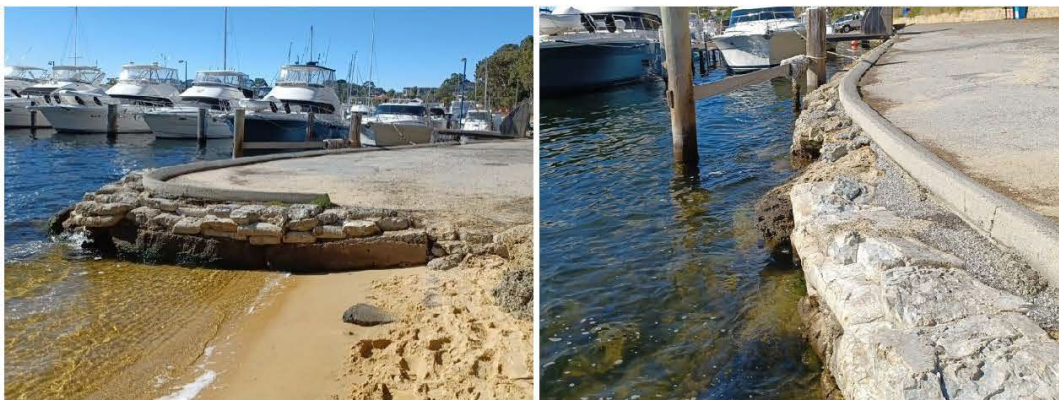
**Figure 3.27 Grout Filled Bags**

Asset ID	Approximate Chainage (m)	Asset Type	Condition Rating	Consequence Rating	OCI
EFYC 01	3100-3120	Wall	3	3	13

The asset is a low-lying wall comprised of a concrete footing and weathered grout bags. The wall protects the downstream end of the East Fremantle Yacht Club (EFYC) carpark and is utilised by members only.

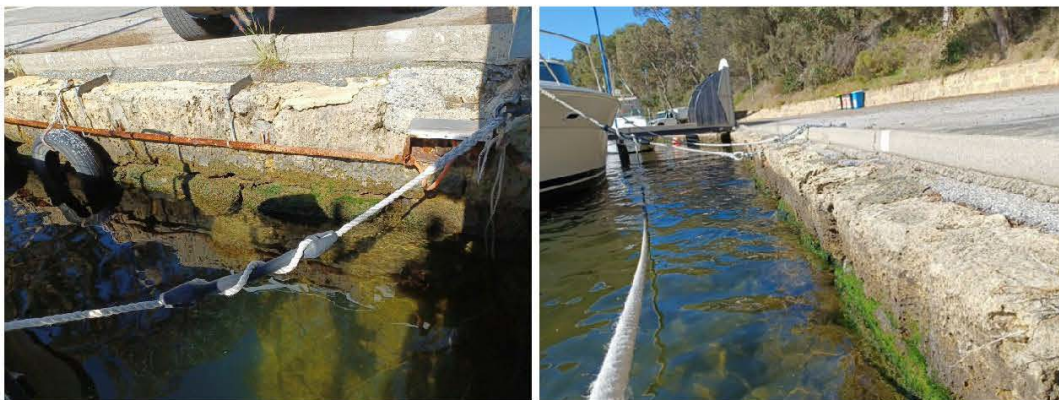
**Figure 3.28 Limestone Blockwall**

Asset ID	Approximate Chainage (m)	Asset Type	Condition Rating	Consequence Rating	OCI
EFYC 02	3120-3200	Wall	4	4	20

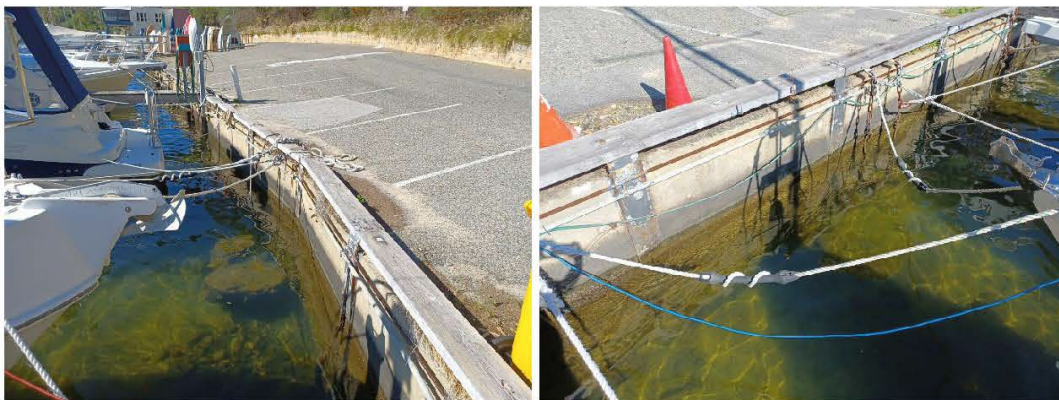
**Figure 3.30 Concrete Panel & Steel Pile Wall**

Asset ID	Approximate Chainage (m)	Asset Type	Condition Rating	Consequence Rating	OCI
EFYC 03	3200-3260	Wall	3	4	14

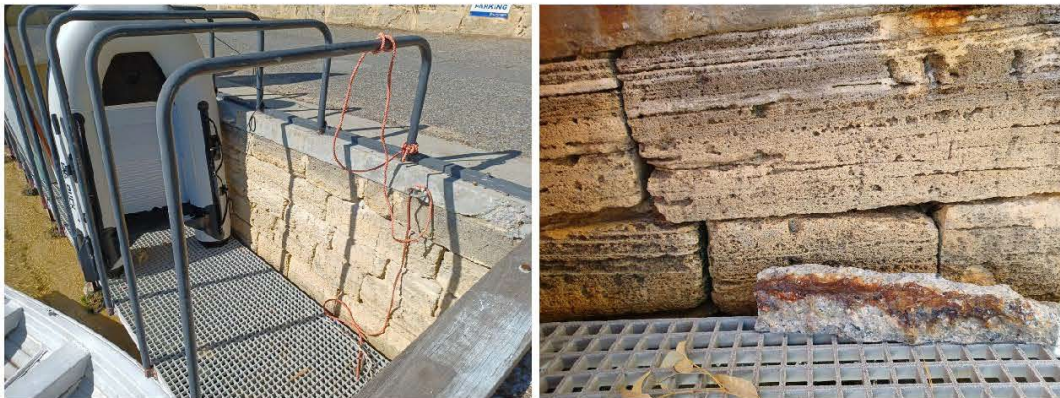
Figure 3.32 Limestone Blockwall with Dinghy Rack

Asset ID	Approximate Chainage (m)	Asset Type	Condition Rating	Consequence Rating	OCI
EFYC 04	3260-3280	Wall	3	4	14

The asset is a limestone blockwall in reasonable condition. The faces are weathered and most of the mortar is no longer evident. Repointing and refacing in the short term will prolong the lifetime of this structure considerably. The wall supports a dinghy rack and retains the road immediately behind the wall which services the carpark. Short-term maintenance will provide value in prolonging service life and reducing the risk of damage to the road.

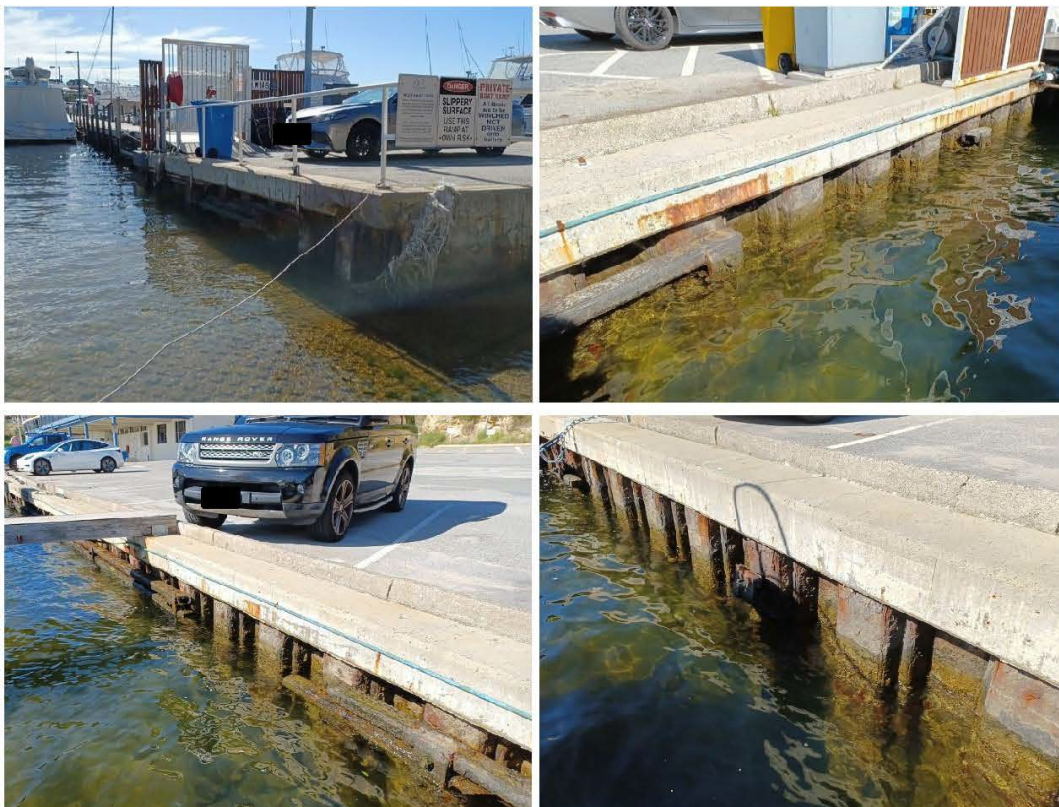
**Figure 3.33 Sheet Pile Wall with Concrete Pile Cap**

Asset ID	Approximate Chainage (m)	Asset Type	Condition Rating	Consequence Rating	OCI
EFYC 05	3300-3340	Wall	4	4	20

The asset features a heavily corroded steel sheet pile wall with a concrete pile cap, immediately backed by bituminous carpark. The steel RHS walers are heavily corroded and entirely missing in places. The concrete capping beam supports multiple finger jetties. Bituminous repairs to the carpark at the rear of the wall are indicative of material loss through the wall. The carpark allows vehicles to park almost directly above the sheet pile wall which likely has a reduced structural capacity. Assets which are fronted by deep water and allow vehicular access to the rear of the crest are considered to have a particularly high consequence of failure. This section of wall should be planned for upgrade in the near future along with a monitoring plan and additional underwater inspections in the interim.

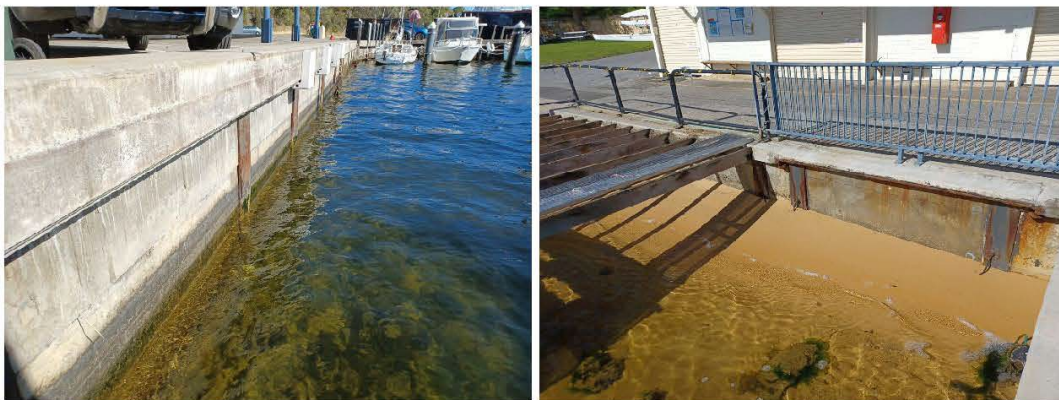
Figure 3.34 Concrete Panel & Steel H-Pile Wall

Asset ID	Approximate Chainage (m)	Asset Type	Condition Rating	Consequence Rating	OCI
EFYC 06	3340-3400	Wall	2	4	9

The wall asset is generally in good condition, and is comprised of concrete panels and driven H-section steel columns similar to EFYC 03 albeit in a slightly better condition. The steel piles are beginning to show signs of corrosion with blistering of the paint, however do not appear to yet be of structural significance. The above water portion of the concrete panels generally appeared to be in good condition. Maintenance could include repairs to the protective paint coating on the steel section.

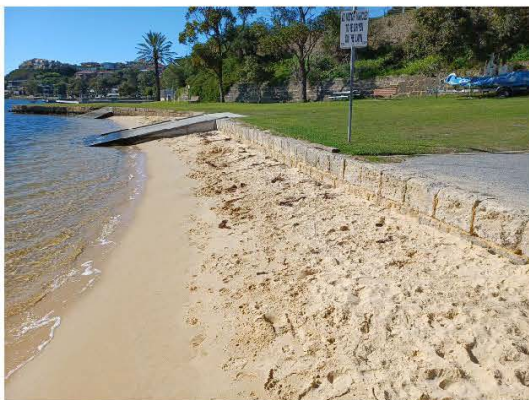
**Figure 3.35 Limestone Blockwall**

Asset ID	Approximate Chainage (m)	Asset Type	Condition Rating	Consequence Rating	OCI
EFYC 07	3400-3420	Wall	2	2	7

The asset is a low-lying limestone blockwall, and was generally in good condition. A sandy beach was present which was covering the lower courses of wall at the time of the inspection. Maintenance requirements include ongoing monitoring and future repointing.
