Works Committee Agenda Tuesday, 27 September 2022 6:30:00 PM

The Town of East Fremantle (Town) has engaged specialist coastal and port engineers, M P Rogers & Associates Pty Ltd (MRA) to prepare a 10-year riverwall maintenance priority plan. The Town manages approximately 3.5 km of foreshore which is comprised of mixed built, natural and private foreshore assets. The riverwalls and other built foreshore assets managed by the Town are the focus of this maintenance priority plan. It should be noted that while most of the Town's foreshore built assets can be classified as vertical block walls, some other built assets such as mortared rock revetments and groynes also exist and have been included the development of this riverwall maintenance priority plan. The foreshore managed by the Town extends from East Street in the west to Petra Street in the east as shown Figure 1.1.

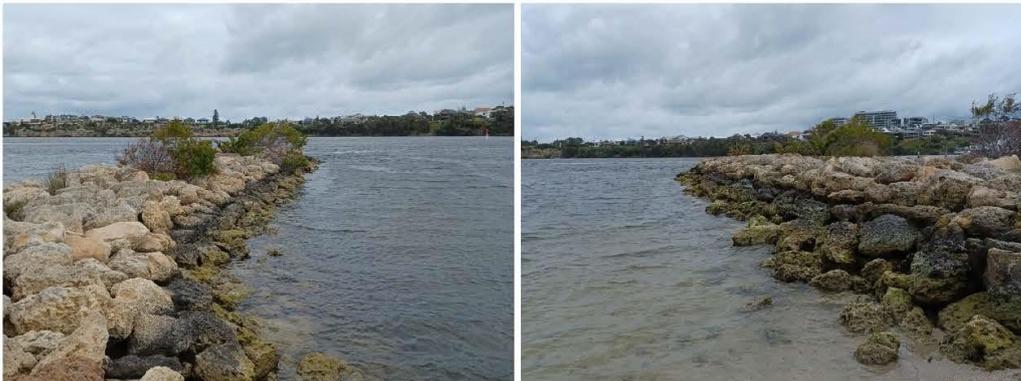
Figure 3.16 Preston Point Groyne

Asset ID	Approximate Chainage (m)	Asset Type	Condition Rating	Consequence Rating	OCI
SLEFr04 John Tonkin Park & Preston Point. B01	1900-1940	Groyne	2	2	7

The asset is a low limestone rock groyne and was observed to be in moderate condition. Minor repacking of loose rock is required. However, this is not considered to be a high priority maintenance item.

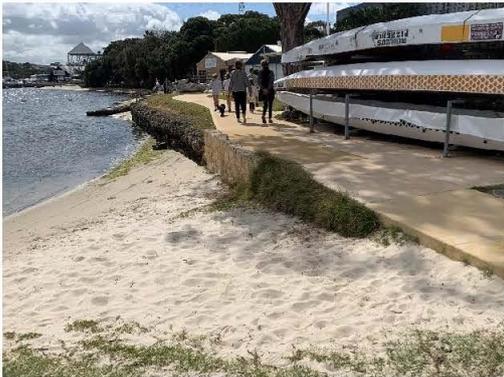
Figure 3.17 Limestone Block Wall

Asset ID	Approximate Chainage (m)	Asset Type	Condition Rating	Consequence Rating	OCI
SLEFr03 Norm McKenzie Reserve. B05	2055-2065	Wall	3	3	13

The asset is a short (approx. 5-10m long) limestone block wall. The wall supports a high use public path and protects the foreshore immediately in front of a building. Some weathering of the face evident and wall is slightly rotated, but overall the asset is in reasonable condition. The wall should be upgraded with improved tie-ins to the neighbouring structures in the long term.

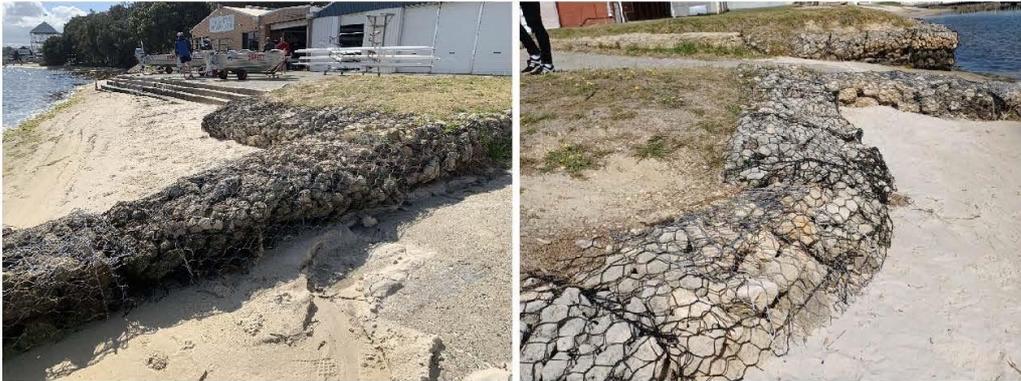
Figure 3.19 Limestone Gabions

Asset ID	Approximate Chainage (m)	Asset Type	Condition Rating	Consequence Rating	OCI
SLEFr03 Norm McKenzie Reserve. B03	2090-2100	Gabion	3	2	12

The gabion baskets protect the beach area and kayak ramp. Some deformation and damage of the baskets was evident, and the baskets appeared to have been previously repaired. Asset requires additional maintenance in the short term to maintain serviceability. Long term planning should include upgrading this entire stretch of foreshore.

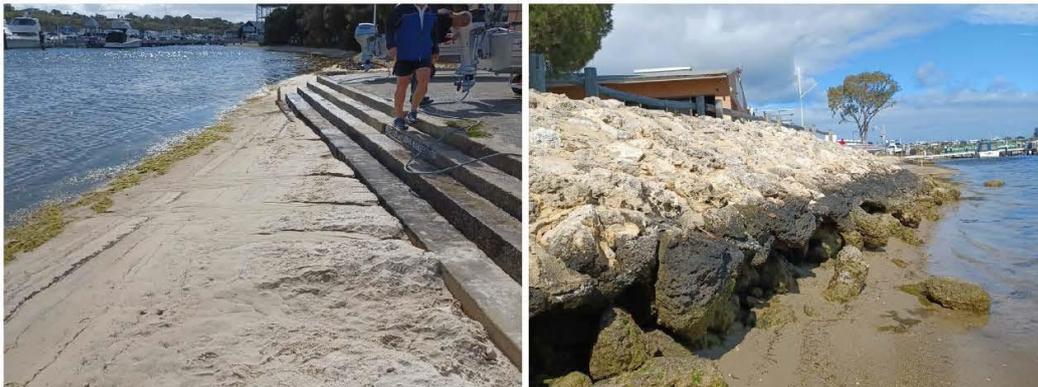
Figure 3.20 Steps (L) & Pitched Revetment (R)

Asset ID	Approximate Chainage (m)	Asset Type	Condition Rating	Consequence Rating	OCI
SLEFr03 Norm McKenzie Reserve. B02	2100-2155	Revetment	3	3	13

The asset here includes a pitched limestone revetment, steps and a ramp that service the Fremantle Rowing Club. The steps appear to be in good condition, and are partially buried by the beach. The crest of the revetment also appears to be in good condition, however the toe is severely undercut. Overall, the pitched revetment is in average condition. The mortar here has cracked and limestone material has settled and/or been lost offshore.

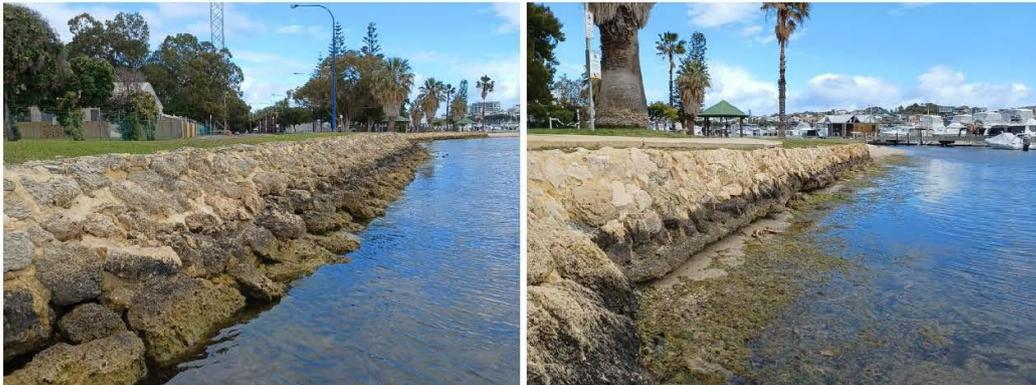
Figure 3.22 Pitched Limestone Revetment

Asset ID	Approximate Chainage (m)	Asset Type	Condition Rating	Consequence Rating	OCI
SLEFr02 Wayman Reserve – Jerrat Drive. B02	2425-2550	Revetment	3	2	12

The asset is a pitched limestone revetment protecting a grassy foreshore reserve and public path in places. The wall is generally in fair condition, with some loss of mortar observed through the lower sections. The toe is undercut throughout the western extent and requires maintenance.

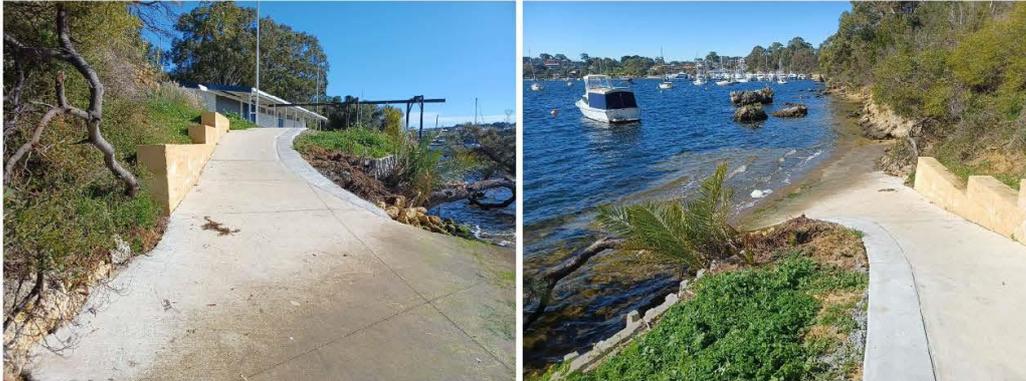
Figure 3.25 Limestone Block Wall & Concrete Apron

The asset consists of a recently constructed limestone retaining wall and a recently repaired concrete apron and path. The condition of the asset is as new. The concrete path is supported by deteriorated crib wall (aforementioned) which requires rebuild.

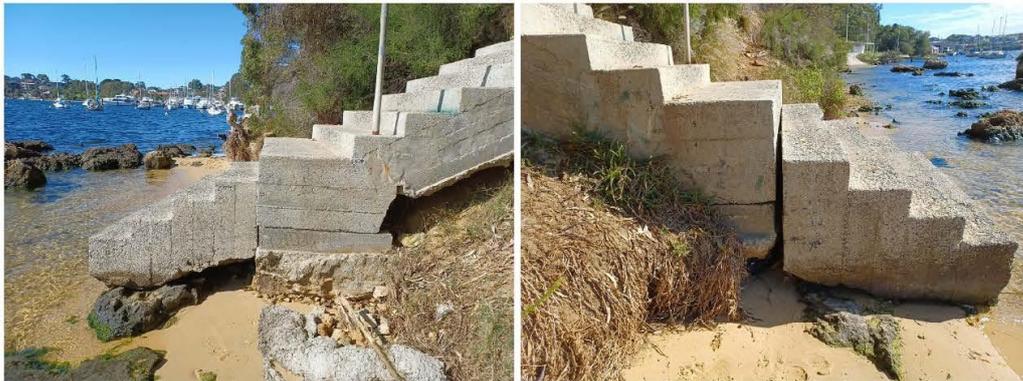
Figure 3.26 Concrete Stair Abutment

Asset ID	Approximate Chainage (m)	Asset Type	Condition Rating	Consequence Rating	OCI
SLEFr02 Wayman Reserve – Jerrat Drive. B03	2970	Abutment	3	2	12

The asset is the concrete stair abutment at the base of the accessway. It is noted that the assessment does not directly include the stairs further up the slope.

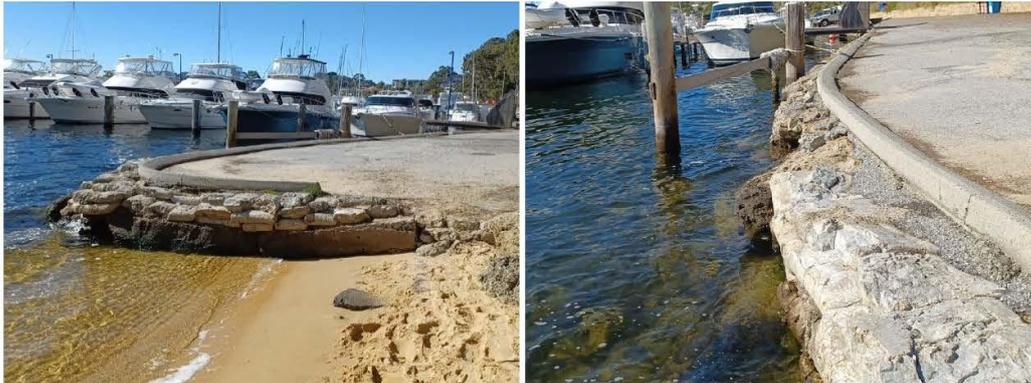
Figure 3.27 Grout Filled Bags

Asset ID	Approximate Chainage (m)	Asset Type	Condition Rating	Consequence Rating	OCI
EFYC 01	3100-3120	Wall	3	3	13

The asset is a low-lying wall comprised of a concrete footing and weathered grout bags. The wall protects the downstream end of the East Fremantle Yacht Club (EFYC) carpark and is utilised by members only.

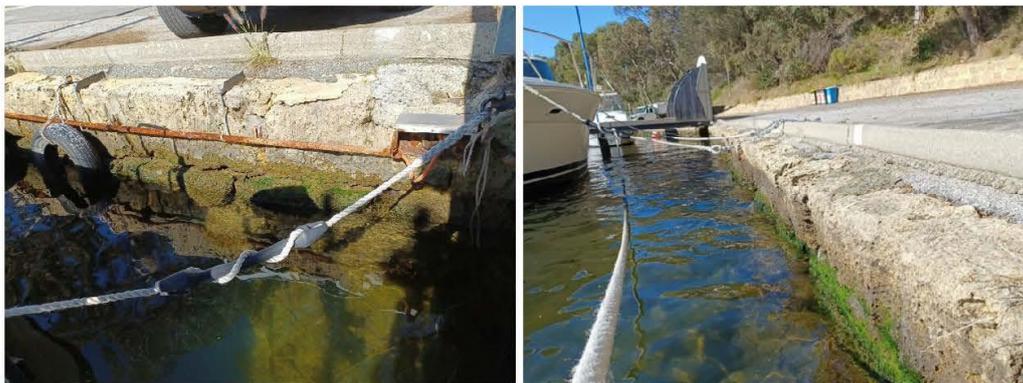
Figure 3.28 Limestone Blockwall

Asset ID	Approximate Chainage (m)	Asset Type	Condition Rating	Consequence Rating	OCI
EFYC 02	3120-3200	Wall	4	4	20

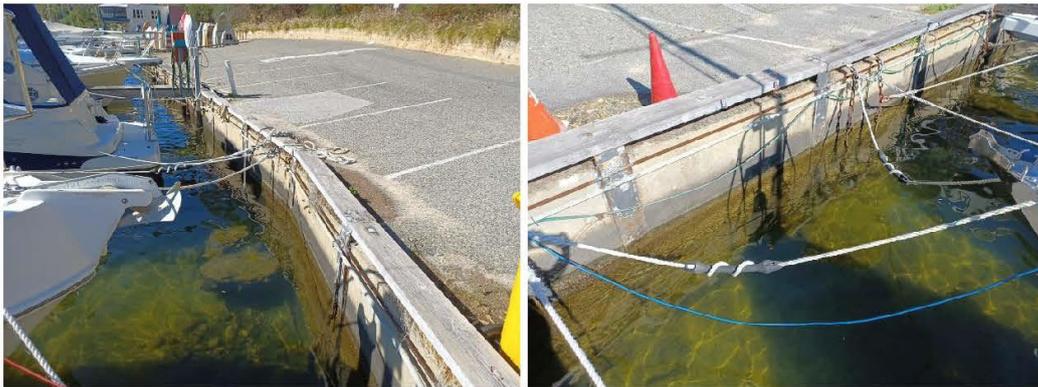
Figure 3.30 Concrete Panel & Steel Pile Wall

Asset ID	Approximate Chainage (m)	Asset Type	Condition Rating	Consequence Rating	OCI
EFYC 03	3200-3260	Wall	3	4	14

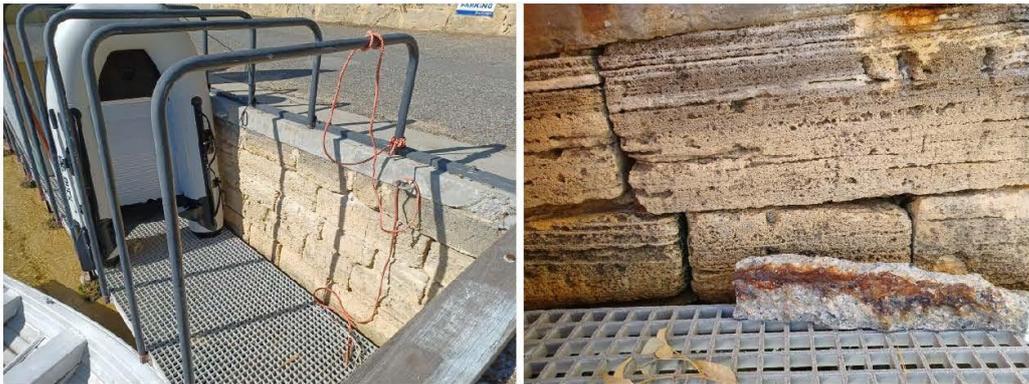
Figure 3.32 Limestone Blockwall with Dinghy Rack

Asset ID	Approximate Chainage (m)	Asset Type	Condition Rating	Consequence Rating	OCI
EFYC 04	3260-3280	Wall	3	4	14

The asset is a limestone blockwall in reasonable condition. The faces are weathered and most of the mortar is no longer evident. Repointing and refacing in the short term will prolong the lifetime of this structure considerably. The wall supports a dinghy rack and retains the road immediately behind the wall which services the carpark. Short-term maintenance will provide value in prolonging service life and reducing the risk of damage to the road.

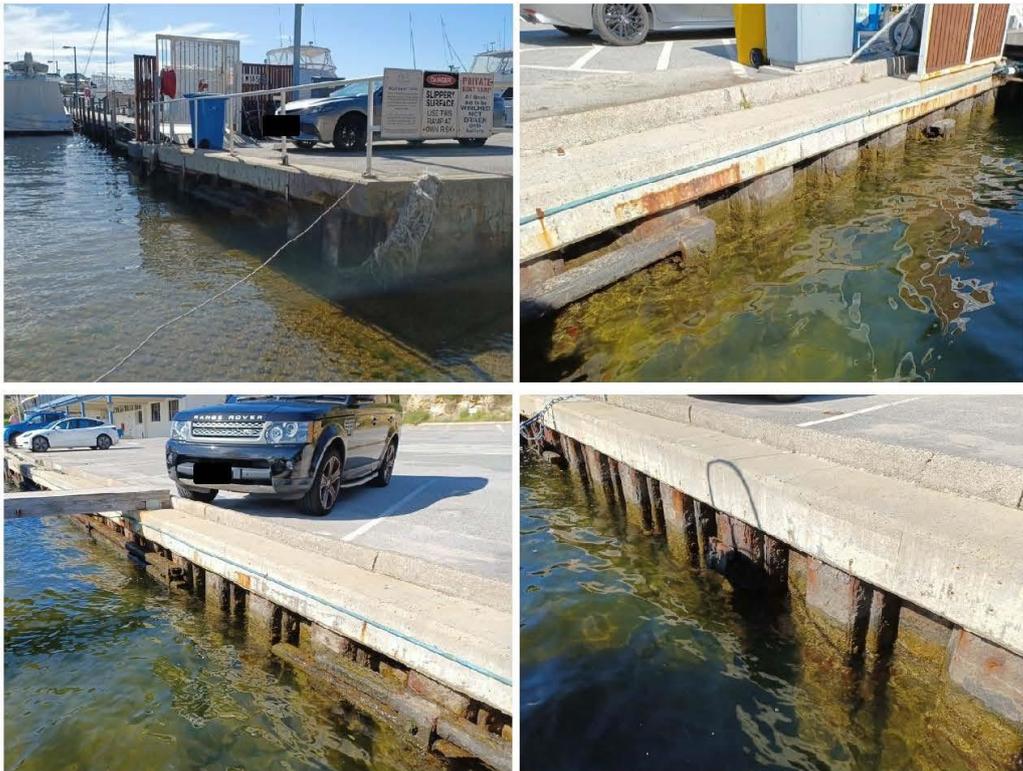
Figure 3.33 Sheet Pile Wall with Concrete Pile Cap

Asset ID	Approximate Chainage (m)	Asset Type	Condition Rating	Consequence Rating	OCI
EFYC 05	3300-3340	Wall	4	4	20

The asset features a heavily corroded steel sheet pile wall with a concrete pile cap, immediately backed by bituminous carpark. The steel RHS walers are heavily corroded and entirely missing in places. The concrete capping beam supports multiple finger jetties. Bituminous repairs to the carpark at the rear of the wall are indicative of material loss through the wall. The carpark allows vehicles to park almost directly above the sheet pile wall which likely has a reduced structural capacity. Assets which are fronted by deep water and allow vehicular access to the rear of the crest are considered to have a particularly high consequence of failure. This section of wall should be planned for upgrade in the near future along with a monitoring plan and additional underwater inspections in the interim.

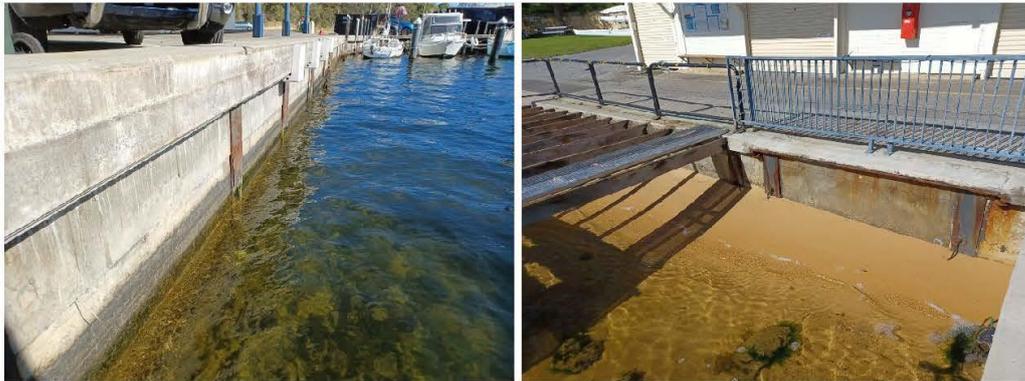
Figure 3.34 Concrete Panel & Steel H-Pile Wall

Asset ID	Approximate Chainage (m)	Asset Type	Condition Rating	Consequence Rating	OCI
EFYC 06	3340-3400	Wall	2	4	9

The wall asset is generally in good condition, and is comprised of concrete panels and driven H-section steel columns similar to EFYC 03 albeit in a slightly better condition. The steel piles are beginning to show signs of corrosion with blistering of the paint, however do not appear to yet be of structural significance. The above water portion of the concrete panels generally appeared to be in good condition. Maintenance could include repairs to the protective paint coating on the steel section.

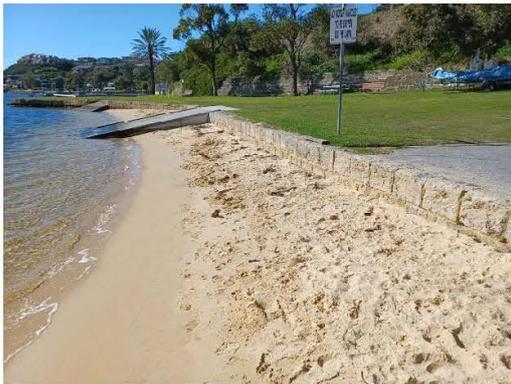
Figure 3.35 Limestone Blockwall

Asset ID	Approximate Chainage (m)	Asset Type	Condition Rating	Consequence Rating	OCI
EFYC 07	3400-3420	Wall	2	2	7

The asset is a low-lying limestone blockwall, and was generally in good condition. A sandy beach was present which was covering the lower courses of wall at the time of the inspection. Maintenance requirements include ongoing monitoring and future repointing.
